HALL BARNs FARM

STONYHURST

HERITAGE ASSESSMENT

DRAFT REPORT
FEBRUARY 2019

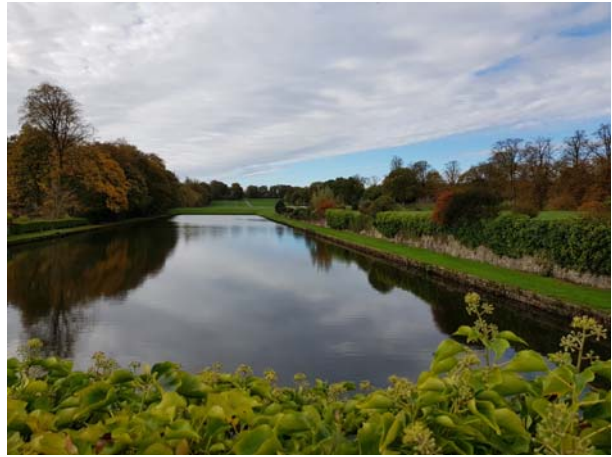
Plate 2 View along the southern of the two 'canals', looking southwest

Sir Richard's grandson, Nicholas Shireburn, extended the house after 1690, and oversaw the introduction of classical features and the formal gardens to the west and south of the house, including the parallel fishponds, or 'canals' that extend westwards from the west front of the house along the great avenue (HA 1; Plate 2). These features are depicted on two estate maps, dating to 1733 (Plate 3) and 1774 (Plate 4), and on a smaller scale on Yates' map of 1786 which shows the large house of Stonyhurst, with a great avenue leading away from the house to the southwest, the park to the west and Weld family lands to the east (OAN 2015).

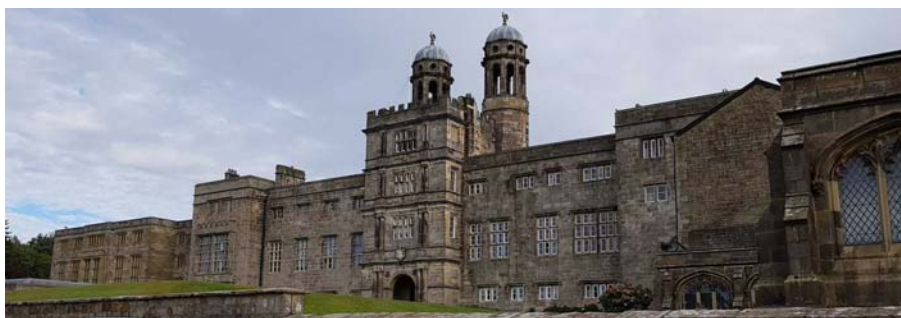
Plate 9 West front of Stonyhurst College

order to accommodate the college, the Jesuits added to the principal building, including the Shirk building of 1799 (HA 26)(Plate 9). Much greater expansion of the buildings occurred from the mid-19th-century onwards, arranged around three quadrangles. Following the Emancipation Act

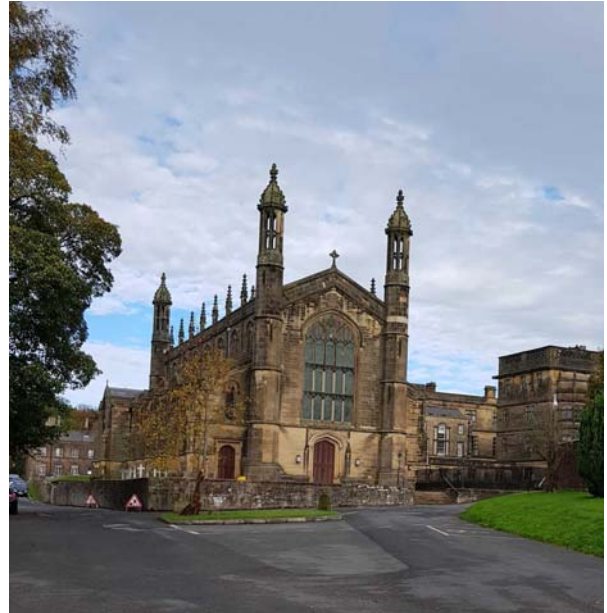
Plate 10 Church of St Peter

(1829), the Jesuits built the Church of St Peter, designed by J J Scoles and built from 1832, adjacent to the Shirk building (HA 26)(Plate 10). The Old Infirmary was added to the north end of the west front in 1842-3 (HA 27), and the service ranges of the 17th century were extended to form the Shireburn quadrangle in the first half of the 19th century (HA 28). The south front was added in 1875-1888 (HA 29).

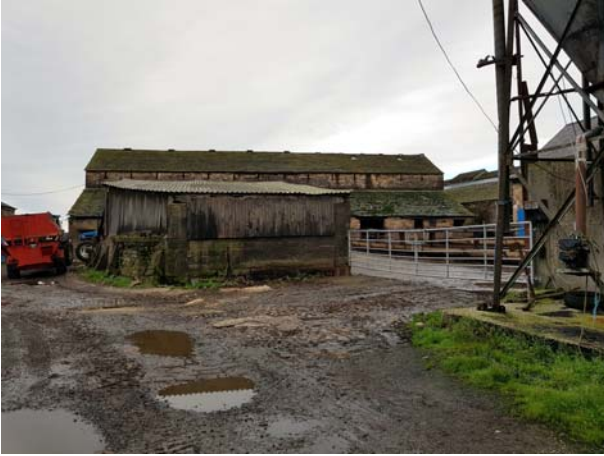
Plate 14 View of the farmyard, looking west

Hall Barns Farm is a working farm (Plate 14), and in addition to the historic barns, more modern structures exist at the site, in particular a large barn to the south of the site (Plate 15)
