**BAT SURVEY AT -
34 PAINTER WOOD
BILLINGTON**

**DATE AND TIME OF VISIT
15th March 2019 10.30 am**

REFERENCE NO. 5744

Demolition of existing house prior to construction of new dwelling.

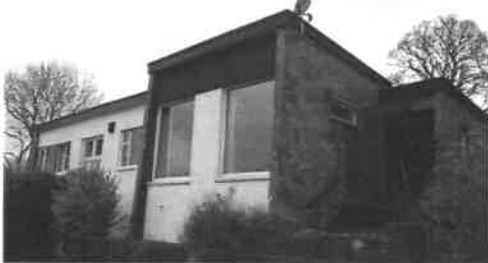
A detached bungalow dating from 1970's. Currently uninhabited.

Front elevation

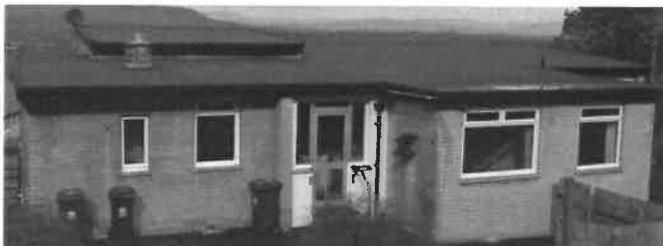
Rear elevation

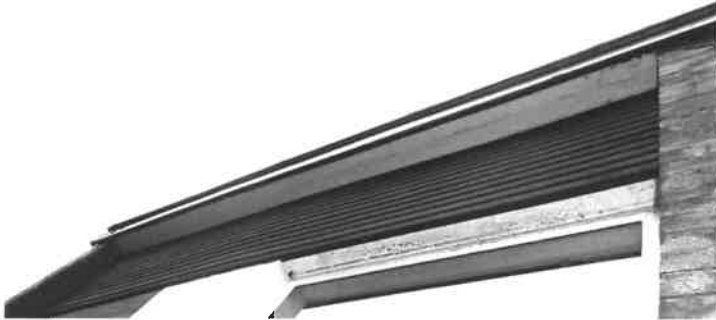
On the front elevation a small section over the windows is timber boarded

The walls are in excellent condition, no cracks, crevices or access points into the building. The timber boarding is in excellent condition it is very tight fitting and flush with the wall.

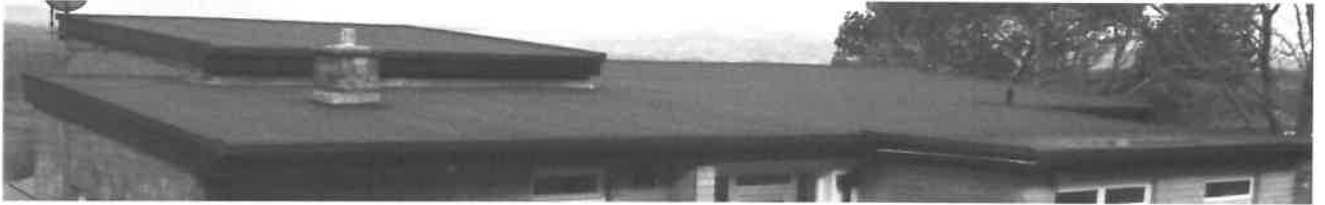
The roof is flat in two sections the smaller one being slightly higher than the main roof. The roof finish appears to be a relatively new single ply membrane system, all the fascias and soffits are upvc. Lead flashings at abutment of main roof with raised section and chimney.

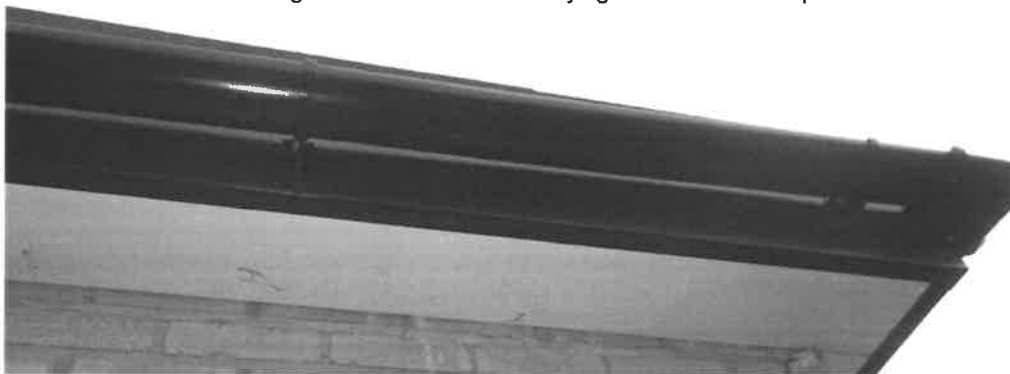
The roof is in excellent condition and all the fascias and soffits are tight fitting, with the exception of the fascia's to the side walls, where there is a small gap behind. The gaps were clear voids not providing any habitat for bats, an endoscope was also used to check if there was access into the void via gaps at the abutment of the roof and the wall. The result was negative the abutment is very tight with no access points.

upvc soffits

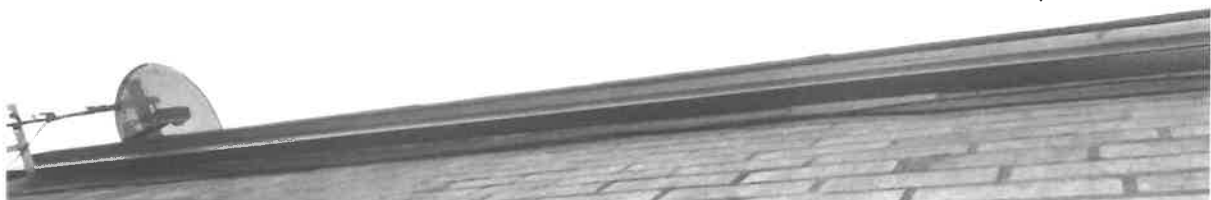
Side wall Fascia with gap behind

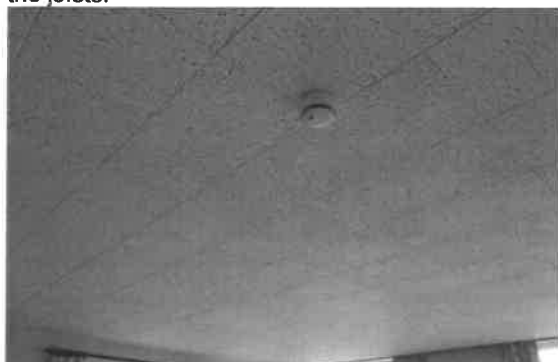
There is no enclosed roof void in this property the ceilings have a proprietary suspended system directly under the joists.
