RE: Proposed refurbishment of the Bowling Green Cafe, Clitheroe Castle Gardens

Thank you for your request for a bat survey in relation to proposed refurbishment works at the Bowling Green Cafe.

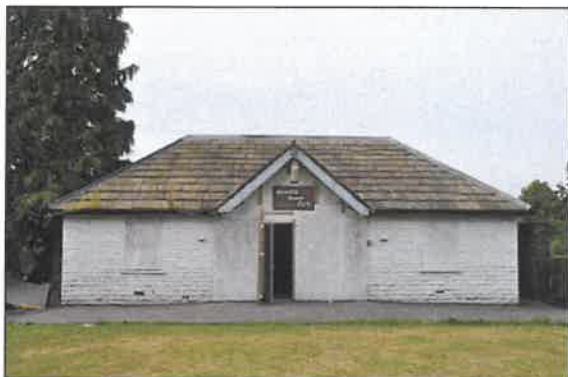
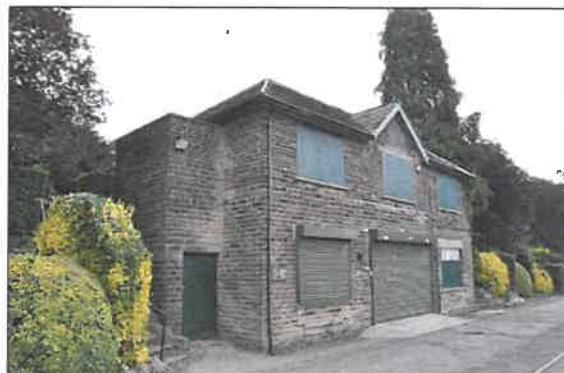
The Bowling Green Café is a disused, two storey detached building set within the grounds of the Clitheroe Castle Garden Park. The building is currently weatherproof but in a deteriorating condition. The walls are constructed of stone with a hipped, stone tiled roof. The ridge coverings are missing and have been replaced with a plastic membrane. There are timber soffits below the roof edges and gables. All windows and doors are boarded with timber boards or metal shutters. There is small, flat concrete roof extension to the west elevation that was locked and sealed at the time of the survey.

Image showing Bowling Green Cafe northeast (lhs) and southwest (rhs) elevations

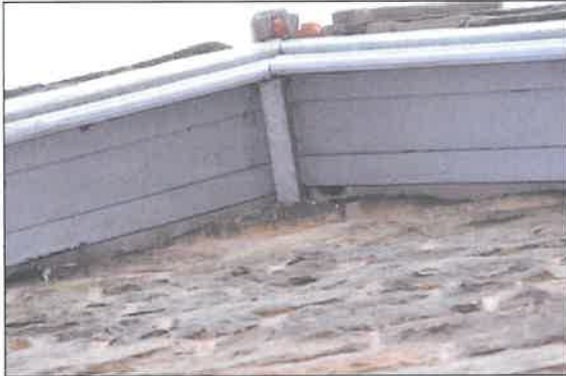
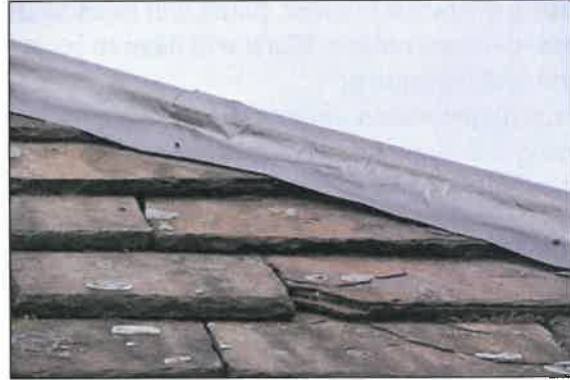
Overall, there are a number of gaps associated with stone tiled roof coverings, roof edges and soffits that have some potential to be used by bats, and some of these gaps also provide potential access for bats and birds to enter the building.

Image showing gaps along wall tops below roof overhang (lhs) and between stone tiles (rhs)

It is advised that when removal or disturbance of potential roost features, roof edges and roof coverings are to take place, this should be done carefully by hand.

It is also recommended that potential roosting features associated with the roof coverings and roof edges are retained and/or recreated following works in order to maintain opportunities for roosting bats and nesting birds.

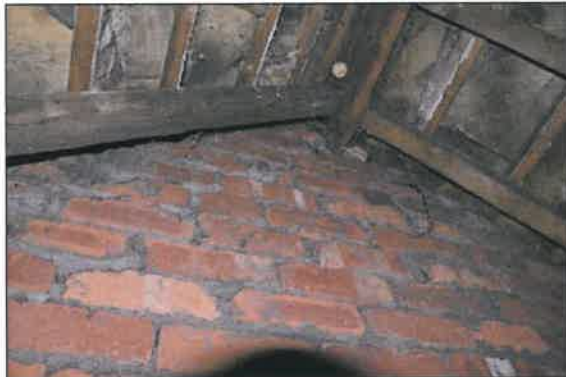
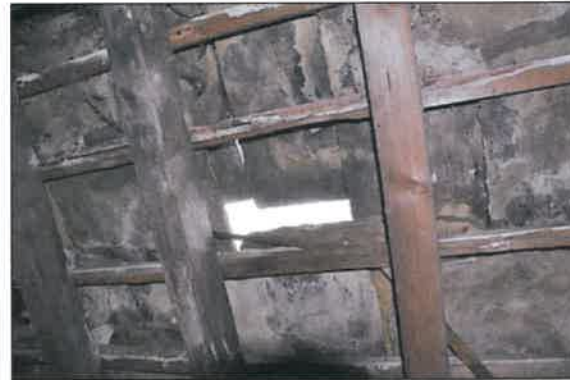
Inside the former café, the ground and first floor floors are all well sealed with no suitable features for bats. The roof void, supported on a timber framed structure, is part lined with torching. The void was draughty and light due to gaps present between tiles and along the roof edges.

Image showing internal roof void with part intact torching (lhs) and gaps between the stone tiles (rhs)
