Bat Survey Report

**Startifants Farm
Goose Lane
Chipping
PR3 2QB**

24.06.2019

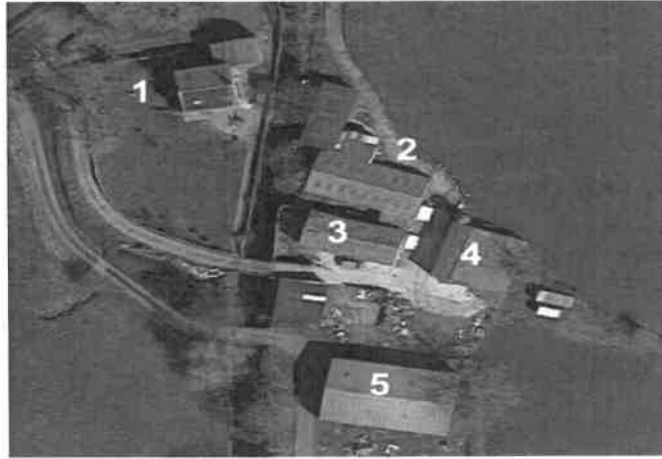
The farm consists of a main farmhouse and a complex of traditional and modern farm buildings.

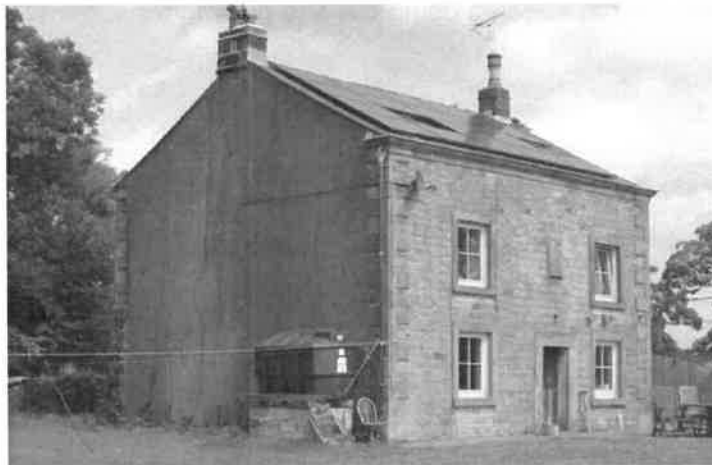
1 - The main farmhouse is a traditional stone built and partially rendered two storey detached farm house with a double pitch slate roof. A two storey extension is present on the north side of the building.

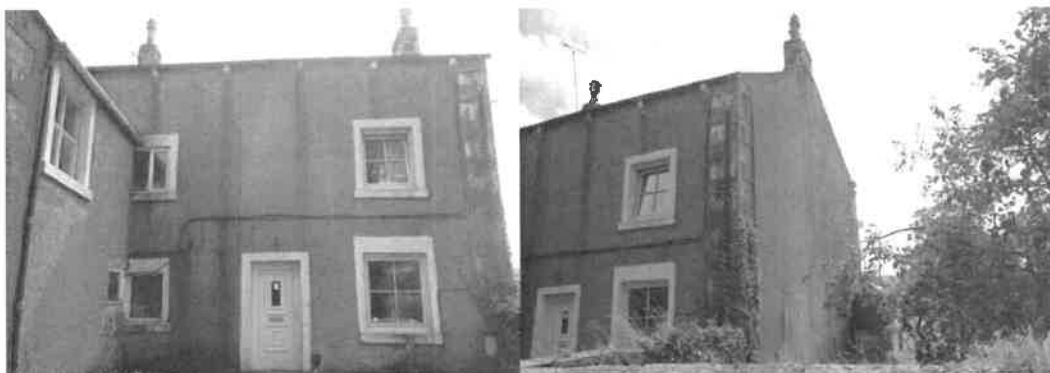
Gaps behind barge boards were recorded, the roof is in good general condition.

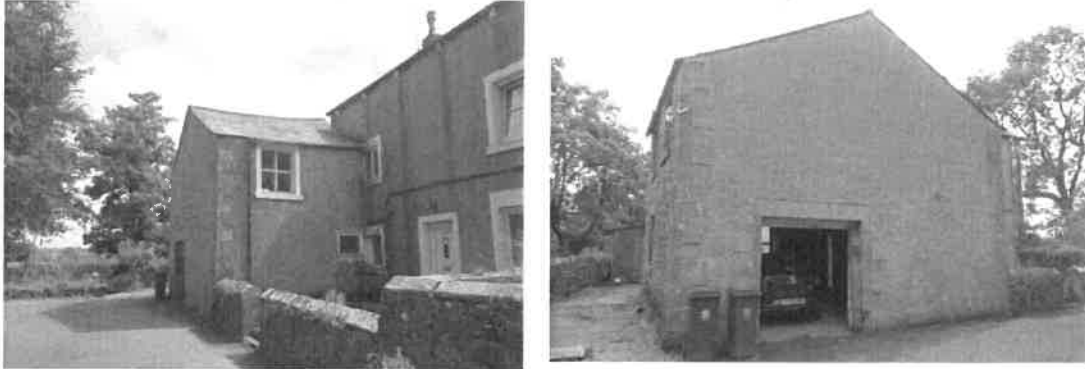
The farmhouse can be considered to be of moderate potential for roosting bats.

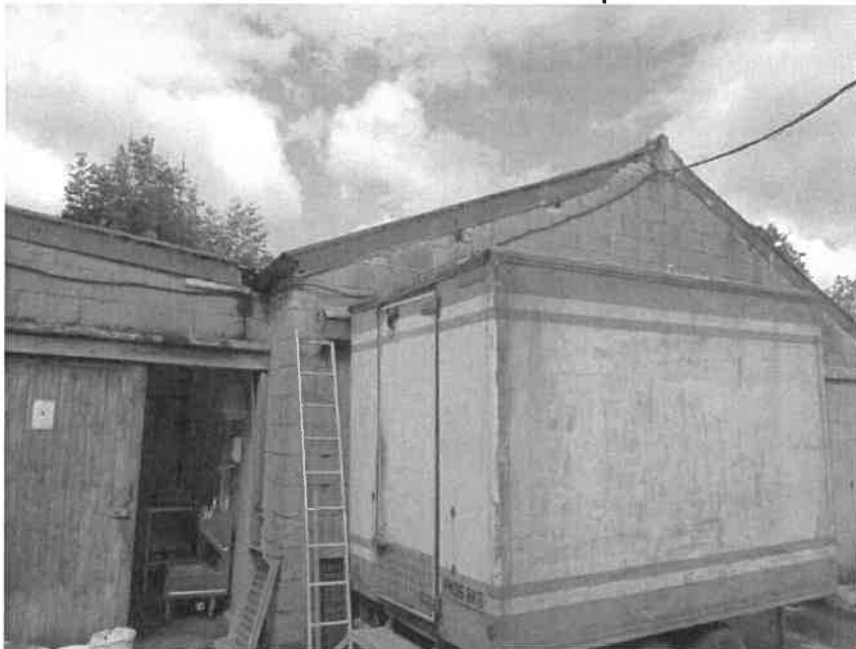
2 – A block built and corrugated roofed dairy. Considered to be of low potential for roosting bats.

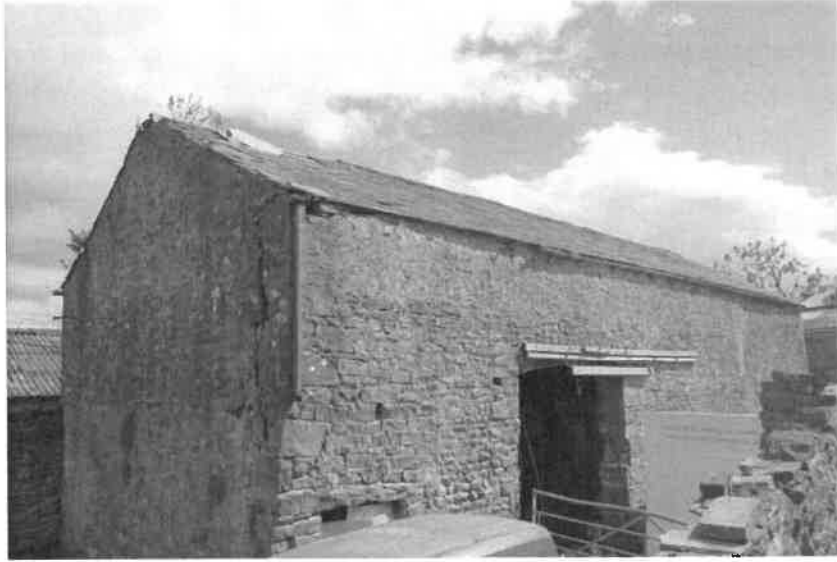
3 - A traditional stone built and slate roofed barn. Gaps and crevices are present in the external and internal walls. Roof slates are unlined and lifted tiles and missing tiles present. The building can be considered of high potential for roosting bats.

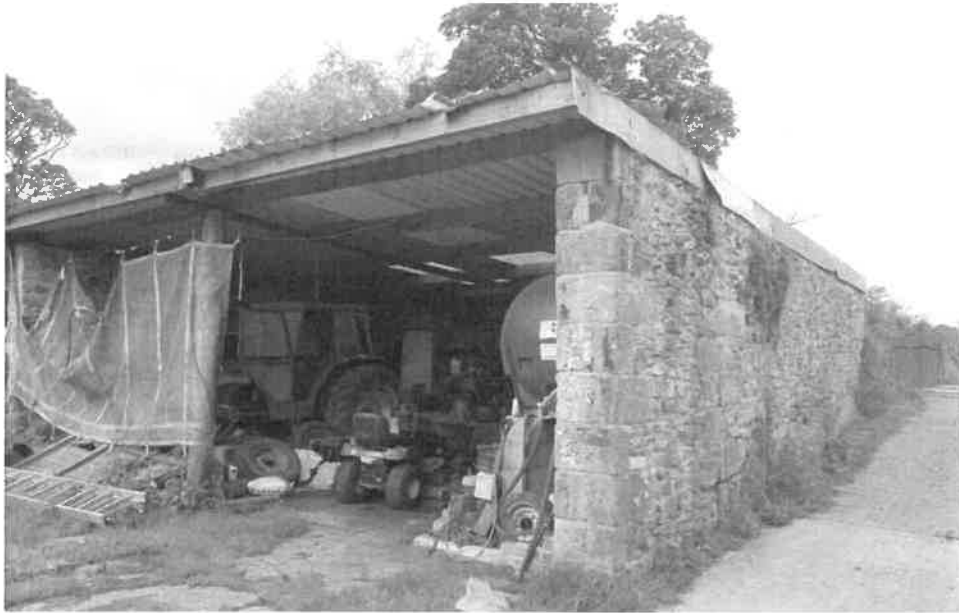
4 and 5 – An agricultural stone built lean to with single pitch corrugated roof used for storage and a modern single skin tractor store. The buildings offer low potential for roosting bats.

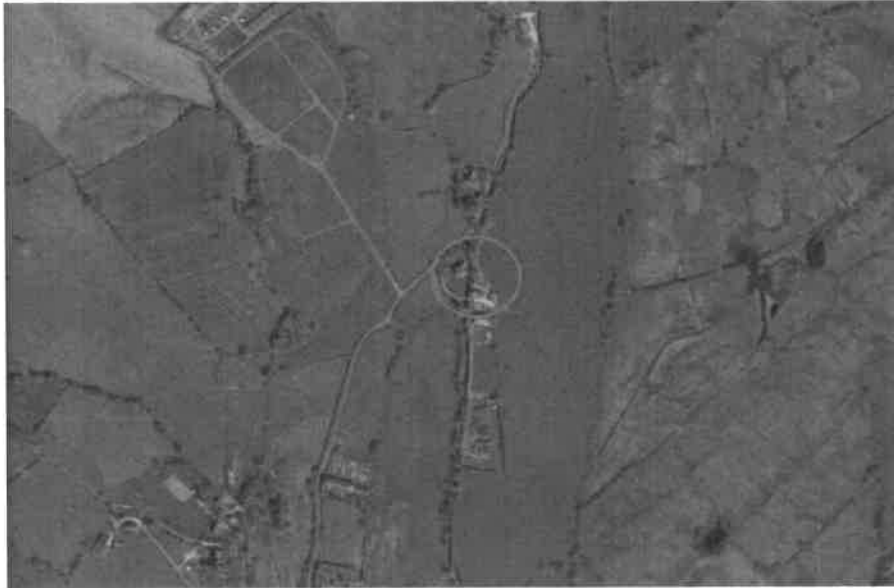
Surrounding habitat.

The property is located in a rural position with surrounding habitat dominated by improved and semi improved grassland. Field boundaries have few remnant hedgerows. Chipping brook runs through the centre of the site. The property is located close to a sewage farm.

Overall foraging potential for bats can be considered moderate to high.
