STARTIFANTS FARM, LONGRIDGE ROAD, CHIPPING, LANCASHIRE:

HERITAGE STATEMENT IN SUPPORT OF PLANNING APPLICATION FOR DEMOLITION AND REBUILDING OF FARMHOUSE AND CONVERSION ETC

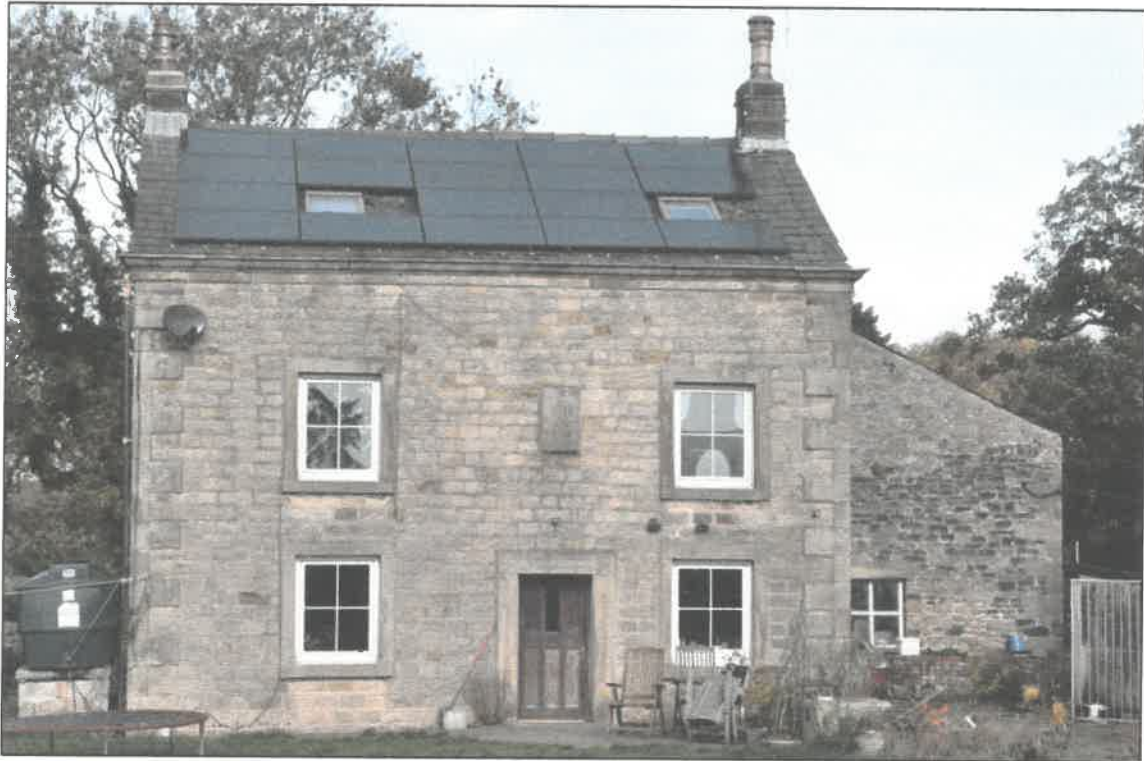
- 6.2 The house is south-facing and its front is of coursed sandstone, embellished by projecting ashlar quoins, a heavy, decoratively tooled door surround, monolithic ashlar quoins to the windows, and a cyma-moulded eaves cornice, as well as the date-stone. The sides and rear appear to be of random rubble, although west gable and rear are rendered, the latter with pebble-dash. The west side is blind, but the east gable contains a tall stair window, with small opening at attic level above, as well as a modern, inserted doorway. There is an original doorway in the rear elevation and four plain windows, two of them slighted by the later garage/trap house; the guttering here is borne on moulded corbels. All windows throughout the house have uPVC frames, and two of the doors are uPVC, though the front door is timber (modern softwood).

Photo 1: Farmhouse, with garage/trap house to right

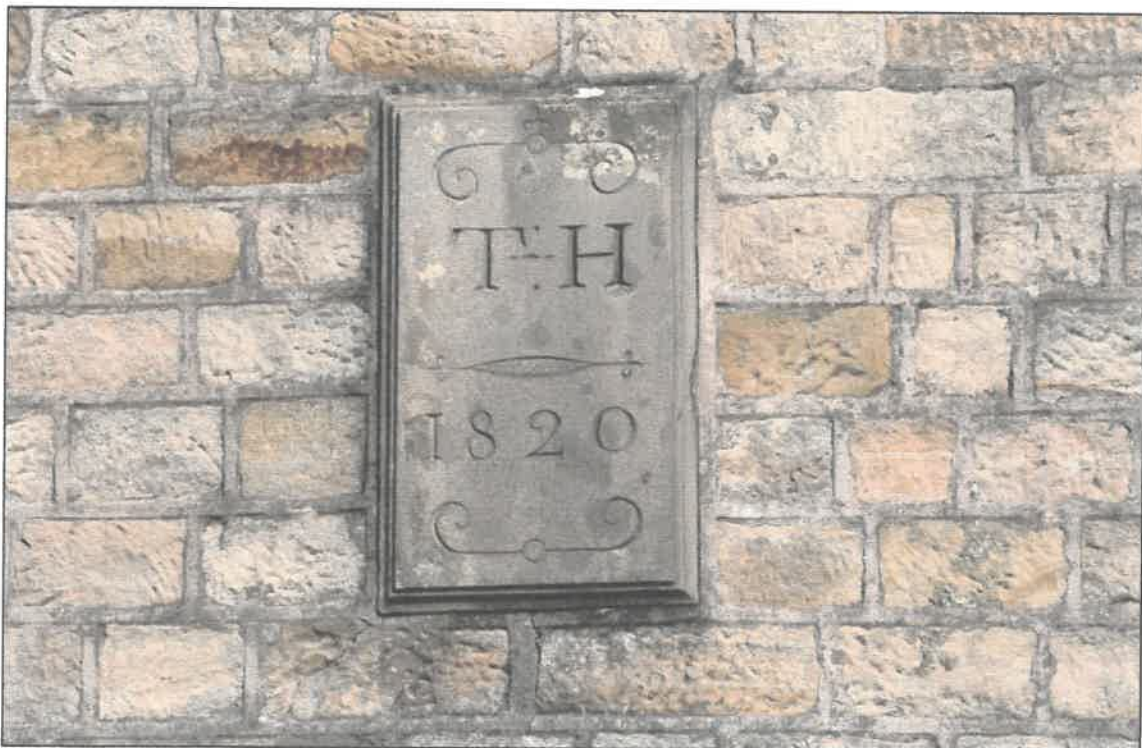
- 6.1 Architectural evidence, in the form of a prominent date-stone to the front elevation, indicates that the present farmhouse was built in 1820, a date entirely in keeping with the building's outward and internal appearances, including its plan-form. The date-stone also bears the initials TH, for Thomas Howson.

Photo 2: Farmhouse: detail of date-stone

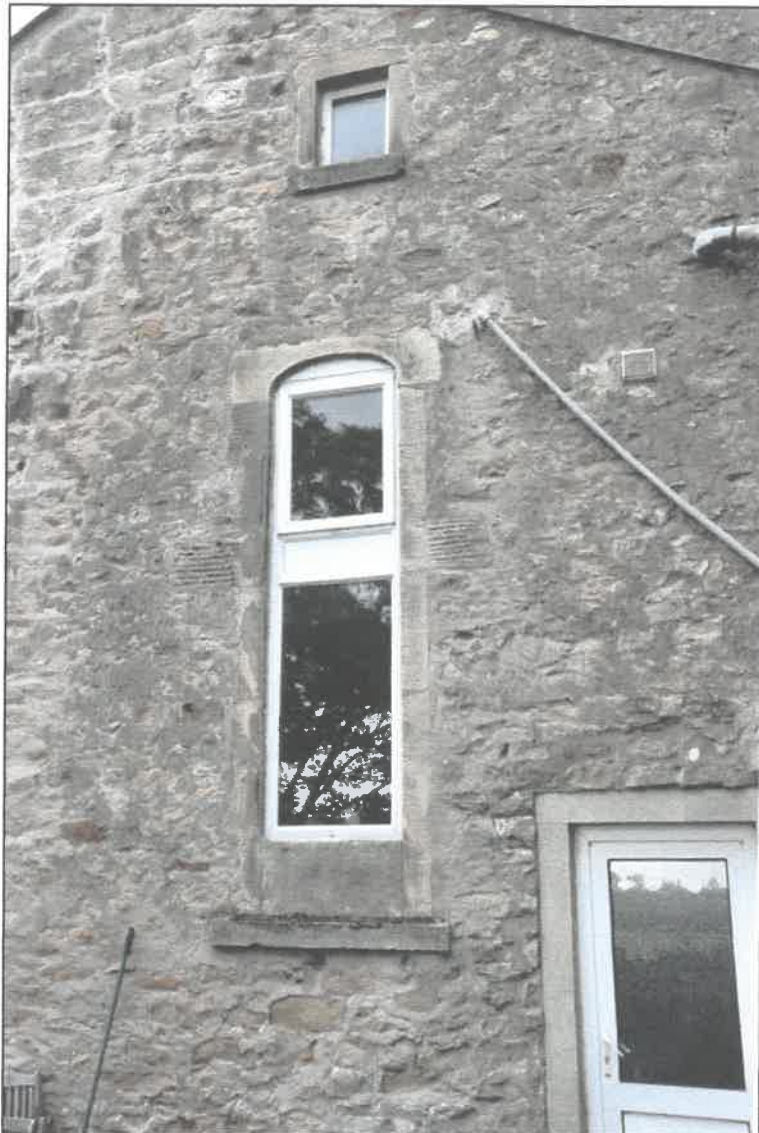
Photo 3: Farmhouse: east gable, with stair windows

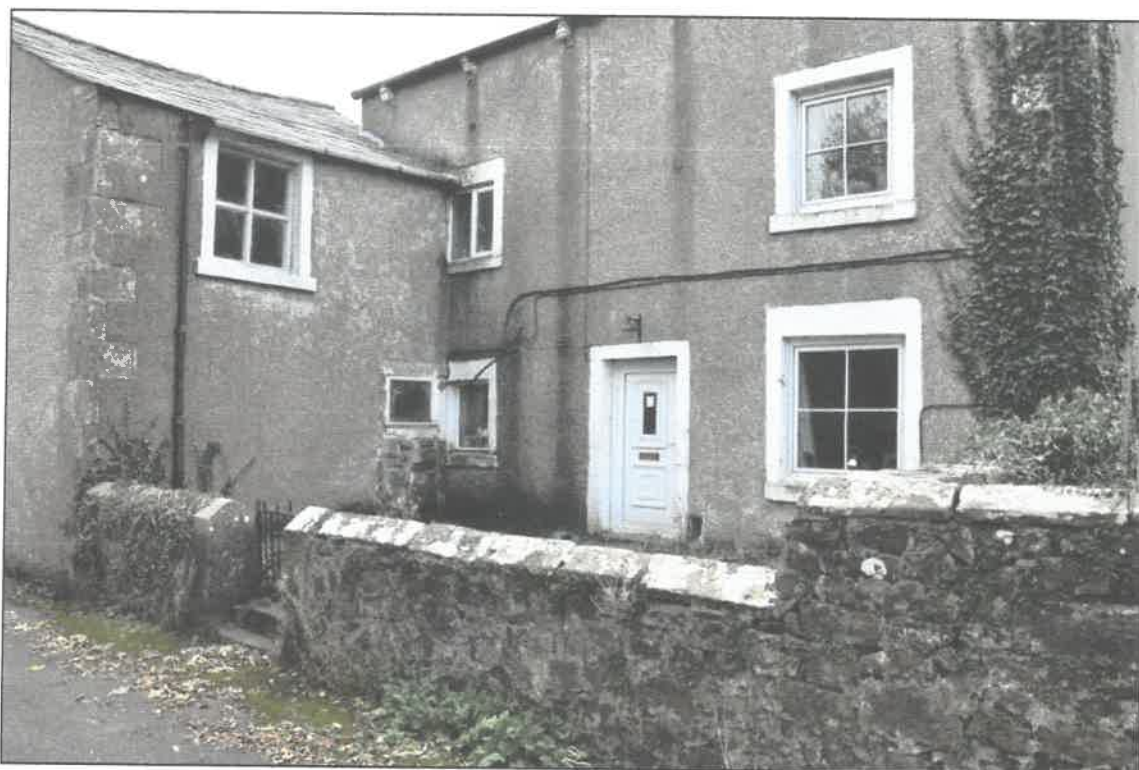
Photo 4: Farmhouse: rear elevation, with adjoining garage/trap house at left

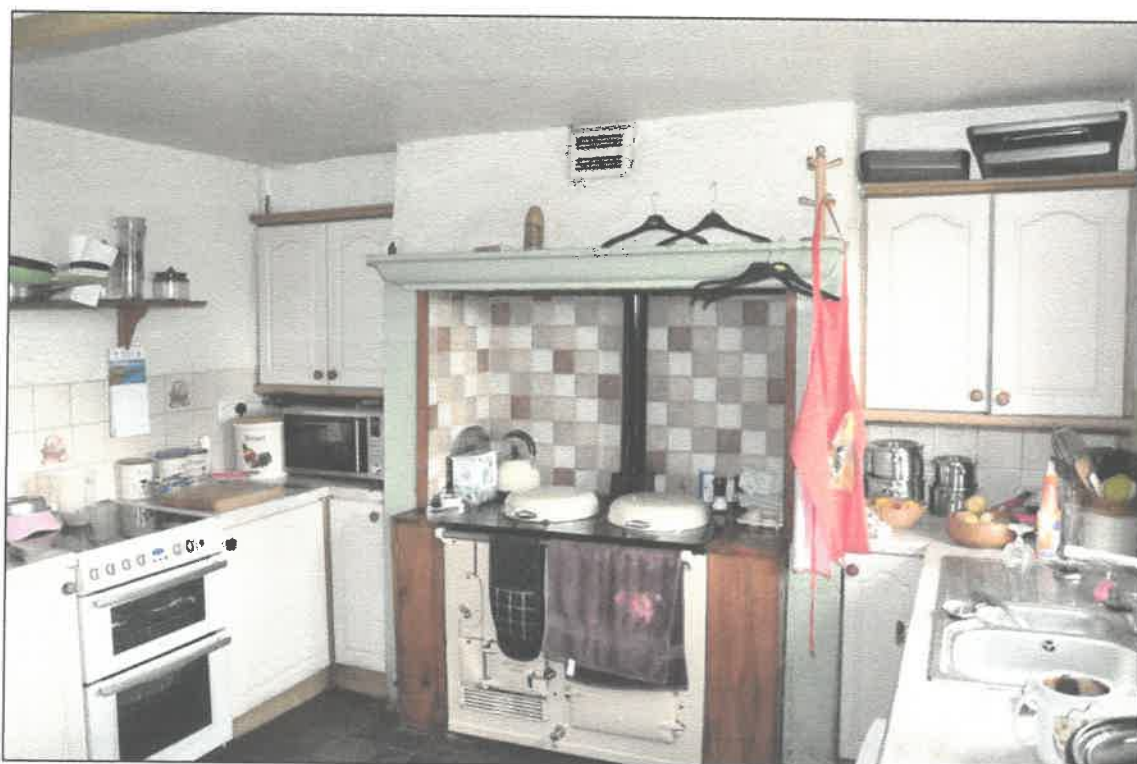
Photo 5: Farmhouse: housebody (present kitchen), with original fireplace opening for range

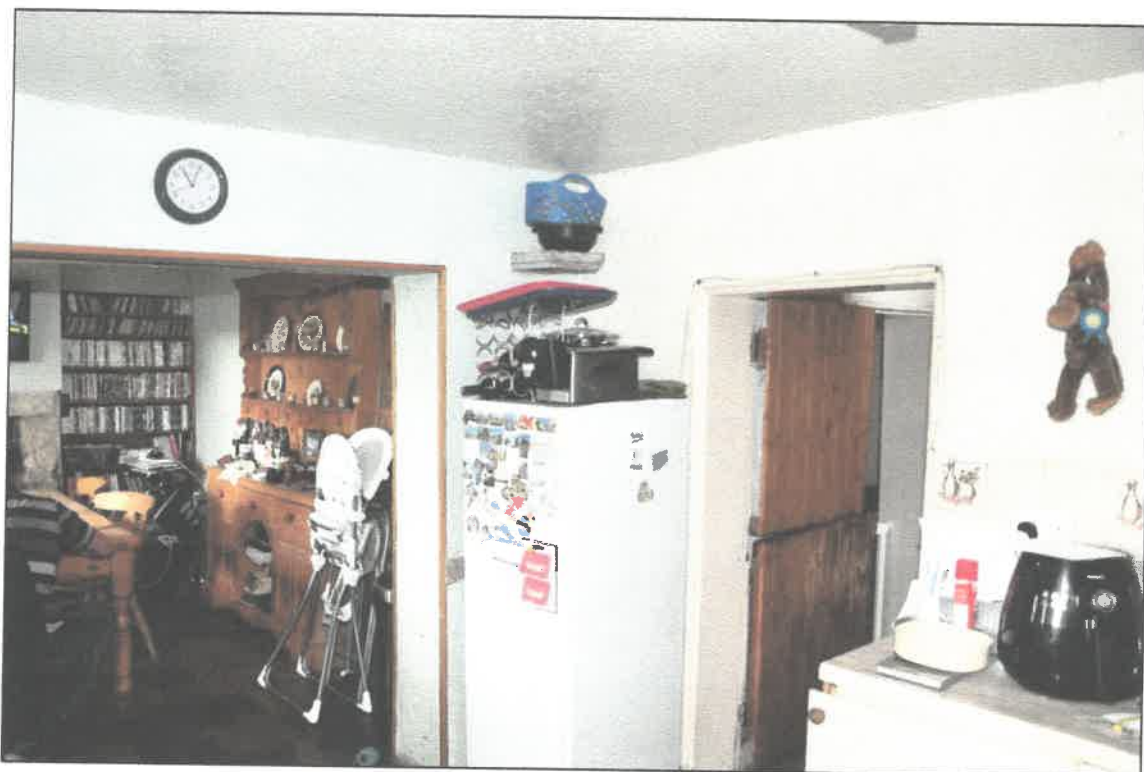
Photo 6: Farmhouse: housebody (present kitchen), with modern opening to parlour (left)

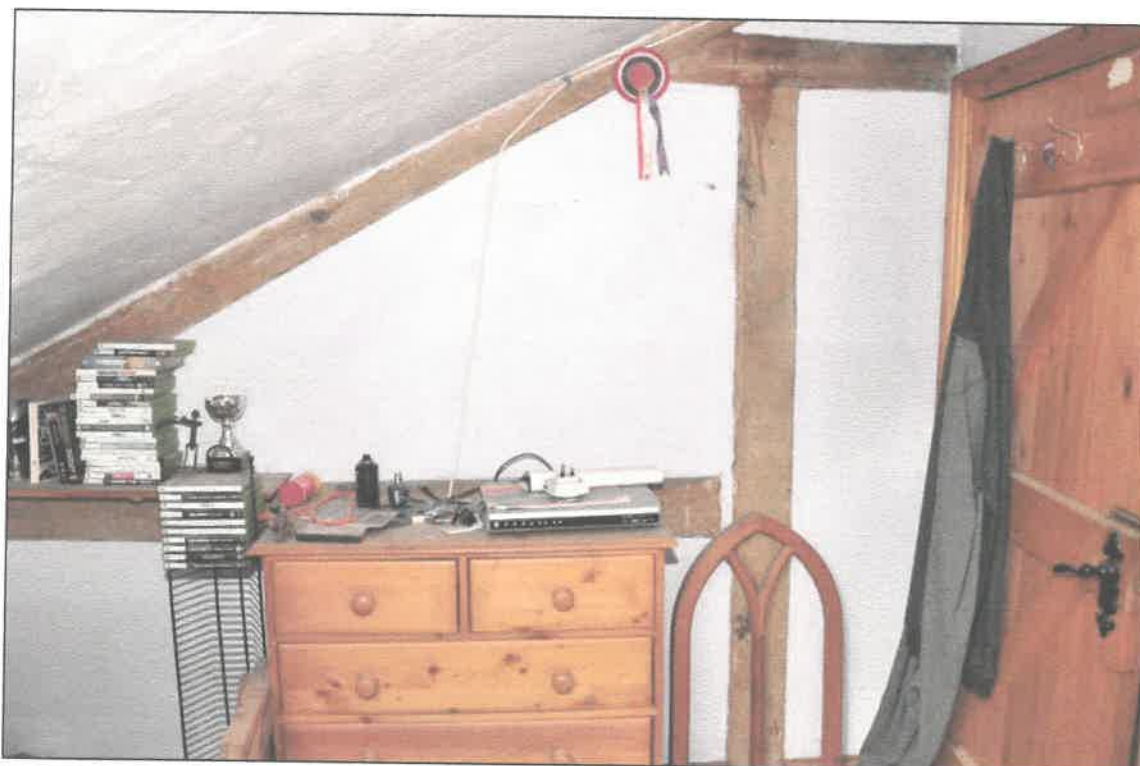
- 6.6 The staircase continues to the attic (possibly as a result of alteration), which is also divided into four, although in this case by lightweight partitions rather than masonry walls. An original, pegged roof truss provides the frame for one of these, between the east and west parts: it is of sawn softwood, with an interrupted tie beam which accommodates a pair of doorways, either side of the east-west partition. These four rooms would have been either servants' bedrooms or storage areas; the small single-light opening in the east gable, which was shuttered, may have been the only lighting originally.

Photo 7: Farmhouse: roof truss forming partition on attic floor

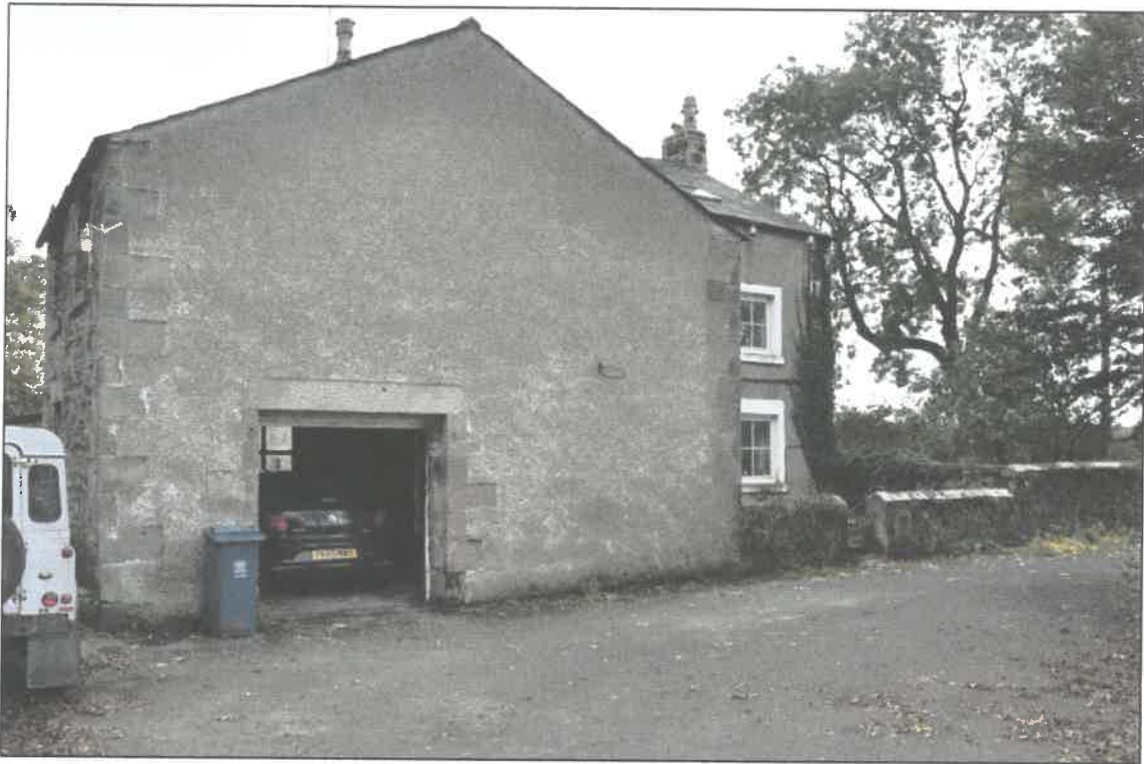
- 6.8 Pedestrian doorways in the south and west sides (the latter reduced to a window) lead into the building, and there is a wider doorway in the north side with massive monolithic lintel, indicating that this was an entrance for a horse-drawn trap or similar. There are also three large windows in the east side, but these may be secondary.

Photo 8: Garage/trap house: north entrance, onto former Longridge Road

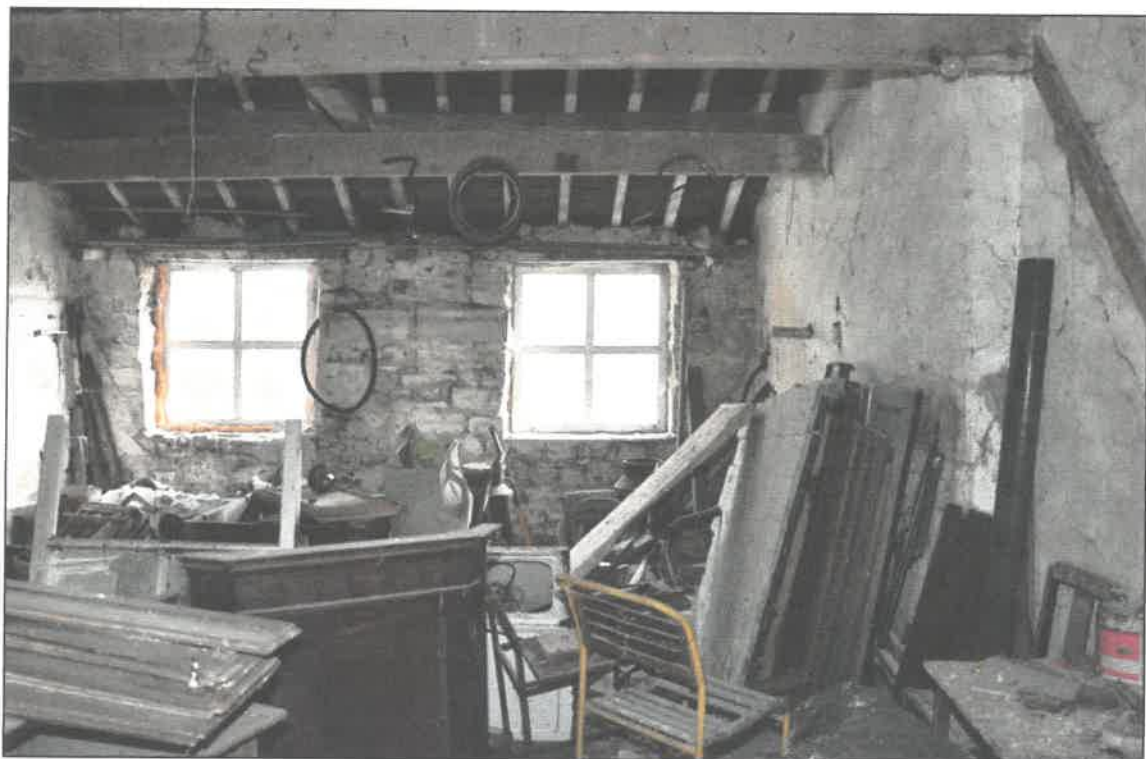
Photo 9 Garage/trap house: first floor, latterly joiner's workshop

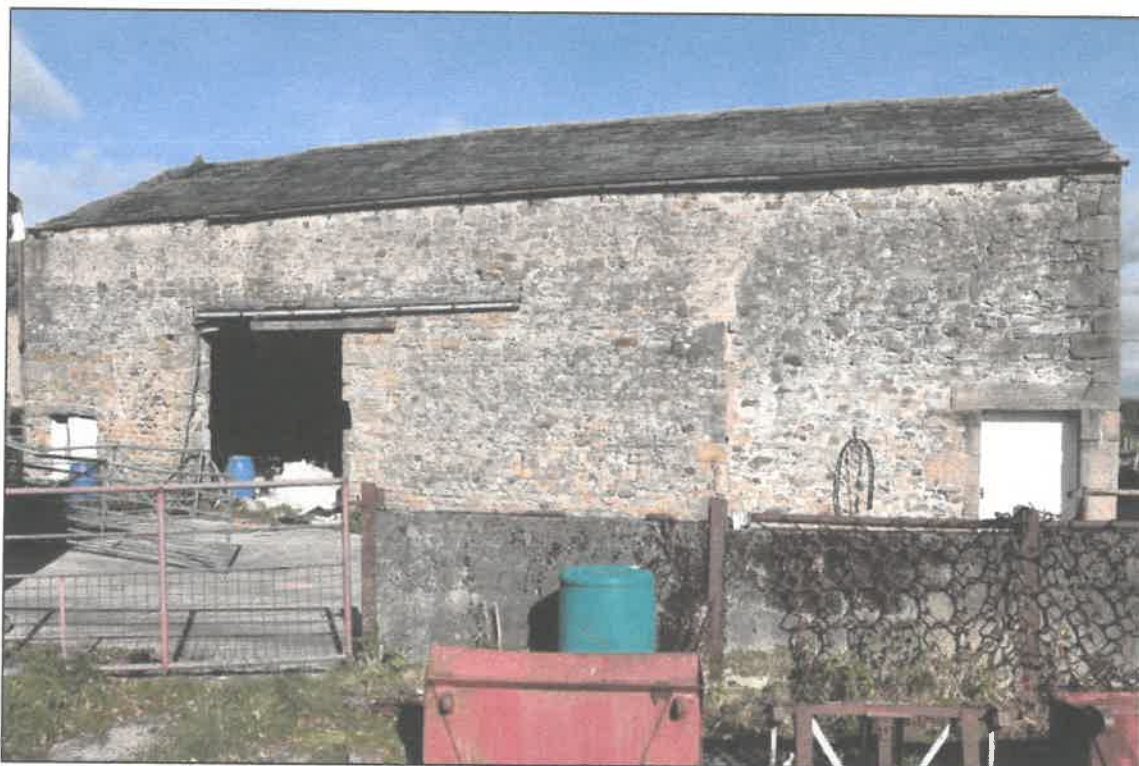
- 6.12 The front elevation of the original barn is largely preserved, and contains a typical cart entrance with stone arch, beneath which is a cambered oak lintel, incorporating the sockets for a pair of doors (now removed). There is a pedestrian doorway to a shippon in the west end of the building, and two blocked breathers to the right of the main entrance. A clear straight joint beyond these, with some quoins, marks the original east gable, with the second phase of the building having been added to it. A large pedestrian doorway, its jambs with linear tooling, suggests a shippon or stable occupied the east end of this addition.

Photo 10 Barn: south front

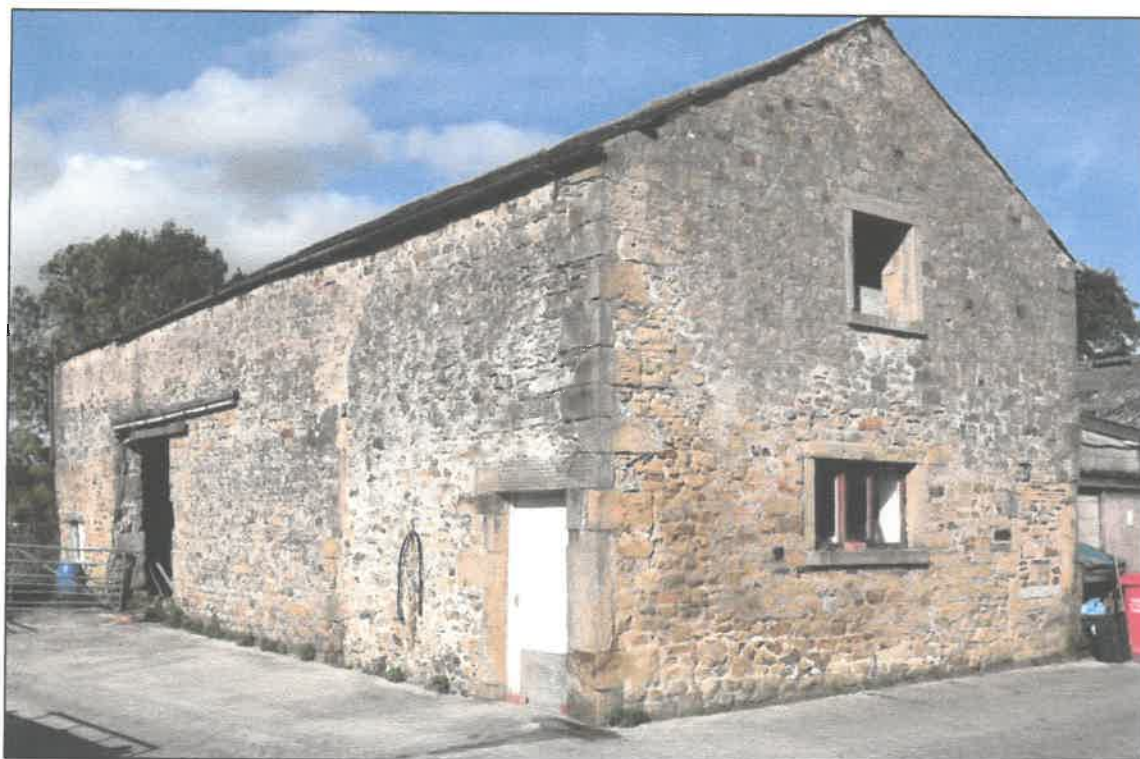
- 6.15 The east gable, which dates from the 19th century phase, has a blocked doorway, a wide ground floor window which appears to be at least partly modern, and a forking hole with sawn stone surround, apparently a 20th century insertion.

Photo 11 Barn: 19th century addition, east end

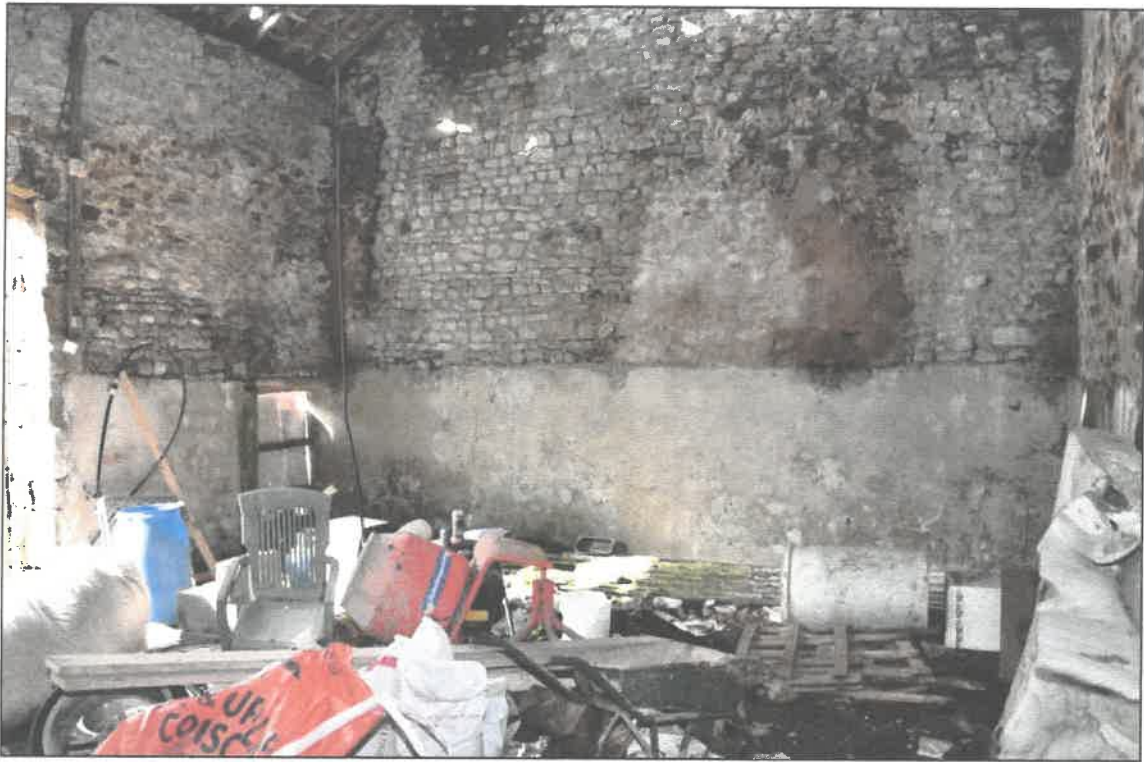
- 6.16 The barn interior contains very little of interest. On the ground floor, the east half contains an area enclosed by blockwork, to accommodate three rooms created for an ice-creamery. The remainder, at the west end, formerly contained a shippon with loft over in the end bay, though nothing remains of this, except the areas of cement render to the walls. There are no historic floor surfaces or fixtures visible.

Photo 12 Barn: site of shippon (removed), in west end

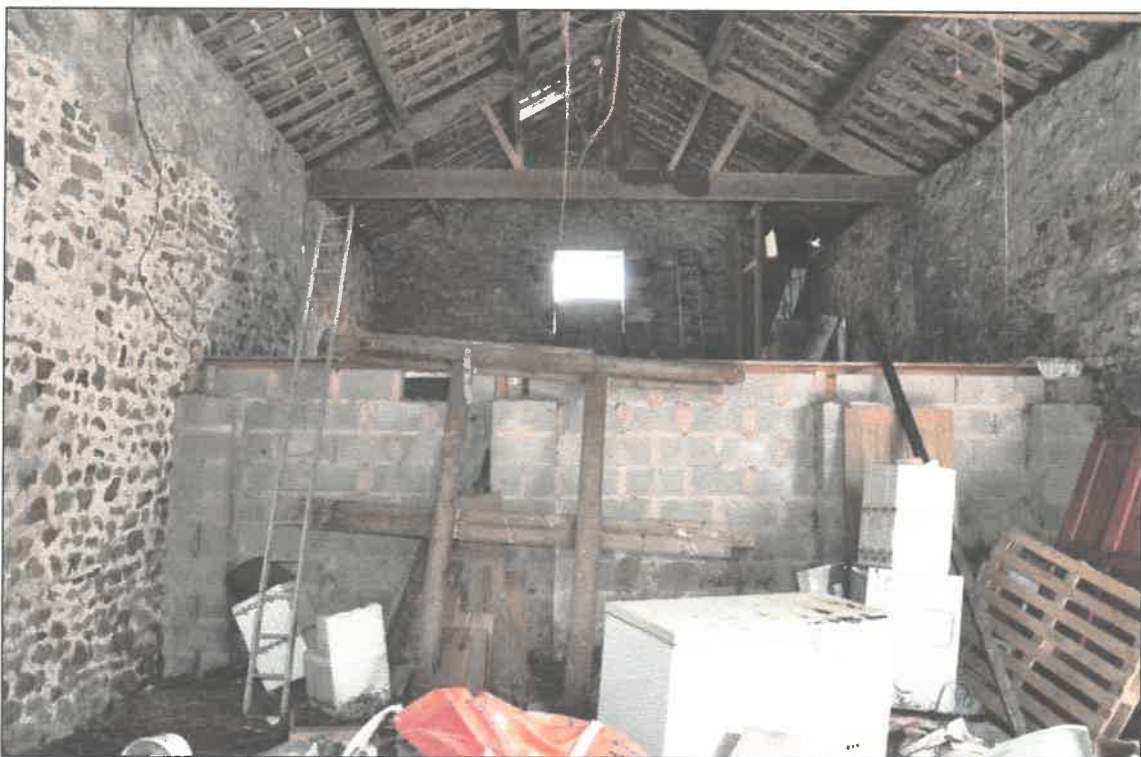
Photo 13 Barn: blockwork enclosing ice-creamery, east end
