**BAT SURVEY AT -  
OLD SAWLEY GRANGE  
GISBURN ROAD  
SAWLEY**

DATE AND TIME OF VISIT  
17<sup>th</sup> April 2019 9.00 am - Scoping survey  
Incorporating the Emergence results recorded on 28/ 09/2017

REFERENCE NO. 5417

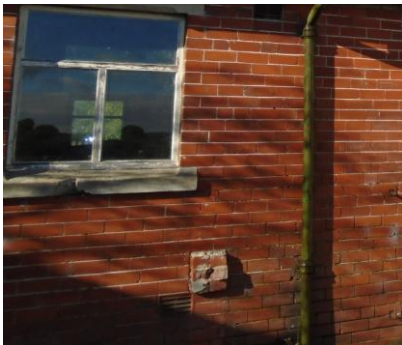
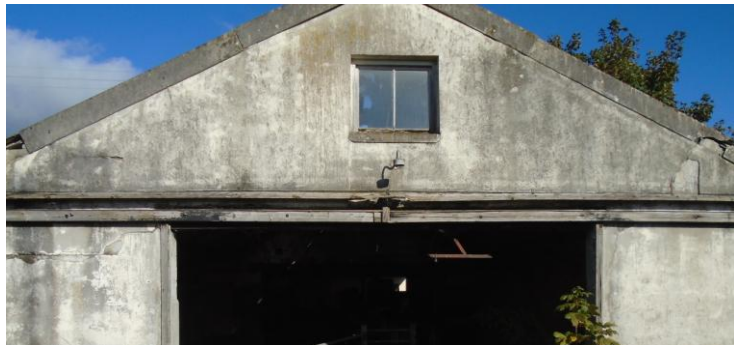
Barn 1. Has two sections, the first section adjacent to the main building has solid brick walls. With a The more recent addition has concrete block walls with a render finish internally and externally.

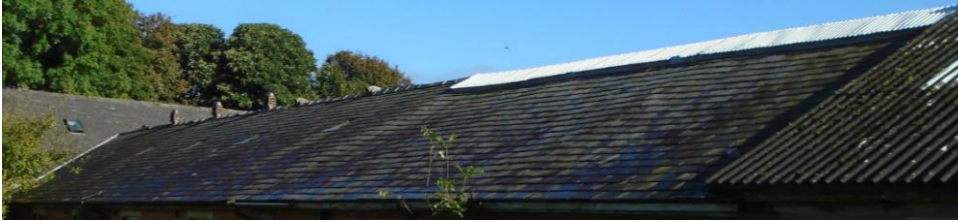
Barn 1 has a conventional pitched roof with a blue slate section with glazed roof lights and a section of clear corrugated sheet at the ridge. The end section of the barn has a corrugated sheet finish.

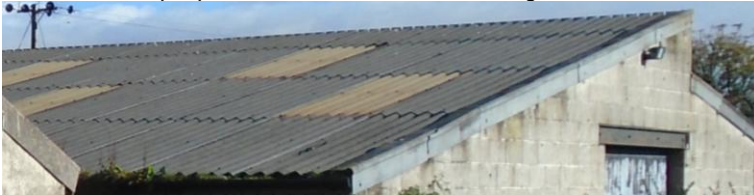
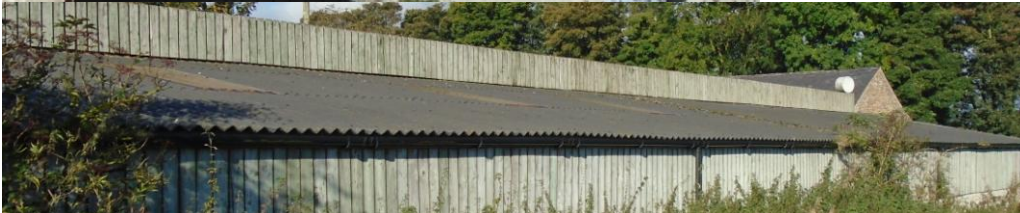
Barn 2 Has a split pitched roof covered with corrugated sheet with clear panels

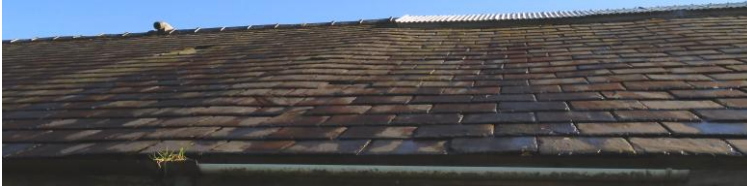
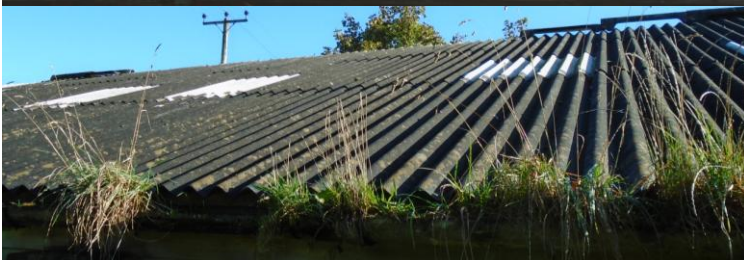
Barn 1 the slates and ridge tiles are in reasonable condition and tight fitting.

The corrugated sheets are in reasonable condition with tight fitting joints, neither section of the roof has any crevices suitable for bats however the ridge is missing on a section of the corrugated roof allowing water ingress.

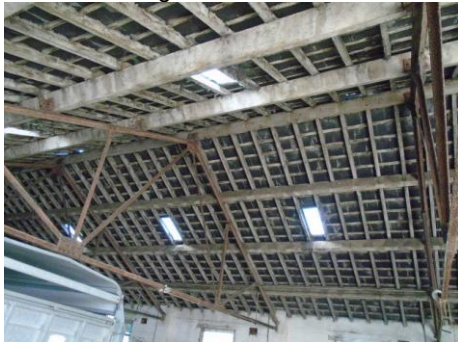
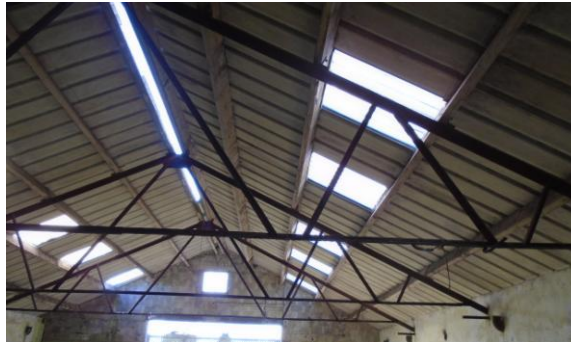
Barn 1, the slated section has metal trusses with timber purlins rafters and battens there is no underlay. The sheeted section has metal trusses with timber purlins with composite corrugated sheets over.

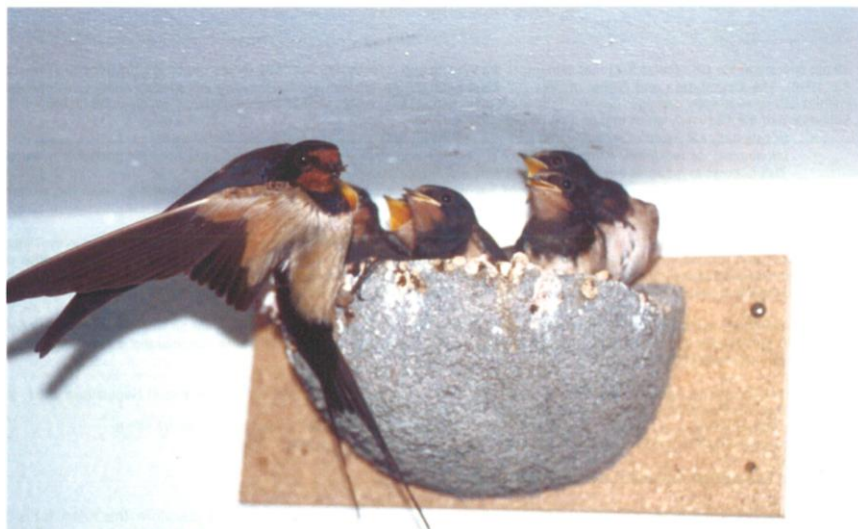
## ‘Schwegler’ swallow nest

These are designed to be mounted under roofs or within out-buildings and open portal garages / buildings.

‘Schwegler’ or similar swallow nests should be fixed at the eaves , min 5no to each elevation. See image
