## **OLD SAWLEY GRANGE**

## **OUTLINE METHOD STATEMENT**

FOR THE PROPOSED DEMOLITION OF AGRICULTURAL BUILDING ADJOINING THE REAR SOUTH FACING  
ELEVATION OF SALWEY OLD GRANGE

**REF:** 5417

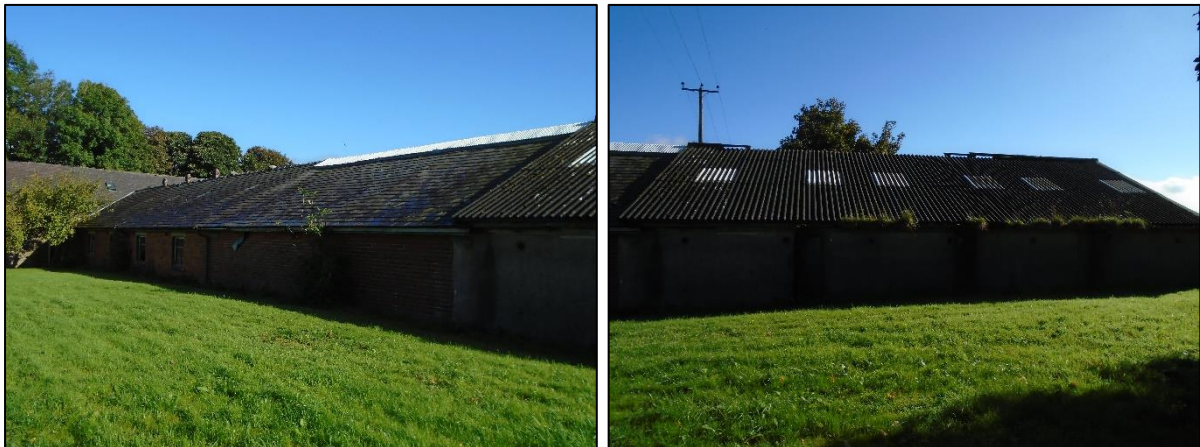
The affected building was constructed between 1949 and 1954 and consists of two phases of construction, the first phase being of brickwork construction and the second phase being of pre-cast panel construction.

PL01: View of the outbuilding to be demolished (first phase to the left and second phase to the right).
