**BAT SURVEY AT -  
OLD SAWLEY GRANGE  
GISBURN ROAD  
SAWLEY**

REFERENCE NO. 5417

Conversion of a disused barn to form offices and demolition of an adjacent barn.

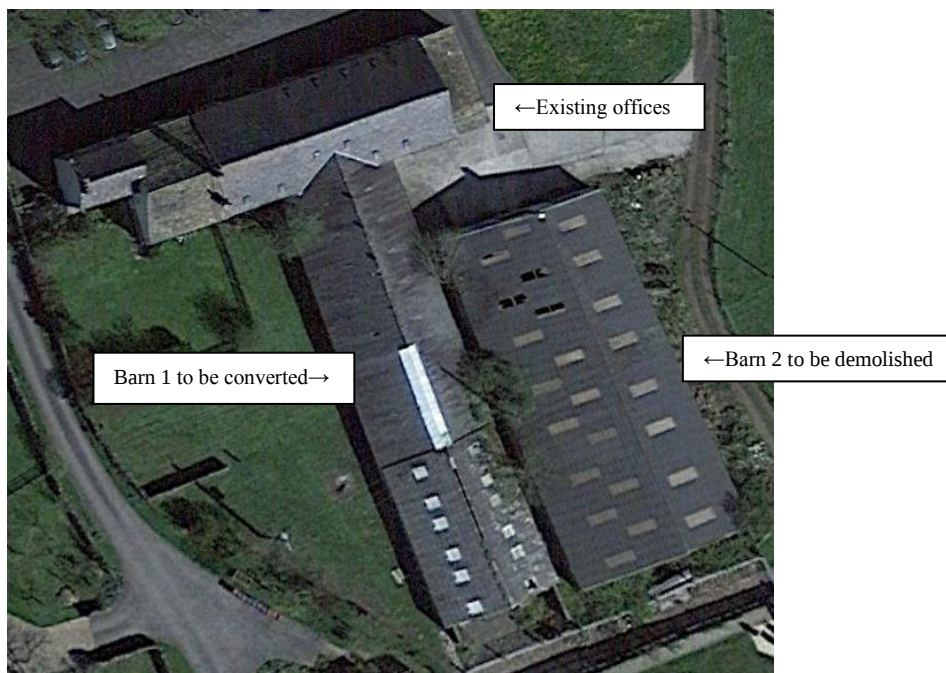
Barn1 is a similar construction but is attached to the main building which functions as an office. It consists of two sections the later being a more recent extension.

Both buildings are disused agricultural barns which are more recent additions ( possibly dating from the 1960's ) to the original farmstead.

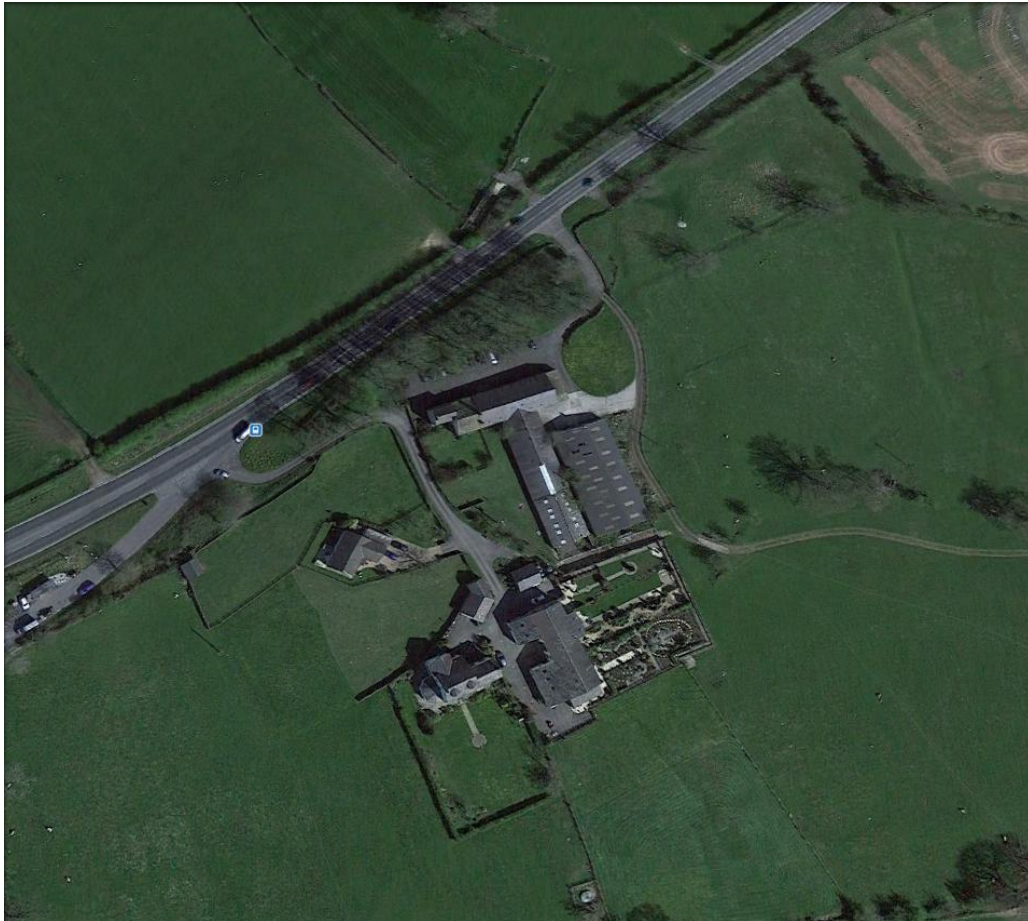
### WALL CONSTRUCTION

Barn 1. Has two sections, the first section adjacent to the main building has solid brick walls. With a The more recent addition has concrete block walls with a render finish internally and externally.

The wall structures of both barns do not provide any cracks crevices or holes which are accessible by bats. However bats are able to freely access the interior of the building via door and window openings.

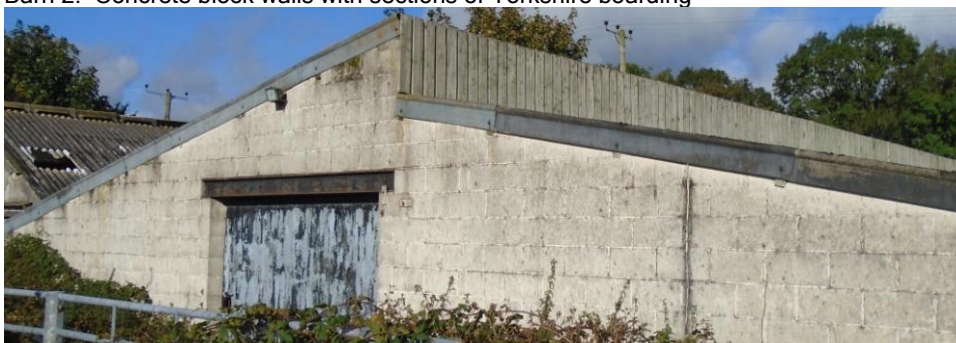
Barn 2. Concrete block walls with sections of Yorkshire boarding

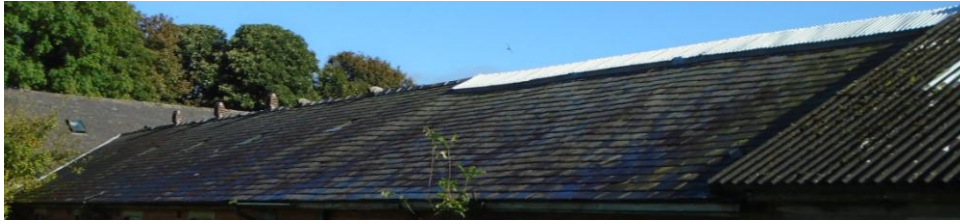
Barn 1 has a conventional pitched roof with a blue slate section with glazed roof lights and a section of clear corrugated sheet at the ridge. The end section of the barn has a corrugated sheet finish.

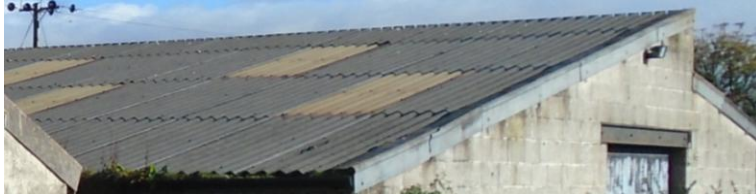
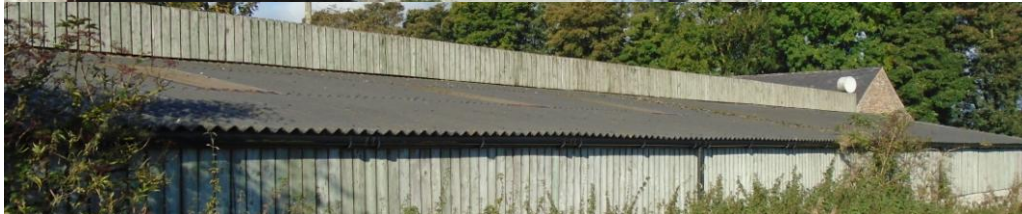
Barn 2 Has a split pitched roof covered with corrugated sheet with clear panels

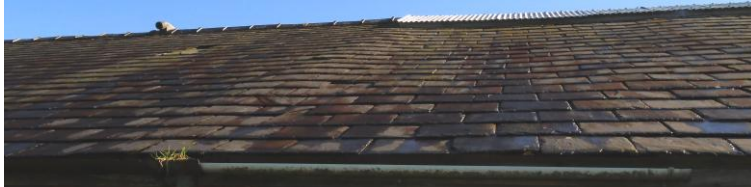
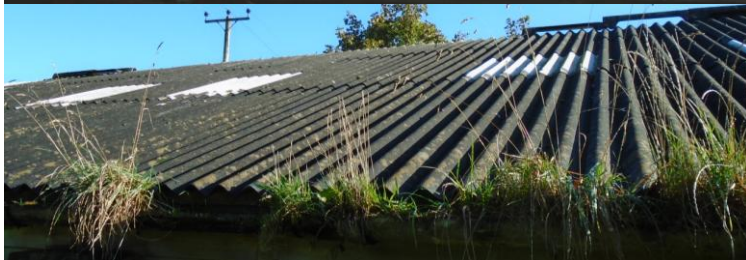
Barn 1 the slates and ridge tiles are in reasonable condition and tight fitting.

The corrugated sheets are in reasonable condition with tight fitting joints, neither section of the roof has any crevices suitable for bats however the ridge is missing on a section of the corrugated roof allowing water ingress.

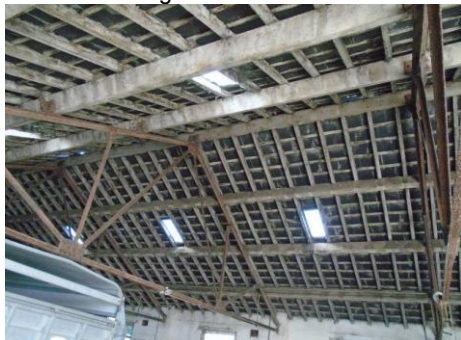
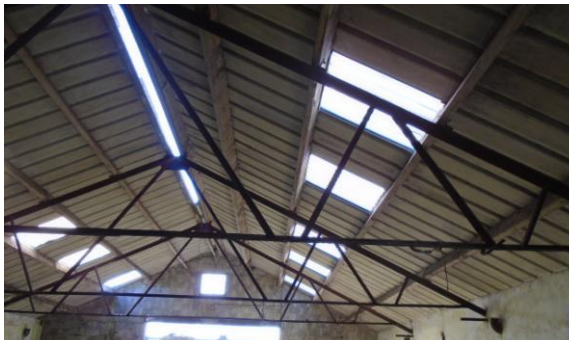
Barn 1, the slated section has metal trusses with timber purlins rafters and battens there is no underlay. The sheeted section has metal trusses with timber purlins with composite corrugated sheets over.

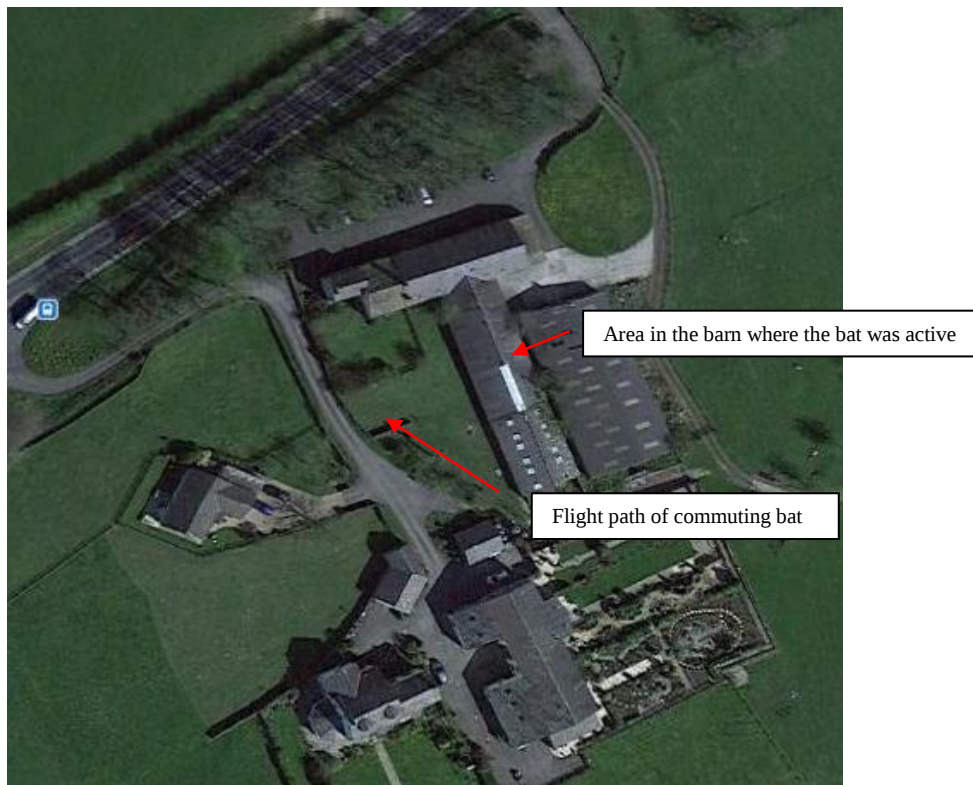
**The Emergence survey** the buildings were monitored externally for any activity no emergence from the building was recorded throughout the survey. However a single bat entered barn 1 at 6.50 pm to forage in the building, this activity was restricted to the middle bay of the barn and continued within the building until 7.20 pm before commuting in a north westerly direction towards the trees.

Although the conditions were optimal for bat activity no further results were recorded in or around the buildings, it is however getting to the end of the activity period and bats are becoming torpid in preparation for hibernation.
