Barn at Little Woodfield Farm  
Longsight Road, Clayton-le-Dale, Lancashire:  
Historic Building Record

# Barn at Little Woodfield Farm

## Longsight Road, Clayton-le-Dale, Lancashire:

### Historic Building Record

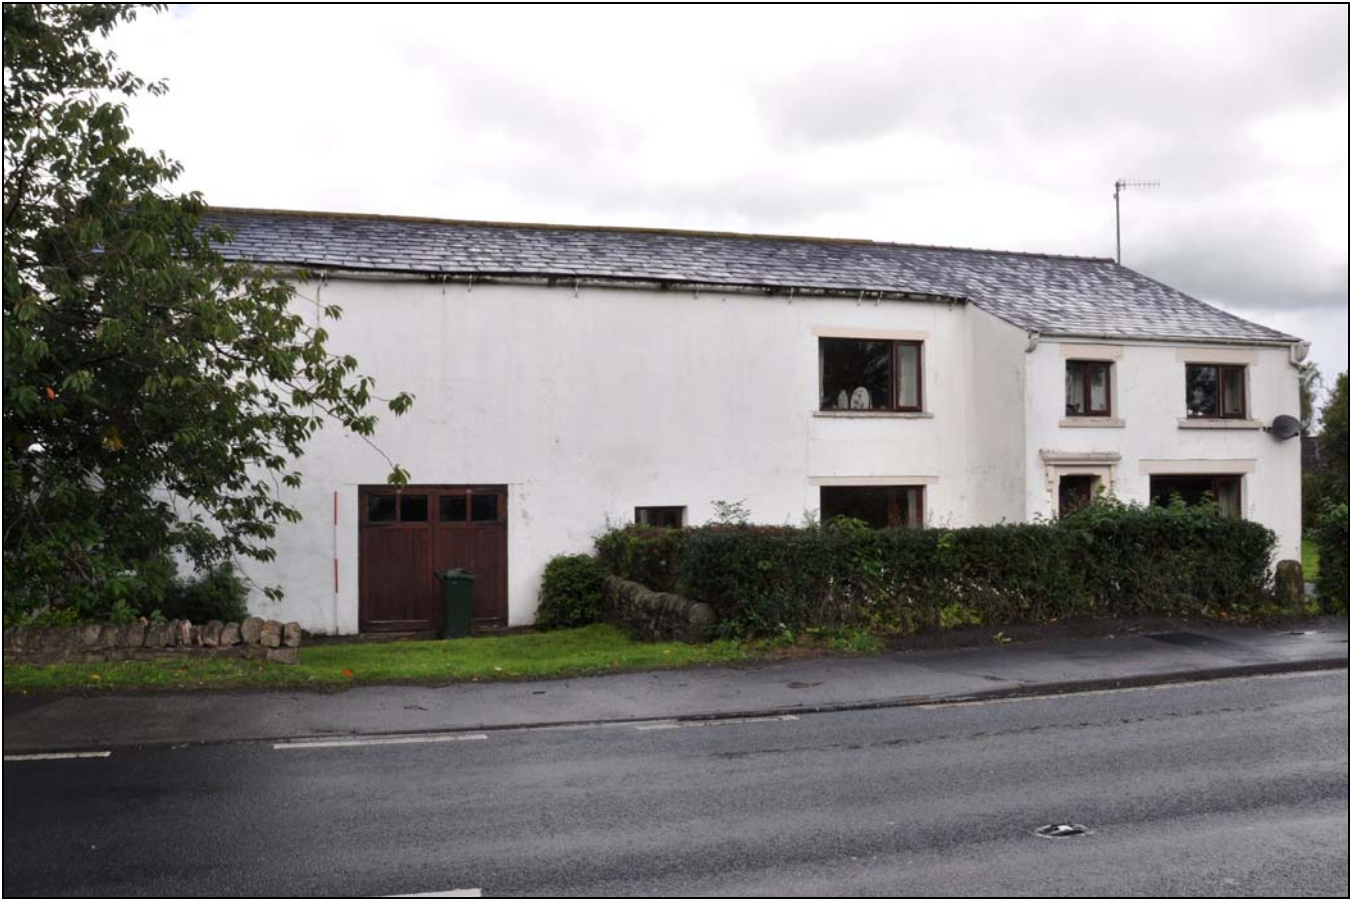
- 8.1 The barn occupies the south-west end of the range, with a modern, single storey lean-to garage forming an extension at its gable, apparently replacing an earlier lean-to, to judge from the historic maps above. All historic parts of the range are built from local sandstone rubble, with sandstone dressings, but the south-east elevation has been rendered and the other two sides of the barn have been limewashed, so much detail which might assist with interpretation is masked. There is a blue slate covering to the historic parts of the roof, though this is not believed to be original, although the sandstone ridge along most of the range is probably an original remnant, replaced over the house by interlocking ridge tiles (1). Shaped kneelers are used at the corners.

Photo 1: Front elevation of barn and house, facing south-east towards Longsight Road

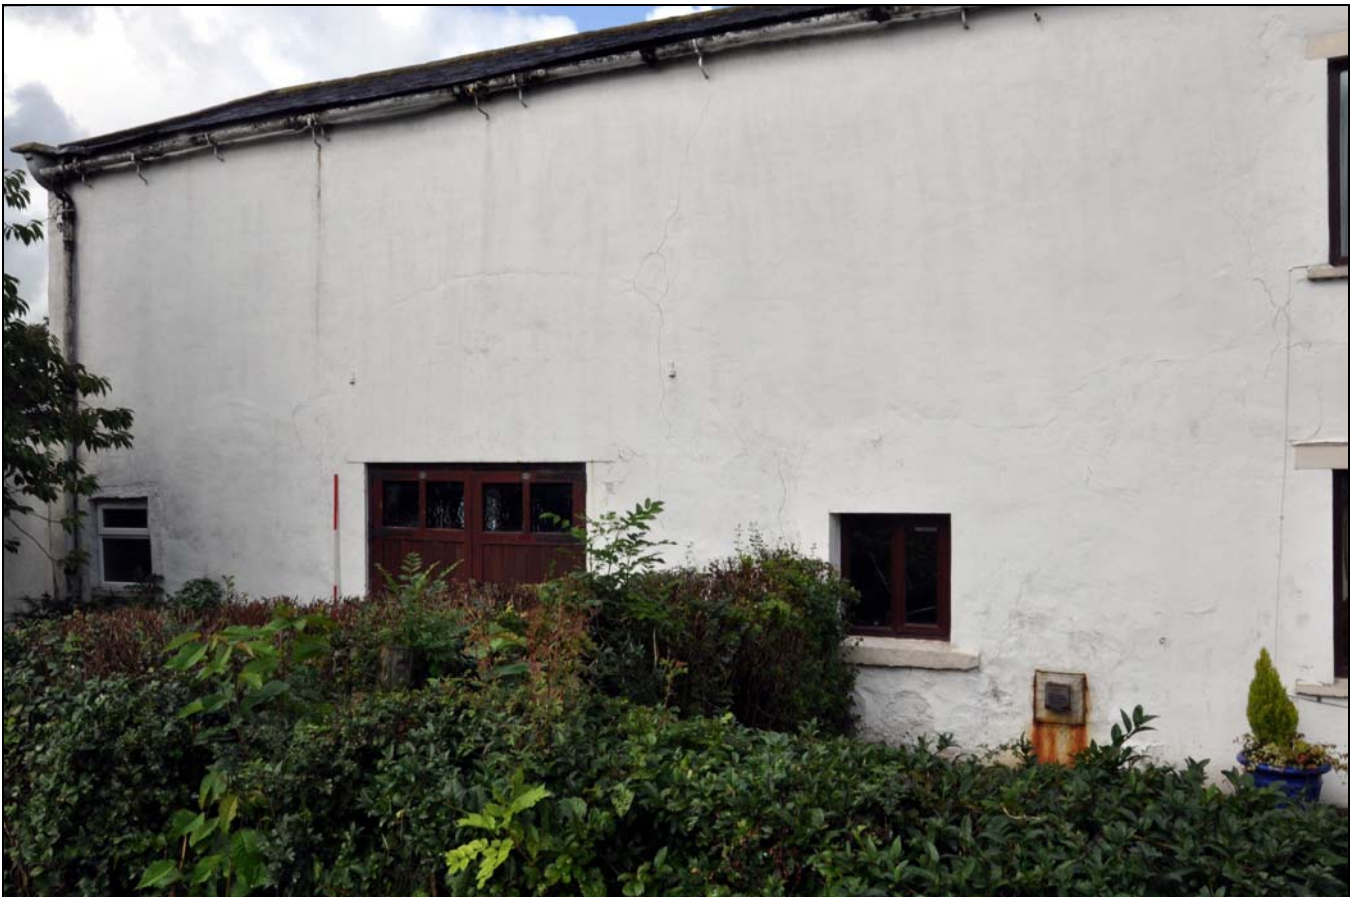
- 8.2 The barn appears to have been four bays long originally, with the house occupying the wider, north-east end of the range, though the domestic accommodation has been extended into it at some date in the 20th century, so that the full extent of the historic agricultural space is now unknown. The present barn occupies approximately two of the original four bays on the ground floor, and three on the upper floor (2).

Photo 2: Front elevation of the barn, with traces of arched cart entry visible above double doors

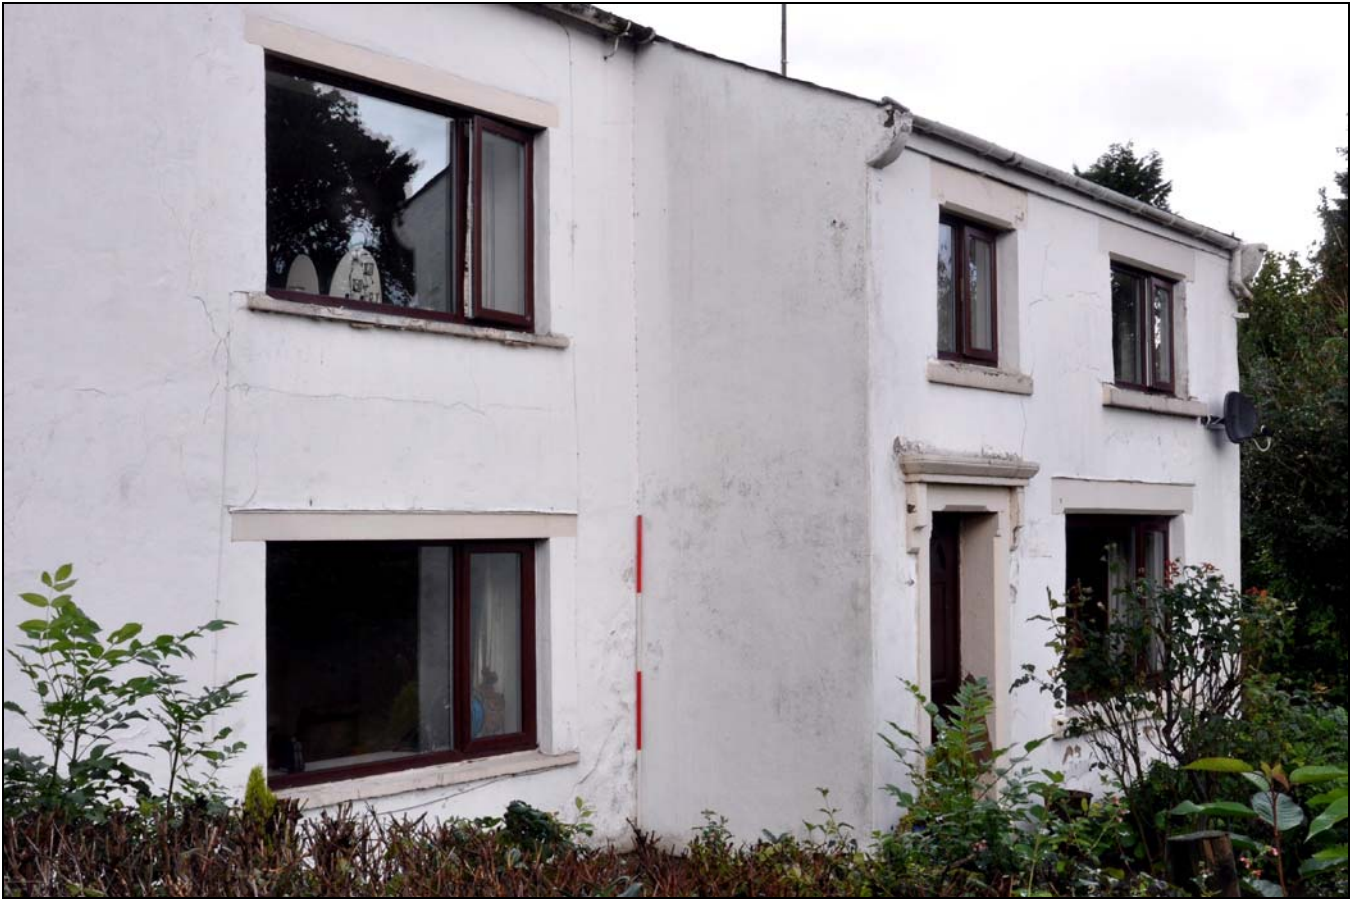
- 8.3 The principal feature in the front elevation is the partly blocked cart entrance, whose segmental arch can be made out within the render, over the double doors (3). This entrance has been narrowed at the right-hand side, as well as being reduced in height. Two hinge pintles also survive, to indicate that the double doors were hung externally. A narrower, pedestrian doorway, at the left-hand end of the front, has monolithic jambs, and formerly gave access to the shippon within the barn, but has also been partly blocked and converted to a window. The present front window to the garage, to the right of the cart entry, may also have been a doorway at one time, but this cannot be said with certainty. Beyond here, large 20th century windows occupy what may have been the barn's fourth bay (4).

Photo 4: Front of house, with 20th century windows in part of former barn at left

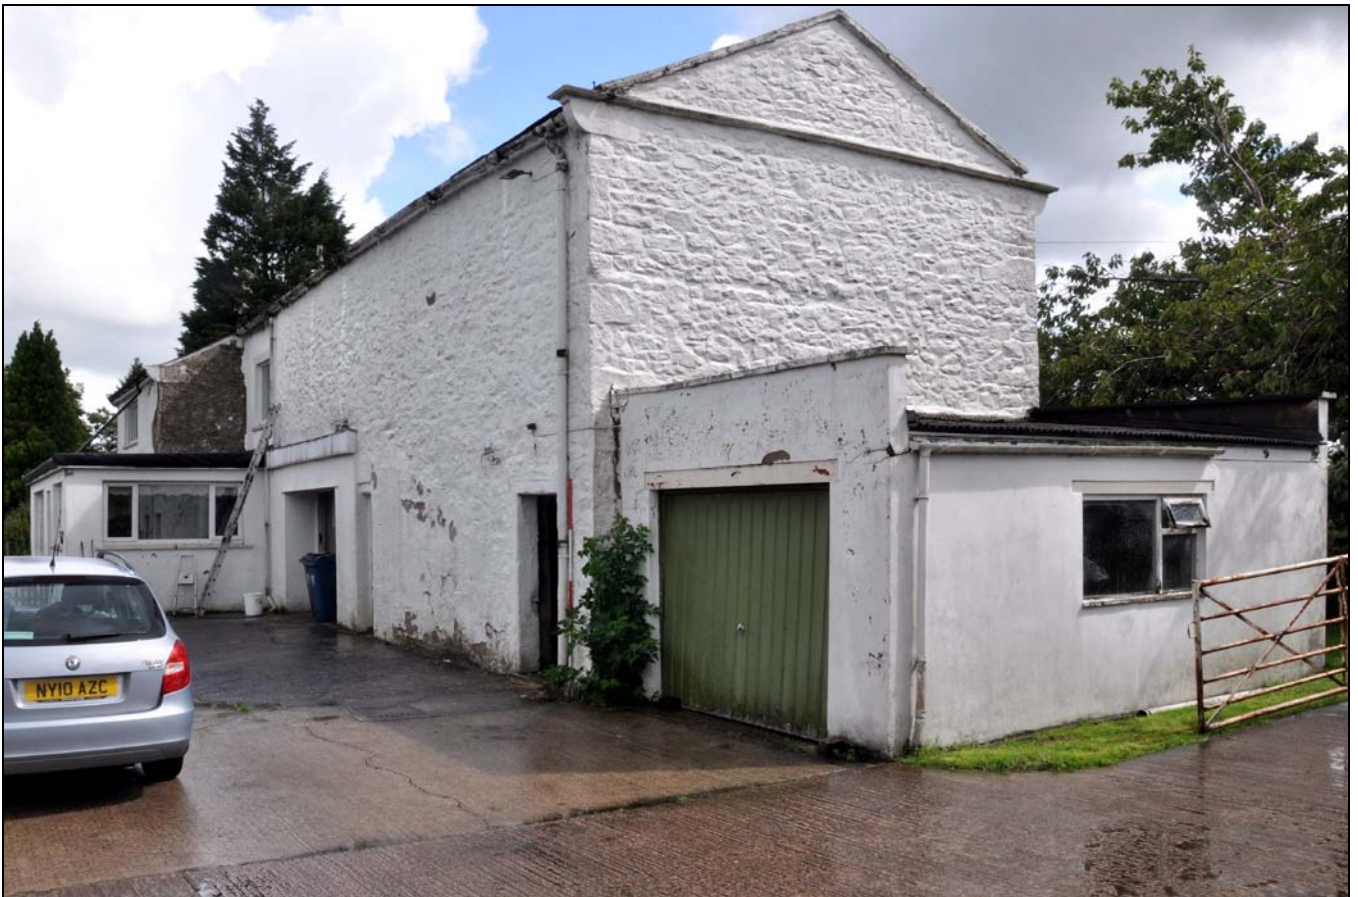
- 8.4 The south-west gable has coping and horizontal tabling which create a pediment (5,6), and at ground floor level is the modern garage; no other historic features are evident here. To the rear, there is a doorway to the shippon matching that to the front, although in this case it remains open and still in use. To the left is a narrow pedestrian doorway which might represent part of an historic opening; the surrounding masonry is partly rendered and little can be deduced from it with certainty. Next to this is a large inserted doorway for a modern garage,

Photo 5: General view of the barn and house from the west

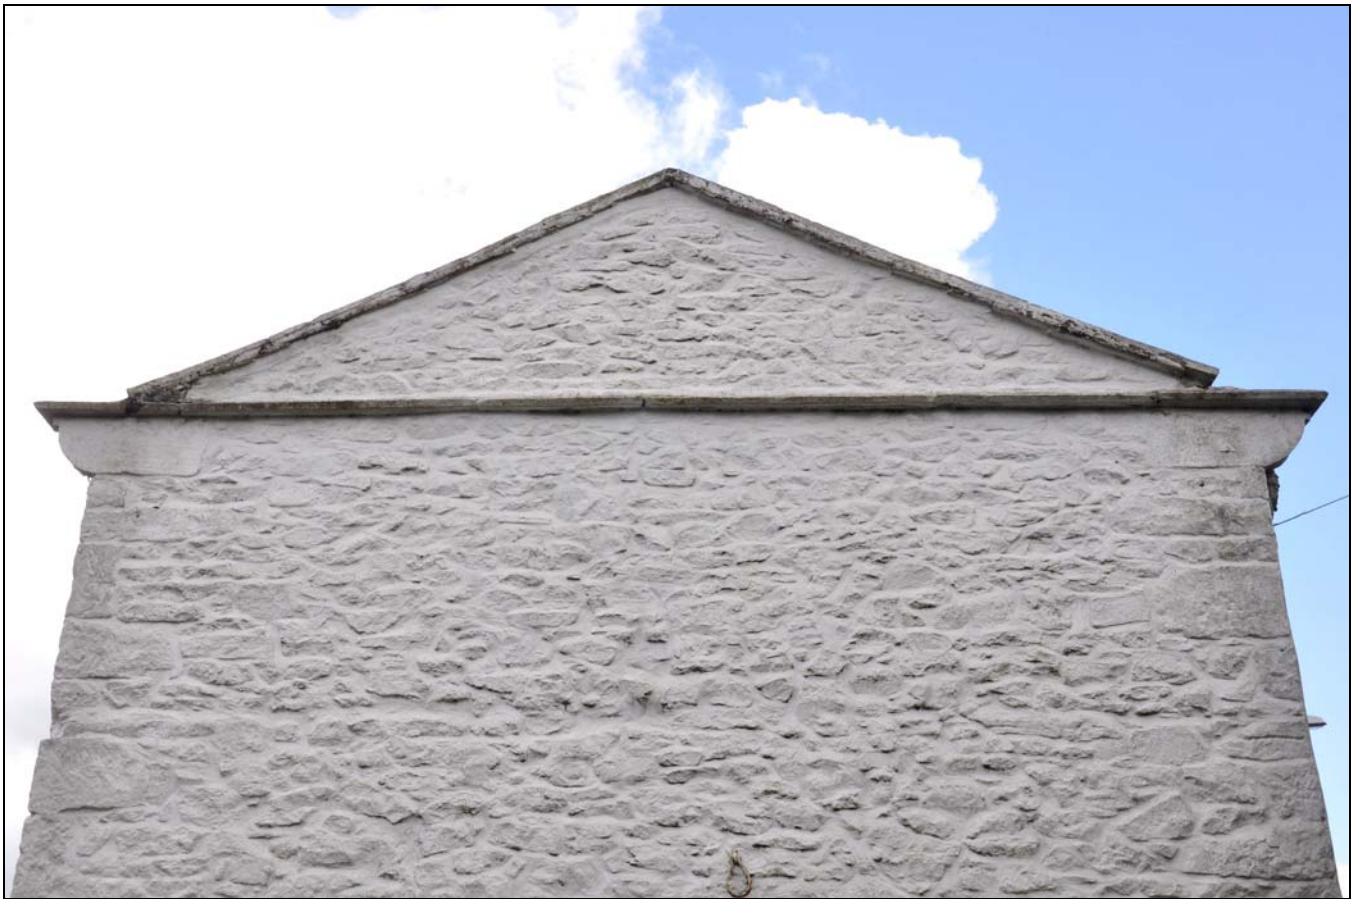
Photo 6: Detail of tabling and kneelers in south-west gable

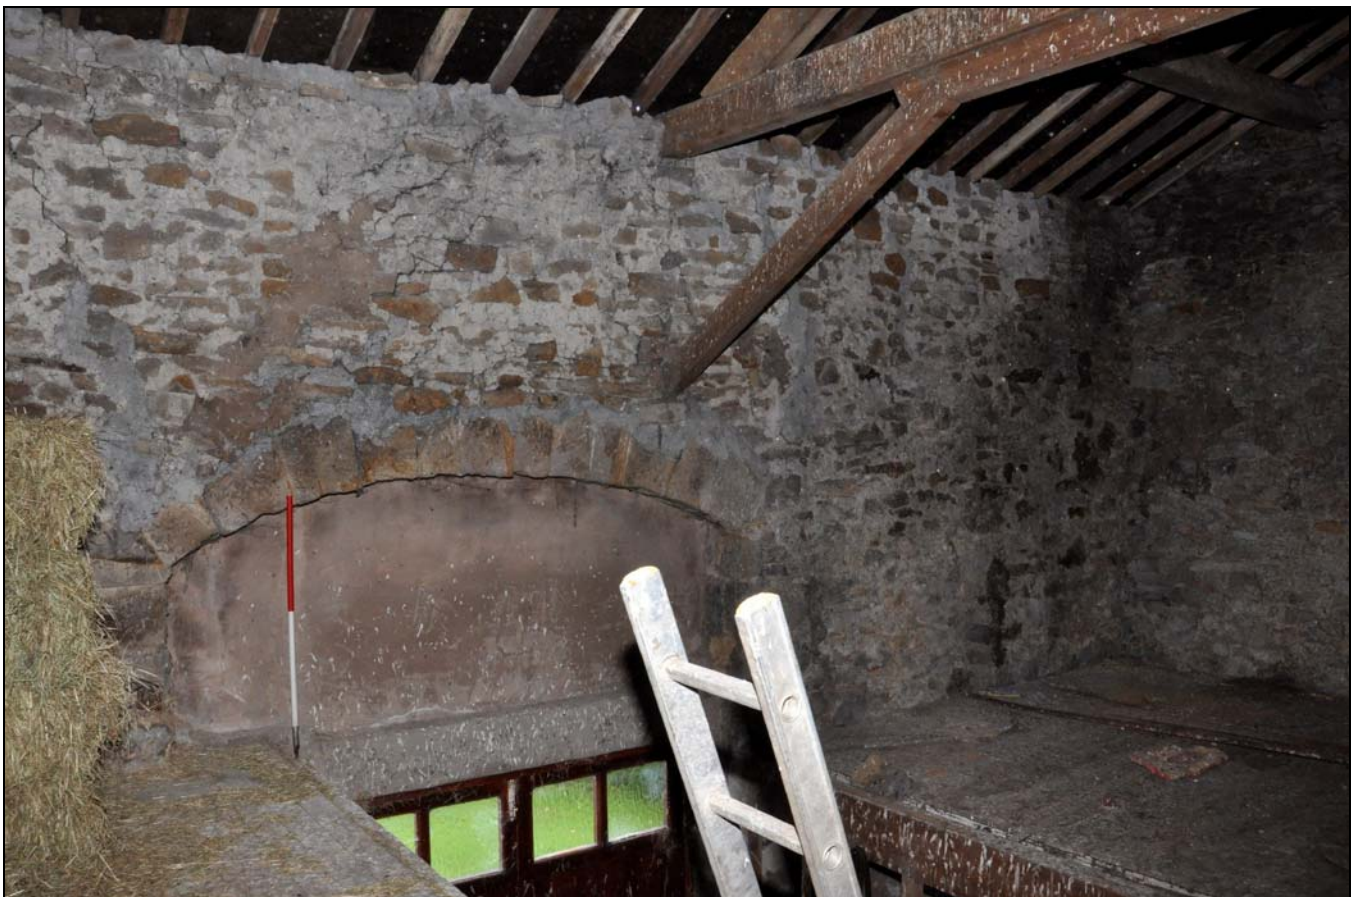
- 8.5 Inside the building, the front cart entrance is mostly exposed, with stone arch above a more recent, lower lintel (7,8), and this would originally have opened onto the threshing bay. A wall of concrete bricks cuts across the north-east end of this space however, enclosing the modern garage (9).

Photo 8: Interior view of front cart entrance, from the north

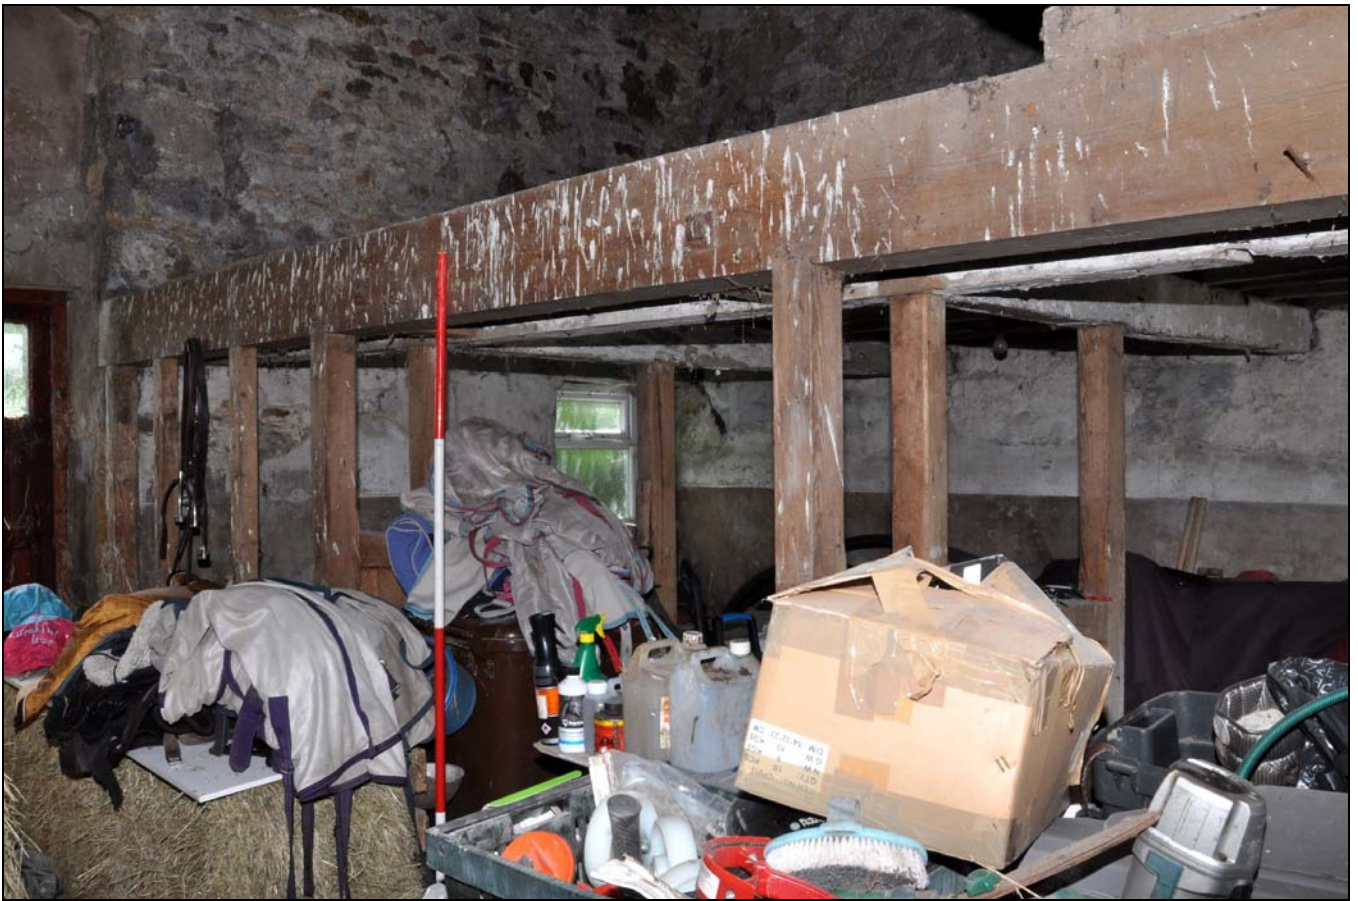
- 8.6 To the south-west of the threshing bay is a shippon for six cows with hay loft over, in characteristic position (10). It has however been altered: the original beam supporting the front of the loft has been supplemented by a more recent, probably early 20th century beam parallel to it, and the loft extended to it. The two boskins or stall dividers also clearly date from this phase of alteration: they are of softwood, though essentially traditional in form (11,12); the positions of the their predecessors' heel-posts can be seen as mortices in the undersides of the loft beams, which are also of softwood. The floor throughout this area and the former threshing bay, is concrete. At the rear of the shippon, the pair of doorways in the long walls gave access for the livestock (13,14), their hinges and latch staples intact within the jambs.

Photo 10: Shippon in south-west end of barn, looking south

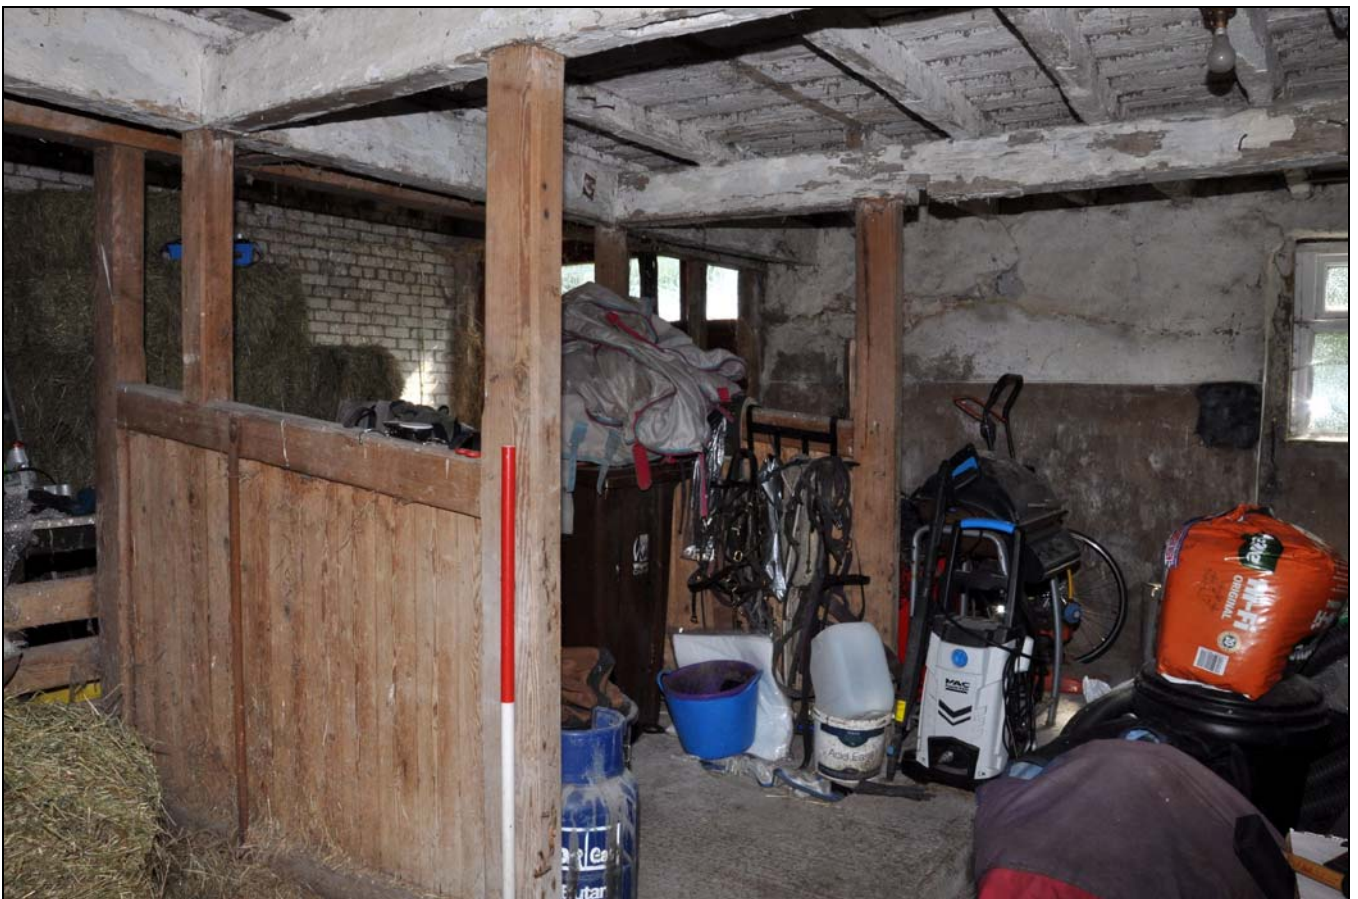
Photo 11: Stalls in shippon, looking east, showing later boskins and front beam to loft

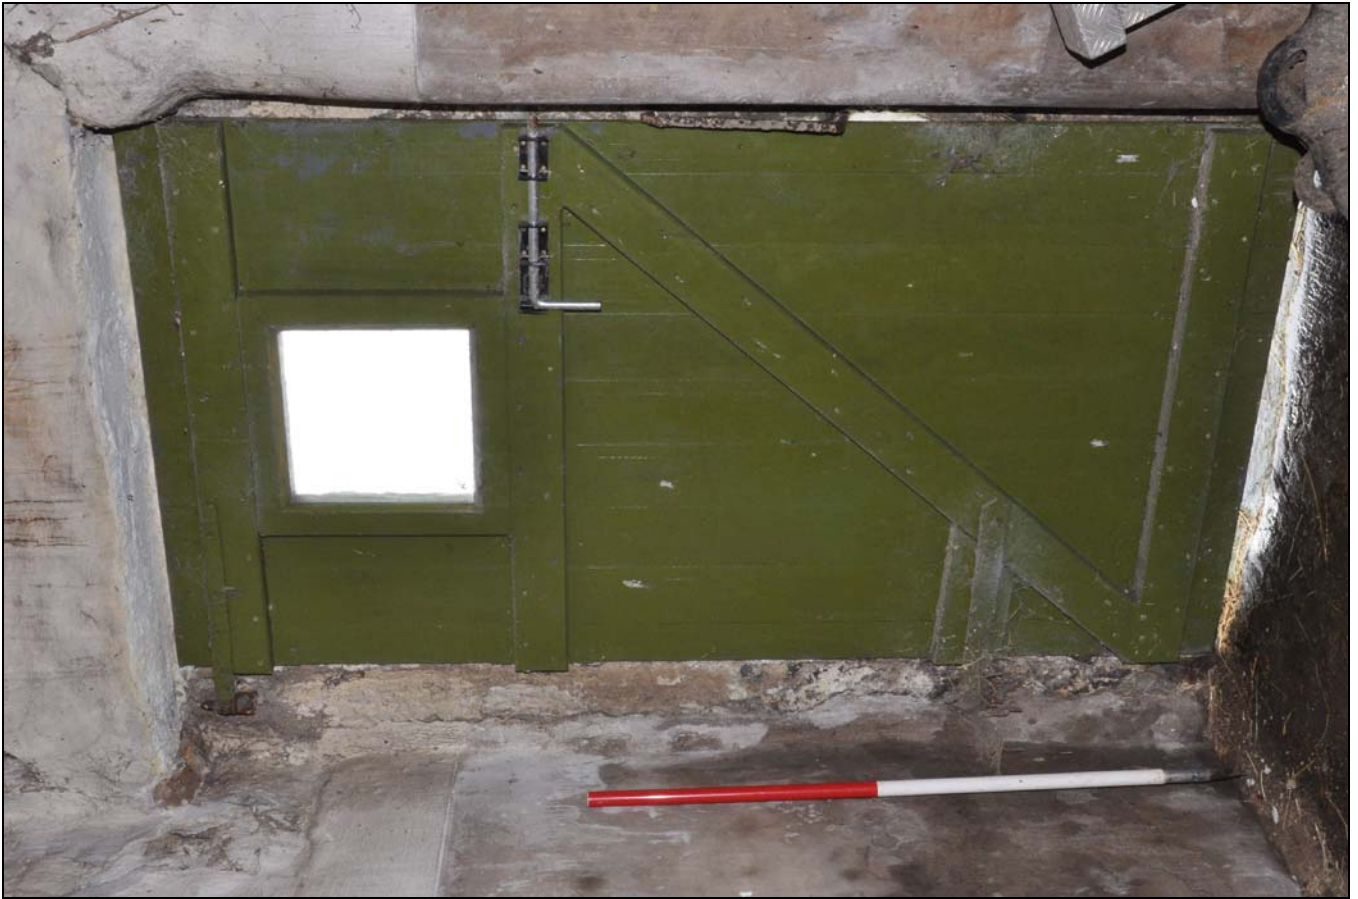
Photo 14: Detail of doorway in north-west side of shippon

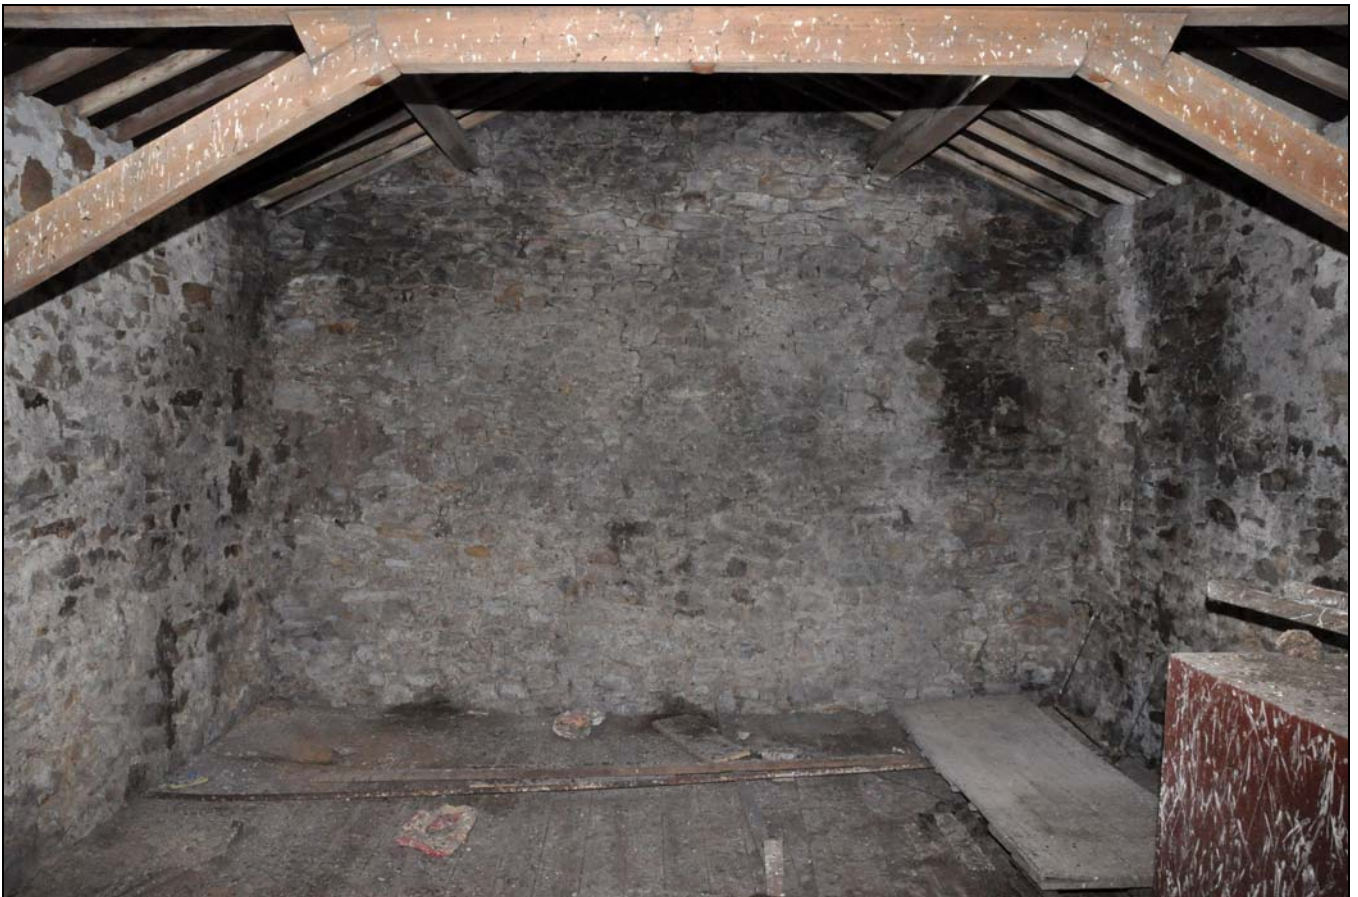
- 8.7 The hay loft over the shippon comprises a single space open to the roof (15,16), without forking holes in the outer walls, so loading of hay onto it must have been done from the threshing bay. Opposite, to the north-east of the threshing bay, the modern brick wall supports another, modern loft at a higher level, with another brick wall at first floor level enclosing the bedrooms within this part of the enlarged house (17). The previous, historic arrangement in this area is entirely unknown.

Photo 15: Hay loft over shippon, looking south-west

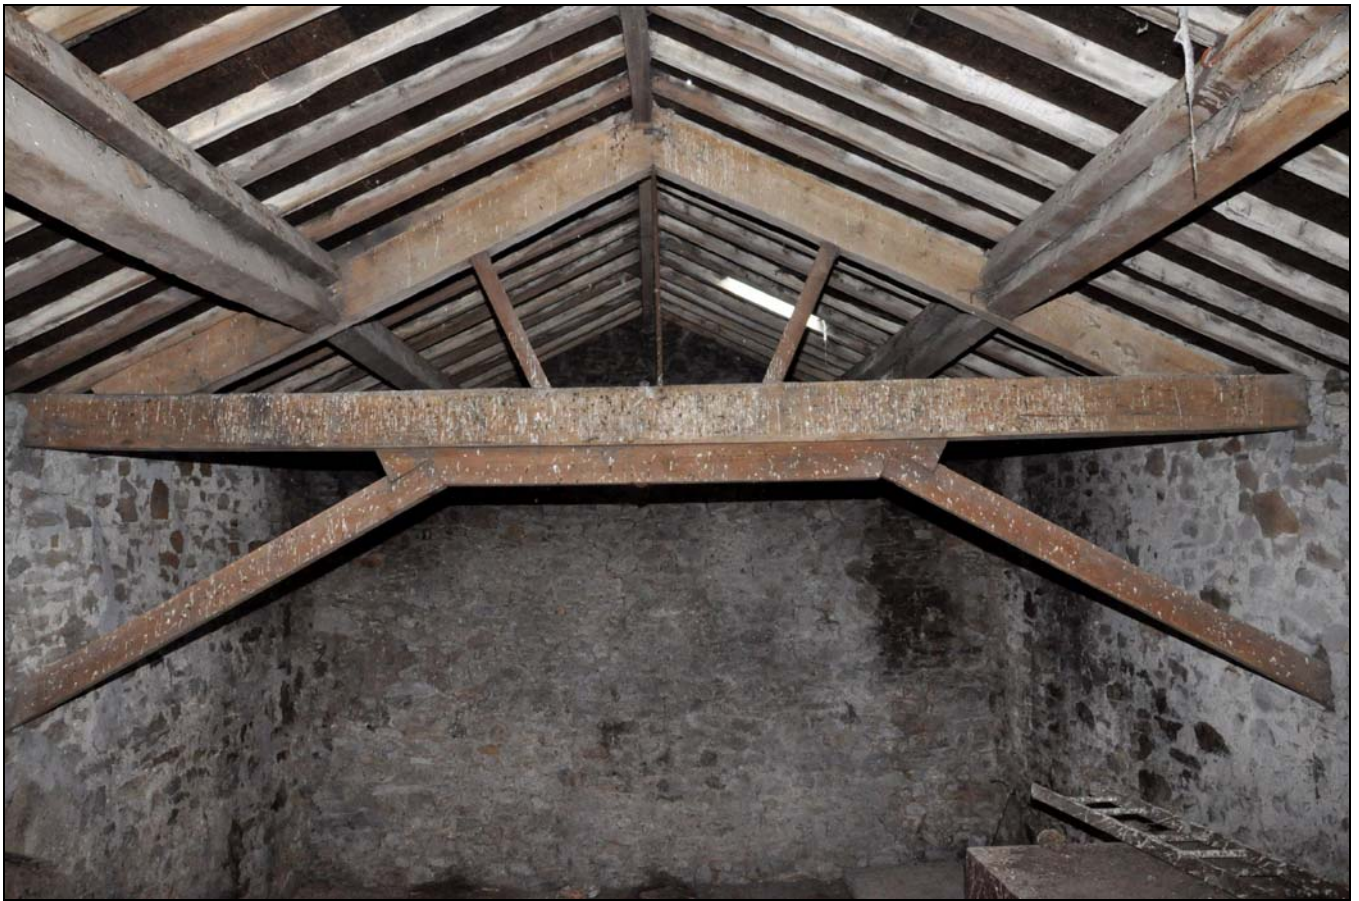
- 8.8 Two roof trusses presently support the roof over the barn, but it is not certain that these are original, at least in their present forms (18). They are entirely of machine-sawn softwood, and have iron rods in place of king posts, as well as struts beneath the tie beams, set into the long walls in an awkward manner. As well as their relatively modern form (though they could be early 19th century), their spacing is unusual, as normally the trusses would be positioned on either side of the cart entry, but in this case, one is located centrally over it, creating rather long bays between the trusses. There is also slight evidence in the stonework near the eaves (in particular, a slightly projecting stone which may have been a rough corbel below a tie beam), which suggest that the trusses were once differently and more closely spaced. It is therefore possible that there

have been alterations to or replacement of the roof structure during the barn's history, perhaps when the present blue slate roof was laid. Another alteration is the "doubling-up" of purlins which has been carried out, though this must have taken place with the present truss arrangement already in place.

Photo 18: South-west truss, looking south-west

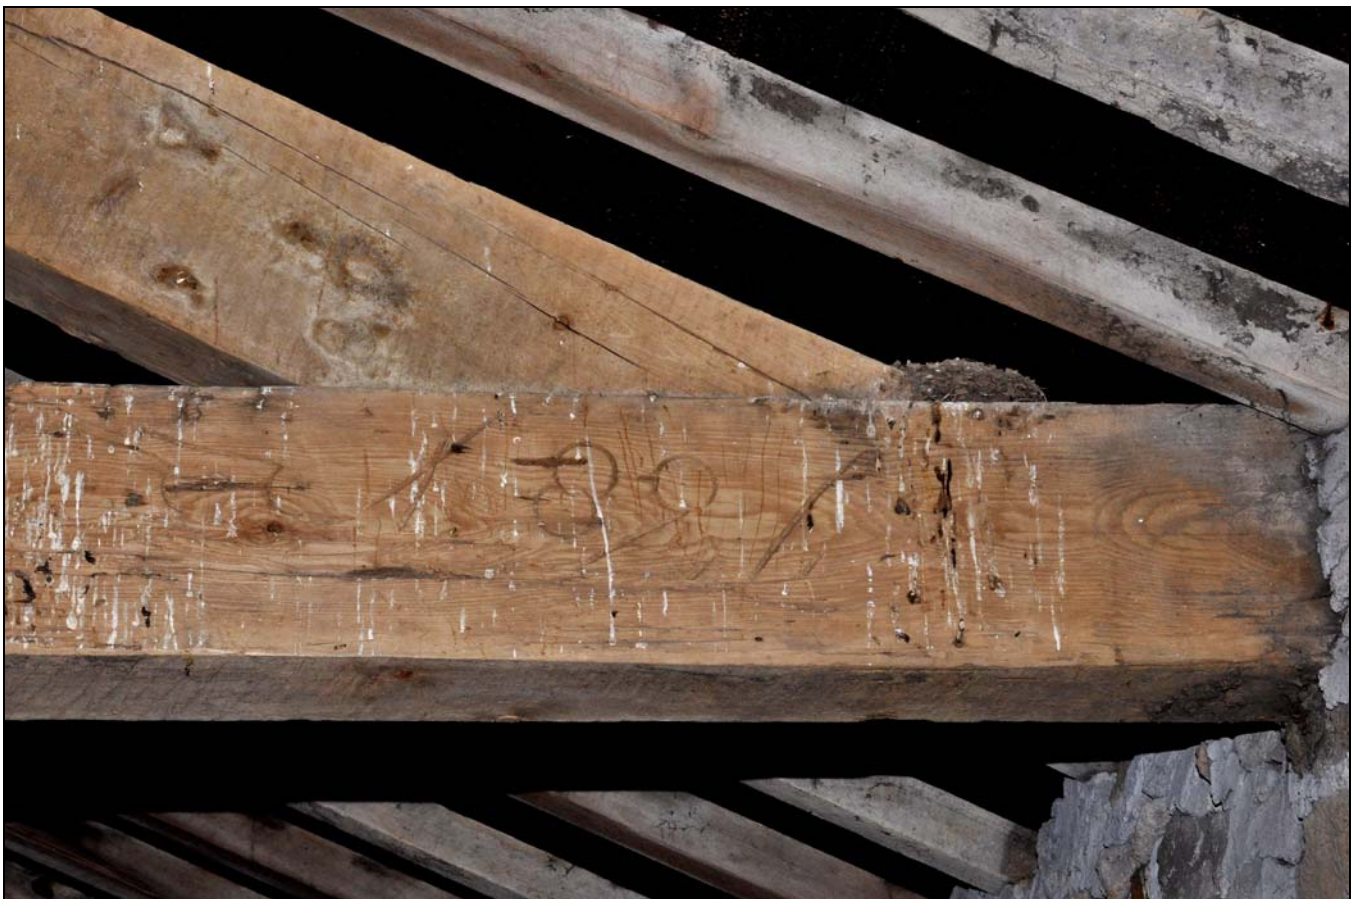
- 8.9 Some carpenter's marks, in the form of linear notches cut by a chisel, were observed on the upper face of the north-east truss, marking the joints between the tie beam and the principal rafters ("I" and "II"). "Baltic" markings were also observed on the south-west truss, their meaning unknown (19,20).

Photo 19: "Baltic" mark on north-east side of south-west tie beam
