**BAT SURVEY AT -  
HIGHER BOYCES FARM  
STONEY GATE LANE  
RIBCHESTER**

DATE AND TIME OF VISIT  
8<sup>th</sup> March 2019 10.00am

REFERENCE NO. 4874

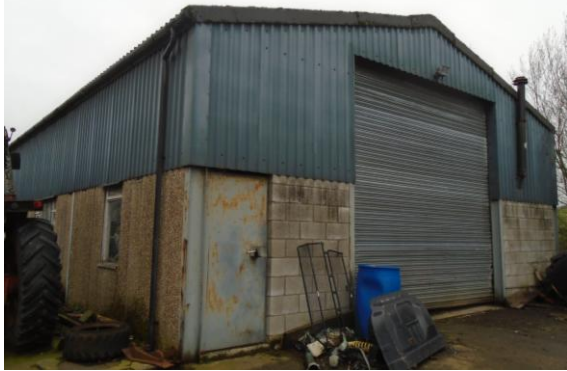
Front east elevation

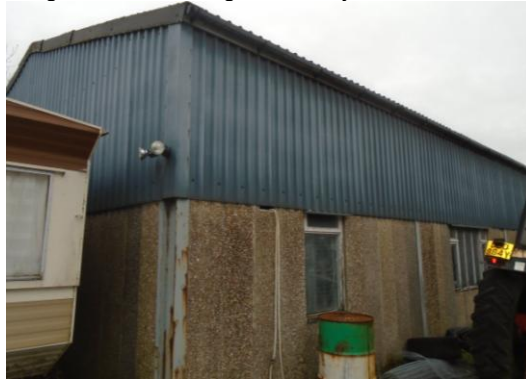
Part south and west elevation

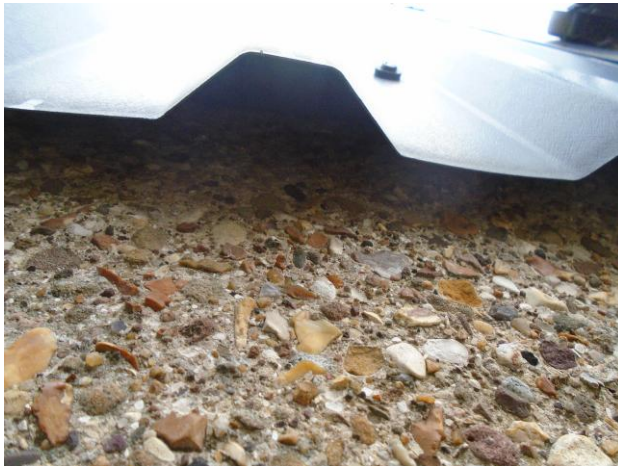
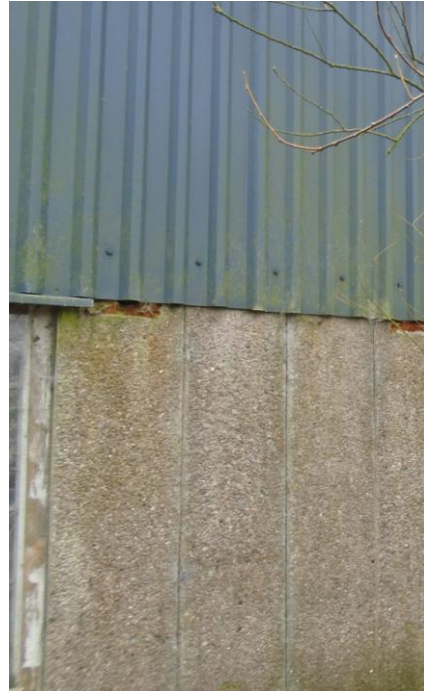
The base walls are pre fabricated concrete panels with a pebbledash external finish with the exception of the walls either side of the main opening on the front elevation which is blockwork. The walls at higher level are profile steel sheet.

The steel sheets and concrete panels are in good condition they do not provide any access points however at the abutment of the sheets and panels there are gaps formed by the profile which could potentially provide access into the building.

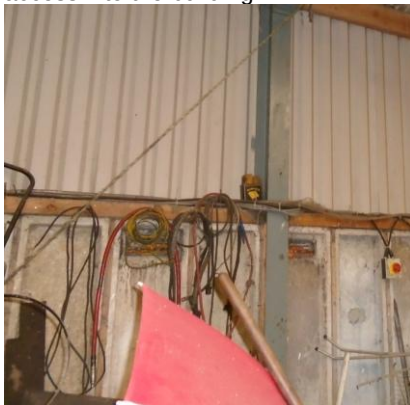
the internal view of the walls.

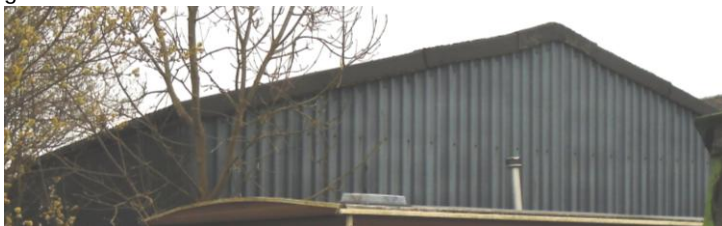
The roof is pitched with a corrugated fibre cement sheet with clear sections forming roof lights, complete with gable and eaves trim.

The roof sheets are in good condition with tight fitting sheet laps. Slight gaps will be formed at the abutment of the steel wall sheets and the roof sheets.

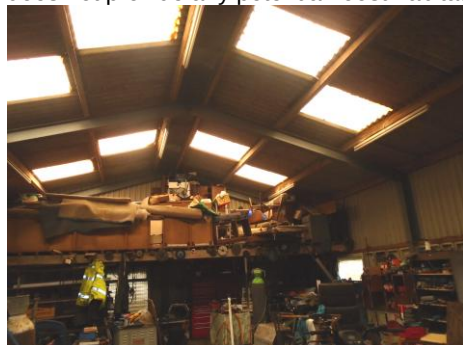
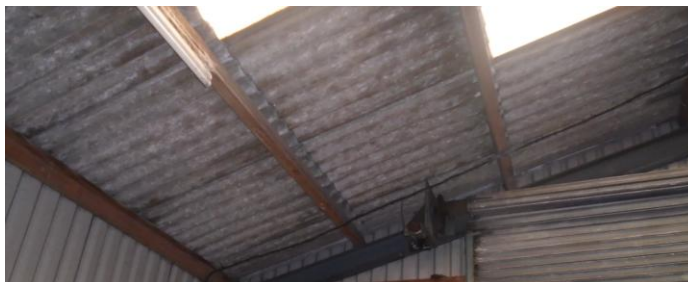
There is no enclosed roof void the structure is fully visible. The steel portal frame supports timber purlins with the sheets fixed directly over. All the timbers are in perfect condition with no cracks or crevices. The roof structure does not provide any potential roost habitat.

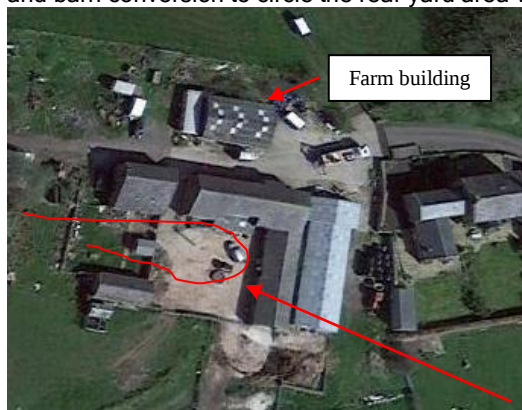
Based on past emergence survey results there is minimal bat activity at this location, emergence from the line of trees to the west of the site, with some foraging activity of a pair of bats travelling down the gap between the barn and barn conversion to circle the rear yard area was recorded.

Previously recorded bat activity
