**UPDATED**  
**BAT SURVEY AT -**  
**34 PAINTER WOOD**  
**BILLINGTON**

DATE AND TIME OF VISIT  
15<sup>th</sup> March 2019 10.30 am  
9<sup>th</sup> July 2019 9.30pm

REFERENCE NO. 5744

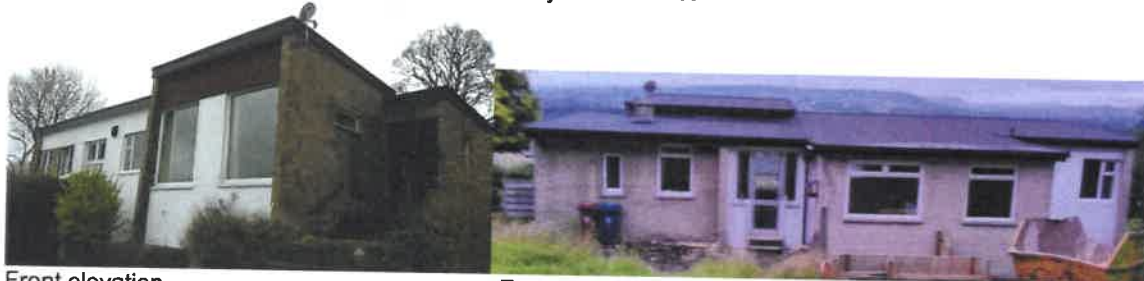
A detached bungalow dating from 1970's. Currently uninhabited.

Front elevation

Rear elevation

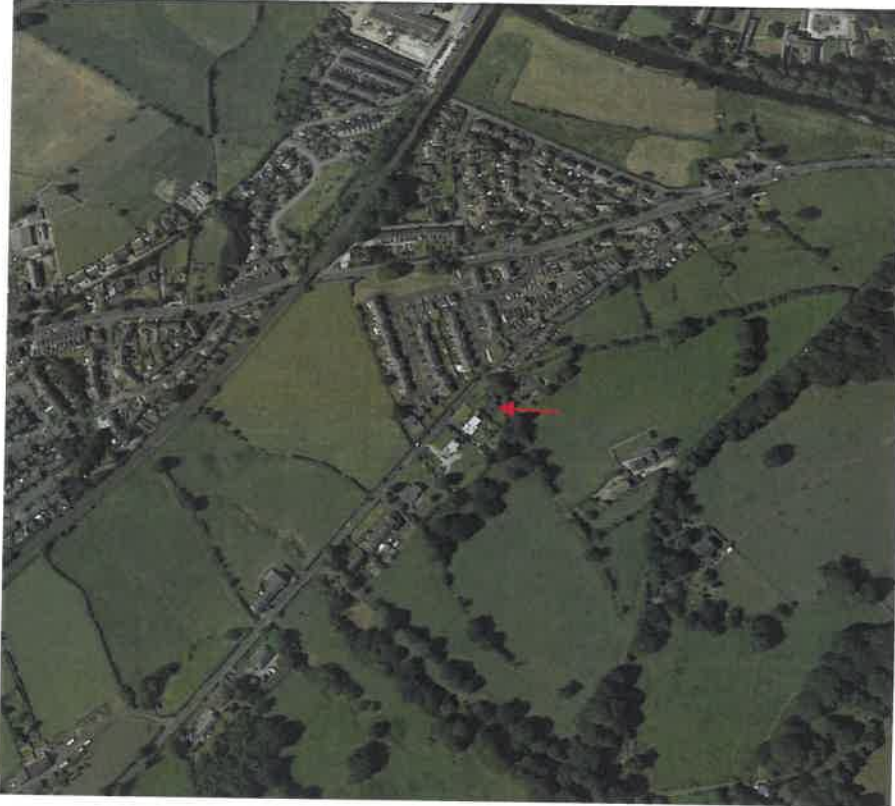
The house is located between Whalley and Billington in an elevated position on Painter wood road on the edge of the settlement area.

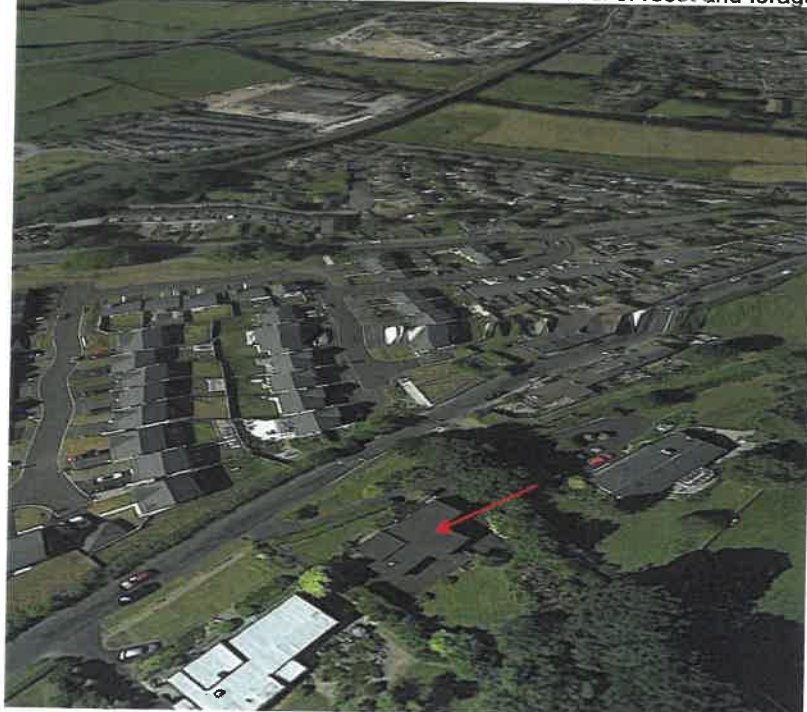
The house is one of 3 houses of similar design lining Painter wood road, all having gardens to the front and rear. The houses overlook a new housing estate to the north side of the road, to the rear and side of the property is large acreage pastureland. Mature trees line the north east boundary of the garden they also extend along the rear garden boundary. These trees are well connected to further tree lines in the greater area which have the potential as forage or commute routes for bats. There are no water courses or areas of standing water within 230 m of the house but the river Calder runs 455m to the N.E and a brook flows down the tree lined Butler clough 232m to the S.W. The location provides a medium level of roost and forage potential.

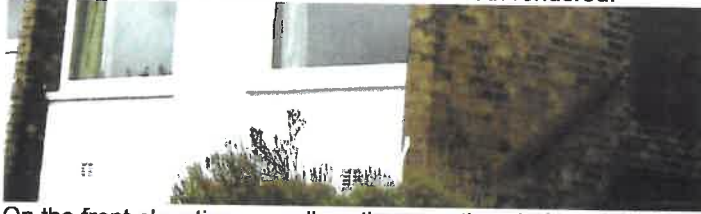
The walls are brick with some sections smooth rendered.

The walls are in excellent condition, no cracks, crevices or access points into the building. The timber boarding is in excellent condition it is very tight fitting and flush with the wall.

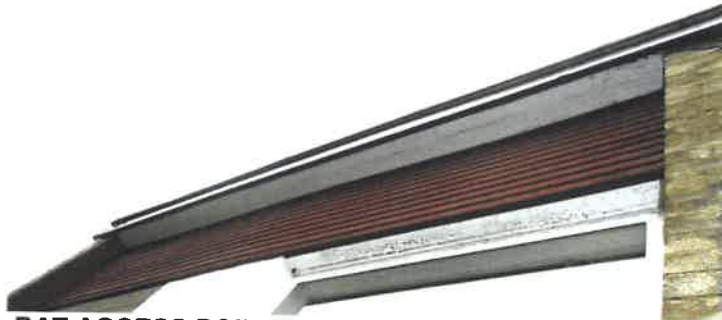
On the front elevation a small section over the windows is timber boarded

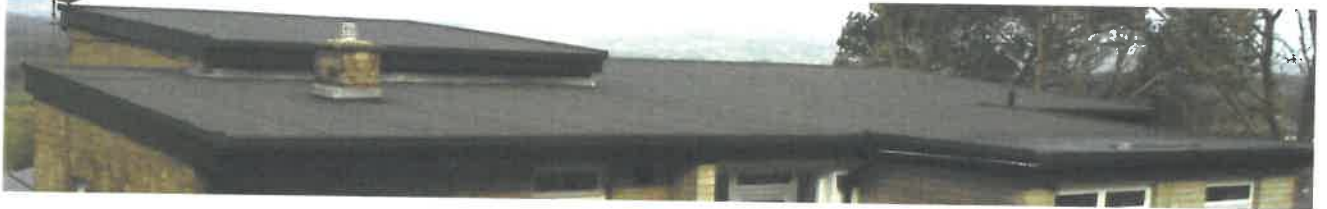
The roof is flat in two sections the smaller one being slightly higher than the main roof. The roof finish appears to be a relatively new single ply membrane system, all the fascias and soffits are upvc. Lead flashings at abutment of main roof with raised section and chimney.

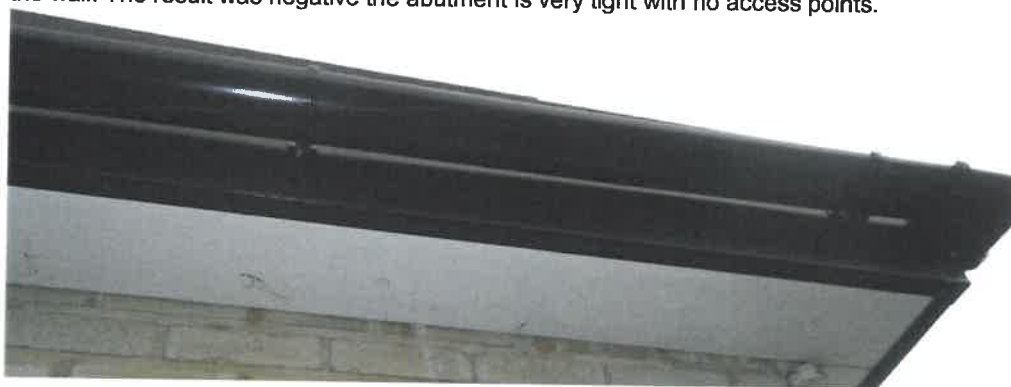
The roof is in excellent condition and all the fascias and soffits are tight fitting, with the exception of the fascia's to the side walls, where there is a small gap behind. The gaps were clear voids not providing any habitat for bats, an endoscope was also used to check if there was access into the void via gaps at the abutment of the roof and the wall. The result was negative the abutment is very tight with no access points.

upvc soffits

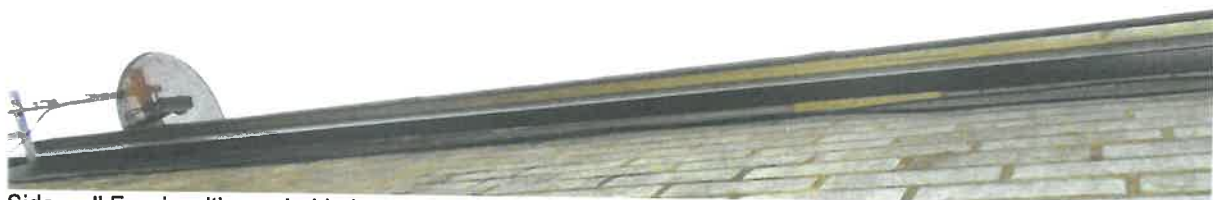
Side wall Fascia with gap behind

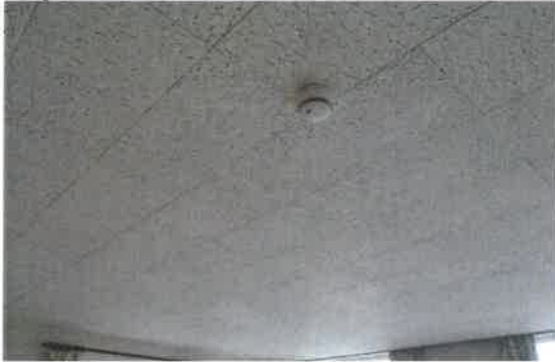
There is no enclosed roof void in this property the ceilings have a proprietary suspended system directly under the joists.

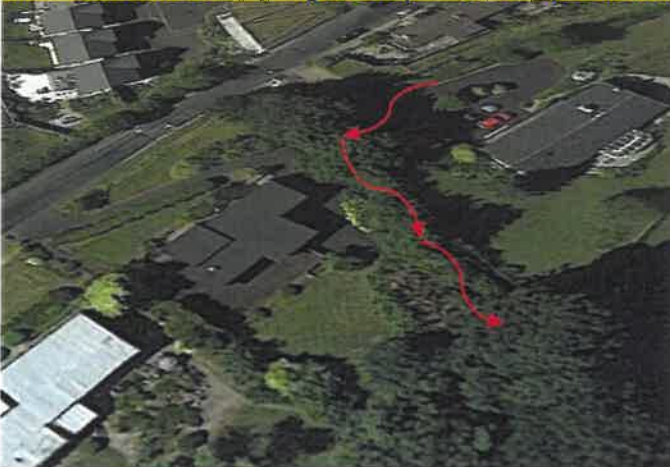
Two no. surveyors were located at the front and rear of the house to monitor all elevations, no emergence from the building was recorded. Minimal activity (route indicated in red) of a single bat was detected in the line of trees to the north east commencing at 9.55 pm the bat appeared from the north east, the forage activity was brief.
