Report type:	Phase I Site Appraisal (Desk Study)
Site:	Petre Wood, Phase 3
Client:	Alan Johnston Partnership LLP
Ref:	GRM/P8827/DS.1
Date:	March 2019

# PETRE WOOD, PHASE 3

## PHASE I SITE APPRAISAL (DESK STUDY)

**Project Ref:**  
P8827

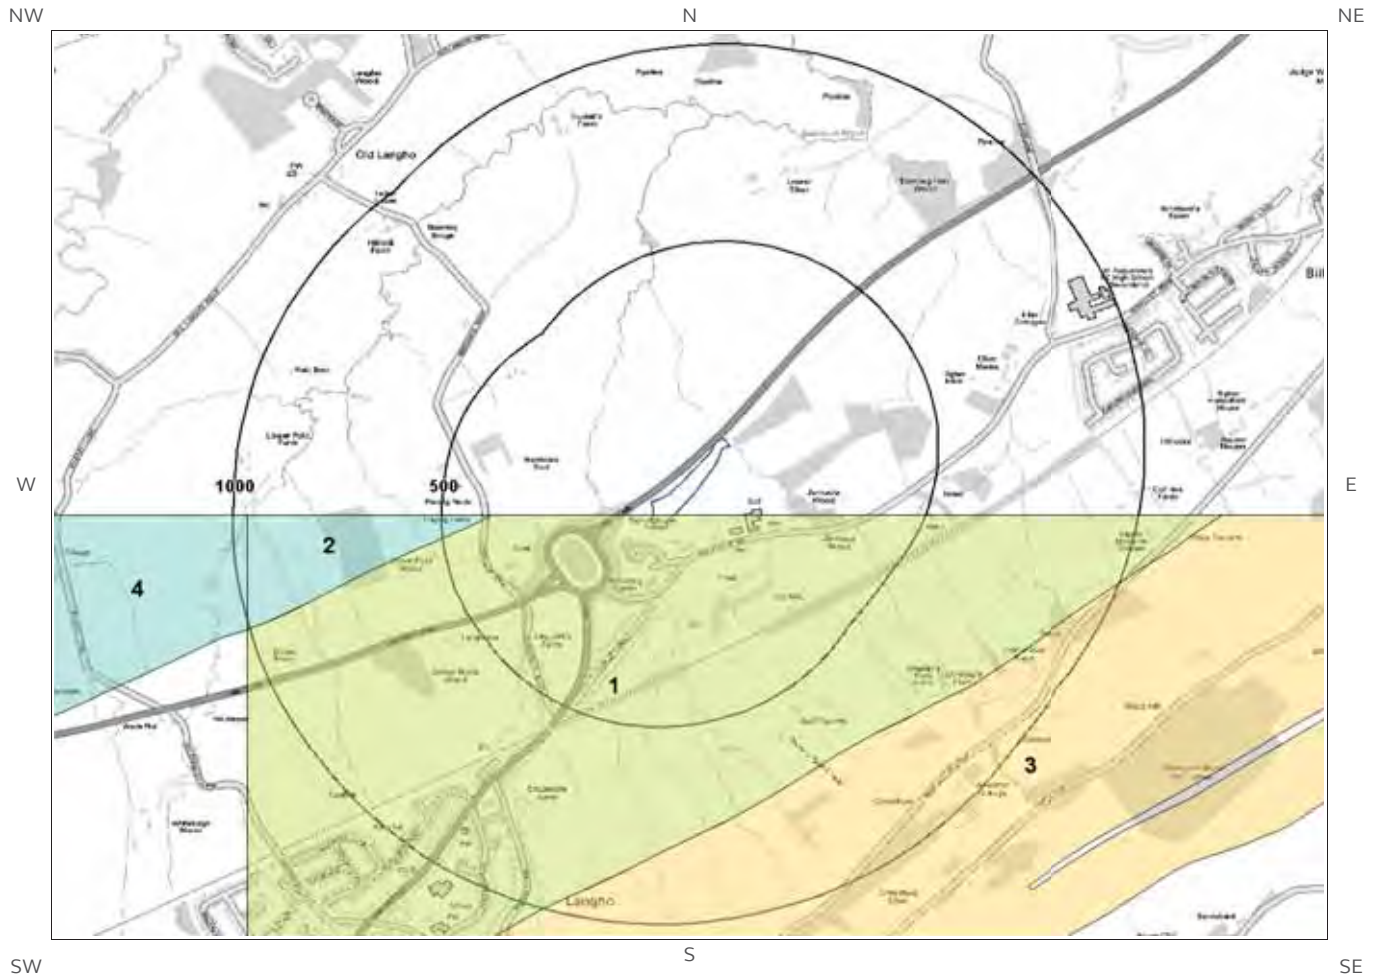
# 1.3 Bedrock and linear features map (1:10,000 scale)

This Geology shows the main components as discrete layers, these are: Artificial / Made Ground, Superficial / Drift Geology and Landslips. These are all displayed with the BGS Lexicon code for the rock unit and BGS sheet number. Not all of the main geological components have nationwide coverage.

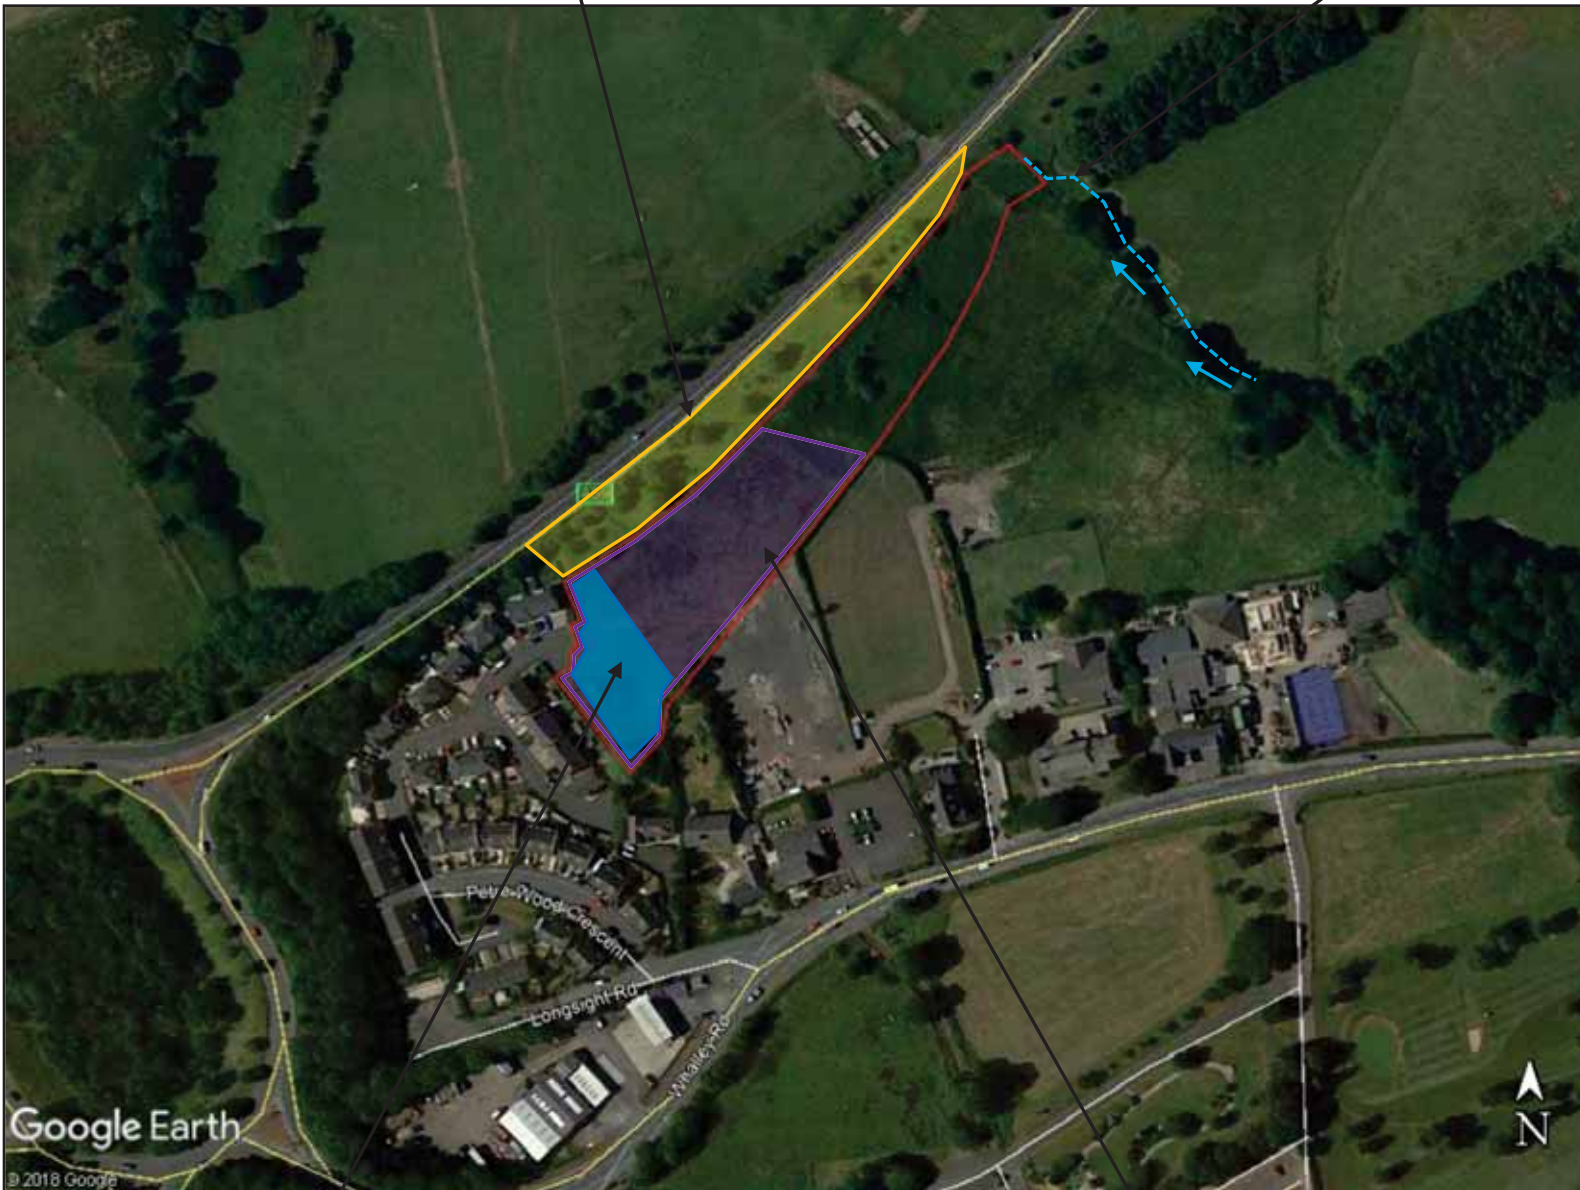
Area of historical buildings demolished by approximately 1981.

Where appropriate potential hazards to the proposed development are shown on the Hazard Plan (Ground Model) presented in Appendix G.
