**BAT SURVEY AT -
WISWELL EAVES HOUSE
PENDLETON ROAD
WISWELL**

**DATE AND TIME OF VISIT
17th Aug 2018 3.00pm**

REFERENCE NO. 5603

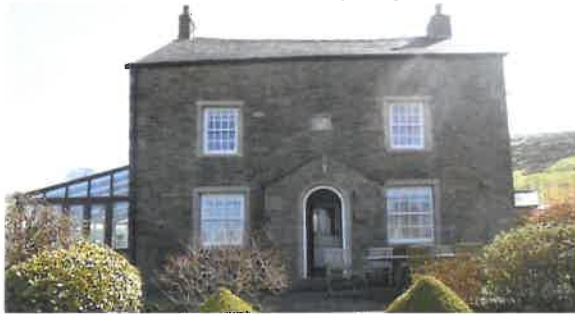
The main house is a detached property in the Georgian style dating from 1766. There is a conservatory to the north elevation which is a contemporary addition.

Front elevation of house

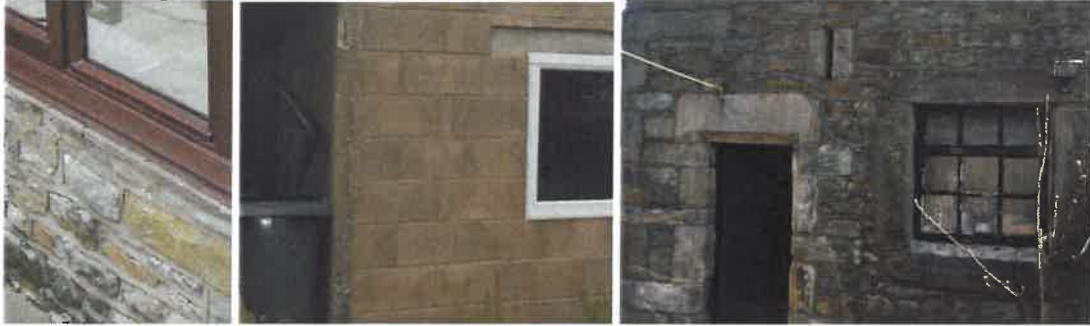
Conservatory

Garage

Outbuilding

The conservatory base walls are strap pointed natural stone.

The garage is a precast concrete construction with concrete block gable wall.

The outbuilding is solid stone.

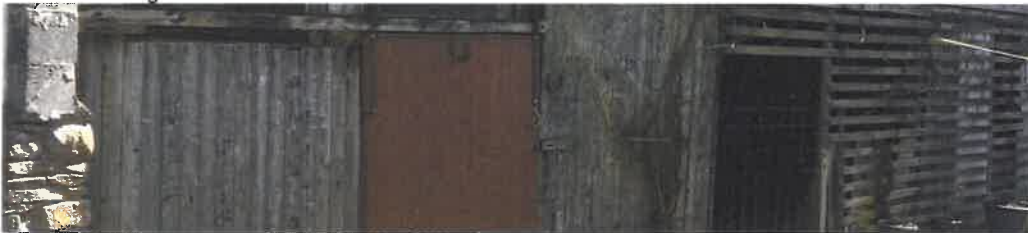
Timber sheds constructed against natural stone back wall. Boarded and slatted timber walls.

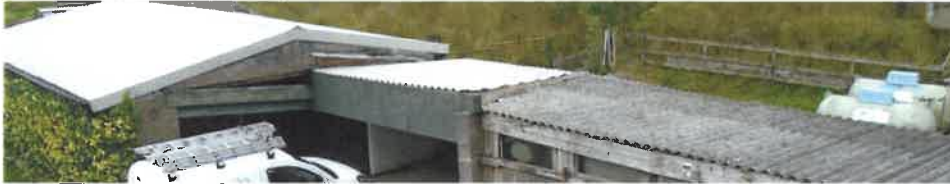
Garage and shed roofs

The garage roof is a slight pitched corrugated steel sheet with verge trims.

The sheds have mono pitch corrugated fibre cement sheets with no rainwater gutter.

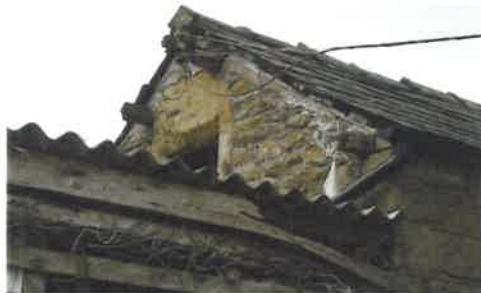
Slate pitched roof to the outbuilding with pointed verges to the gables

outbuilding gable and part shed roof

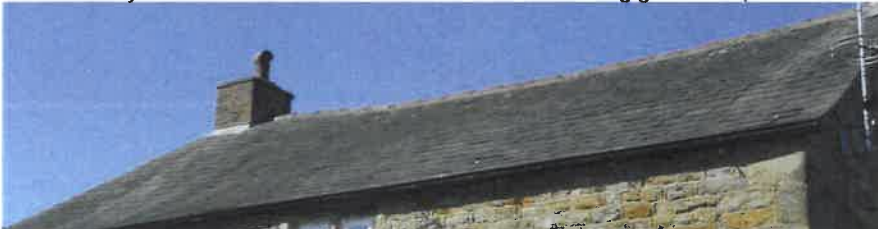
The rear main roof pitch in which it is proposed to insert velux roof windows, is slate pitched with pointed verges, gutters on brackets.

The main roof slates do not provide any access points for bats, the installation of the roof windows in the main house roof will not disturb or harm any bat population. No mitigation required or timing restraints .

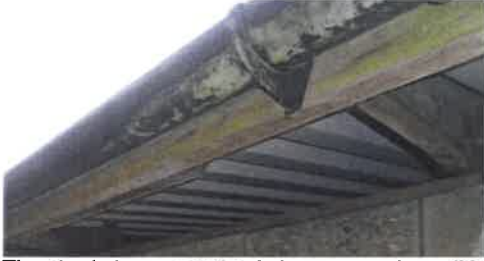
The garage roof is new and in excellent condition and does not provide any access points or crevices, however the abutment of the roof sheets and the walls have small corrugation gaps.

The garage does not provide any roost or forage potential for bats, the demolition of the garage will not remove any bat roost or forage potential, and the scale of the proposed replacement will not have a detrimental effect on any bat population. No mitigation required or timing restraints .

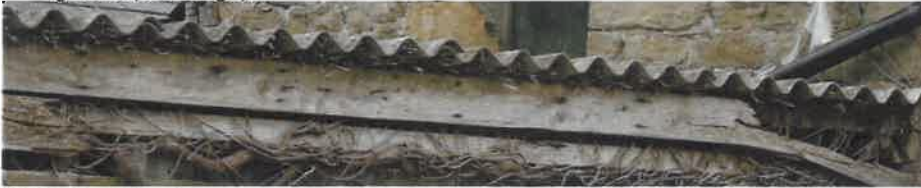
The shed sheet covering is in very good condition and does not provide access points however again the corrugations provide gaps

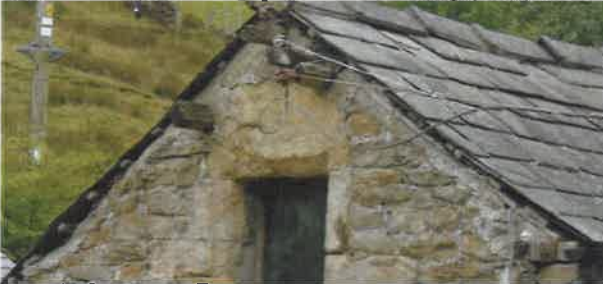
The outbuilding has external crevices in the north gable at slate abutment which have the potential to be used by bats. There is also a ridge slate which has a gap under.

The outbuilding although not currently used by bats nor were there any signs to suggest that bats have historically used the building, it does have some external gaps which have the potential for future use. It is recommended that the gaps are re pointed or netted so as to prevent any potential future ingress prior to the commencement of work. If the works on the outbuilding are to commence during the activity period (April - September) an emergence survey should be carried out .

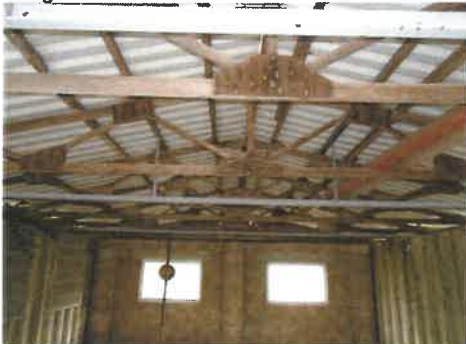
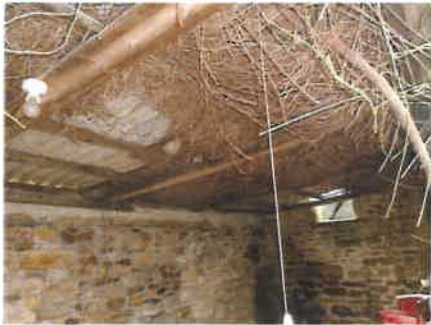
The garage roof structure is a combination of timber and steel trusses with timber purlins. Sheets fixed directly over, no enclosed roof space. All timbers are in good condition. The space does not provide any potential roost or forage habitat for bats.

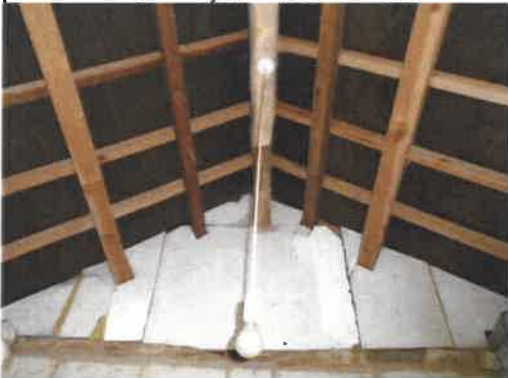
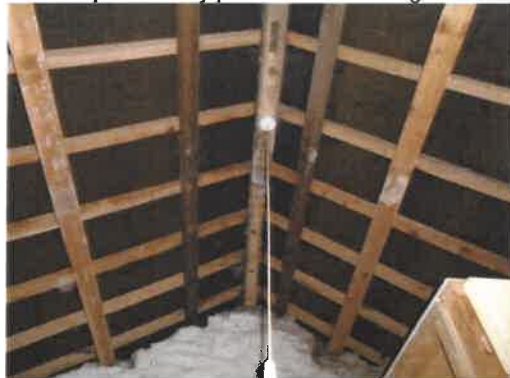
Shed lean to roof is timber purlins and rafters with fibre cement sheets fixed directly over. Timbers and sheets are in good condition with no cracks or crevices however there has been tree ingress and the dead branches remain insitu. All the structure was easily examined no evidence of past or current use by bats was recorded. The roof does not provide any potential for roosting.

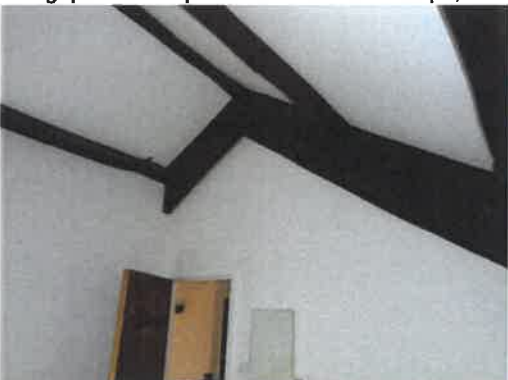
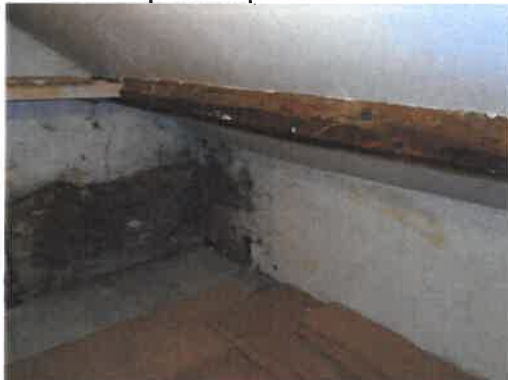
The outbuilding roof appears to have been replaced quite recently all the timbers, rafters and felt are in excellent condition with no cracks or crevices. The south gable wall has some gaps at the abutment of the rafters and wall. The gaps were inspected with the endoscope, no evidence of bat presence past or current was found.

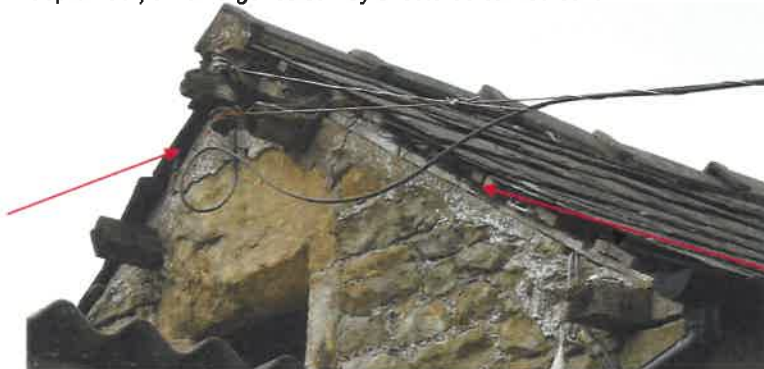
Gaps at abutment with slates

Notwithstanding the result of the emergence survey it is also recommended that the roost potential of the outbuilding be enhanced with the provision in the roof of the ridge access detail illustrated below.
