**GREENBANK BARN, GRINDLETON,
LANCASHIRE**

HISTORIC BUILDING RECORDING

Planning ref. 3/2019/0140

JB Archaeology Ltd

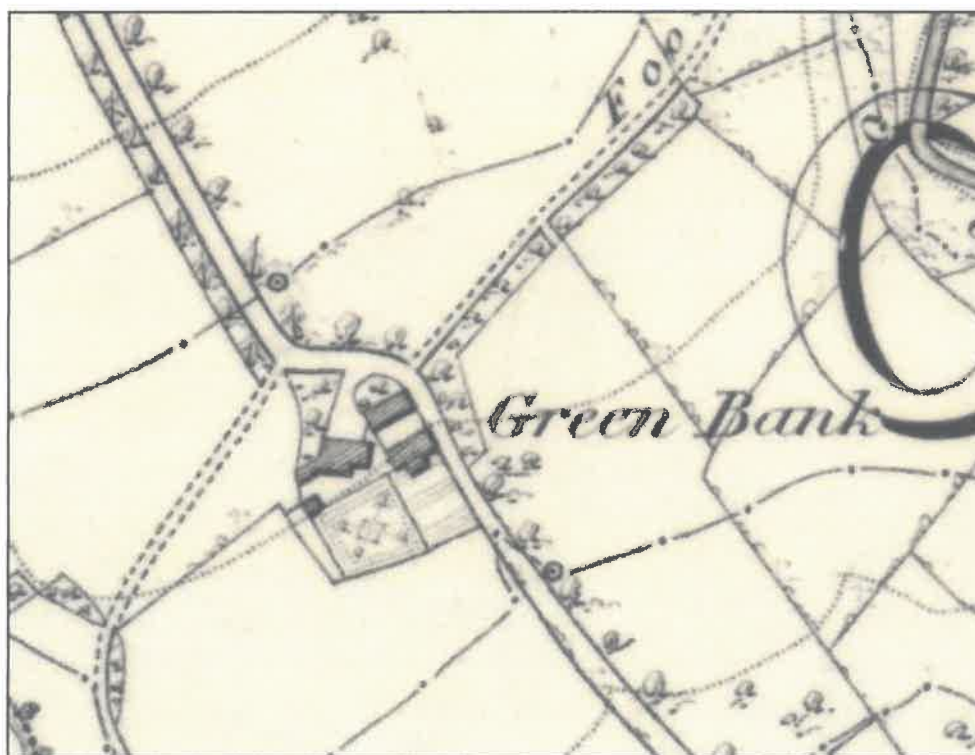
Figure 3. Extract 1850 OS 1st edition

4.1 Green Bank farm is already established by the Ordnance Survey 6" to 1 mile 1st edition of 1850 (Figure 3) and the barn is depicted as a more or less rectangular building. However, by the OS 25" edition of 1886 the barn is shown in the configuration that it is seen today and it would seem possible that the earlier depiction is a simplified one.

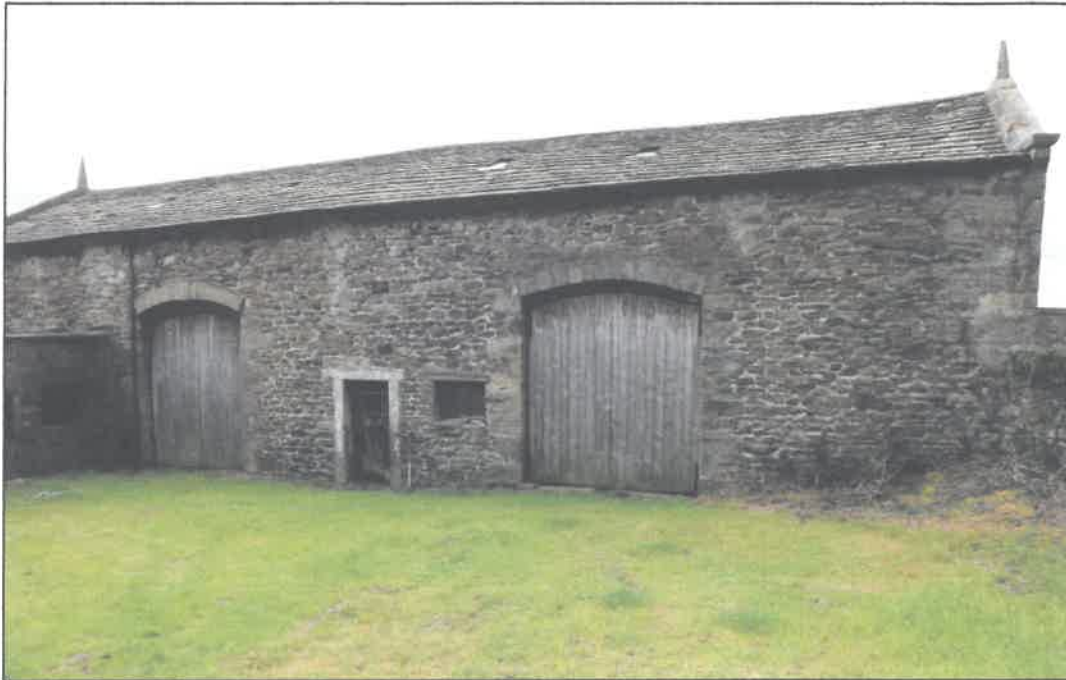
Plate 1. Rear (northern) elevation, looking south, scale 1m

- 4.4 The barn had been built on a modest man-made terrace cut into the south facing slope of the hillside. The rear (north) elevation (Plate 1) contained two large cart doors along with a single, centrally located doorway and window.

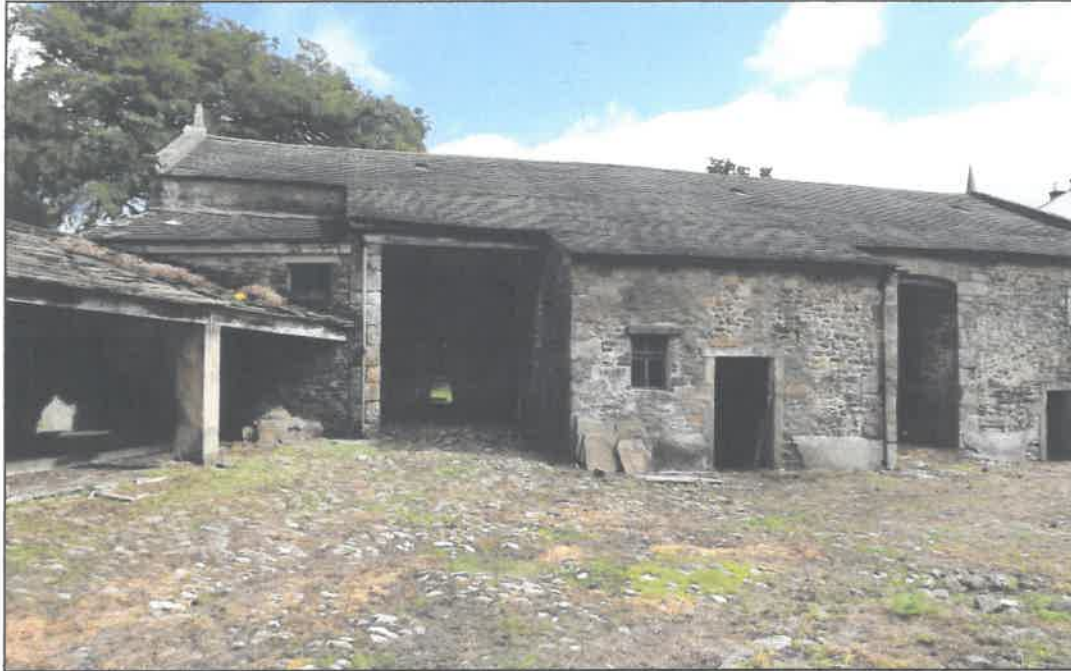
Plate 2. Front (southern) elevation, looking north, scale 1m

- 4.5 The southern elevation (Plate 2) had a similar arrangement with two large cart doors directly opposite the ones in the northern elevation. There were a number of small doors leading to a variety of small rooms which appear to have been added to this elevation over time.

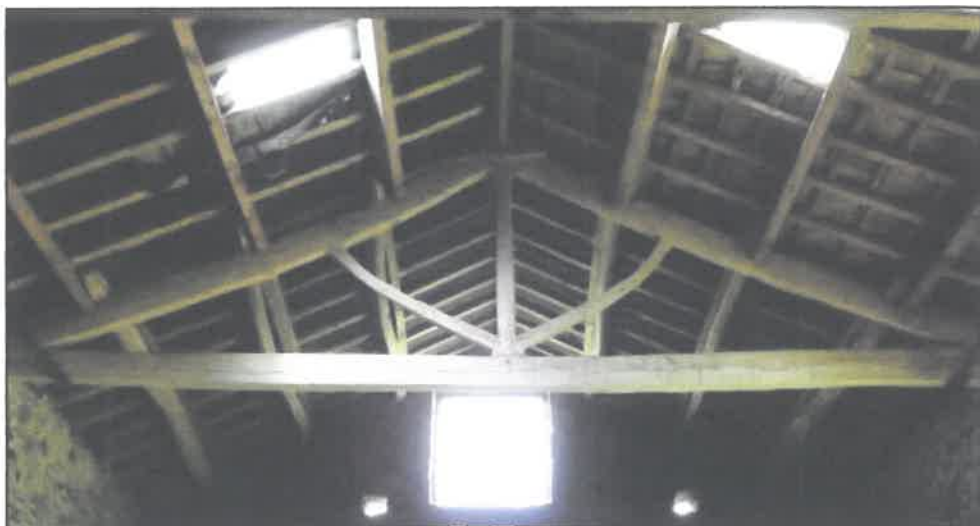
Plate 3. King post truss with curved braces at west end of the barn, looking W

architectural features including a king-post truss of hand-cut timber which has curved braces (Plate 3). This suggests an 18th century date.

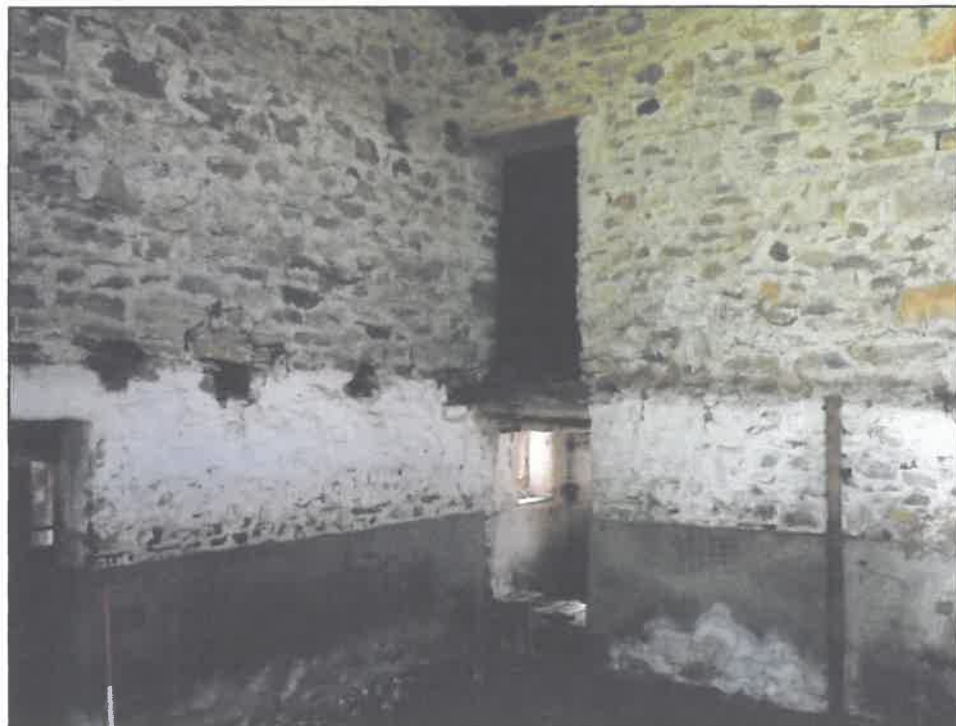
Plate 4. Joist holes and 'tide mark' showing hay loft, looking SE, scale 1m

- 4.9 The original configuration of the barn appears to have been as a large hay barn with two cart porches on the southern side with matching doors on the northern side. The size and location of these doors would have allowed for threshing to have taken place. A row of joist holes in the dividing wall between the two parts of the barn attest to a hay loft (Plate 4). A further possible indication of a hay loft, or possibly even a granary, is a line of large staggered stones in the north-eastern side of the barn (Plate 5 & Figure 7). These stones appear to be the remains of a flight of external steps to a loft of some form which were probably removed during the Phase II works in 1817 – see below.

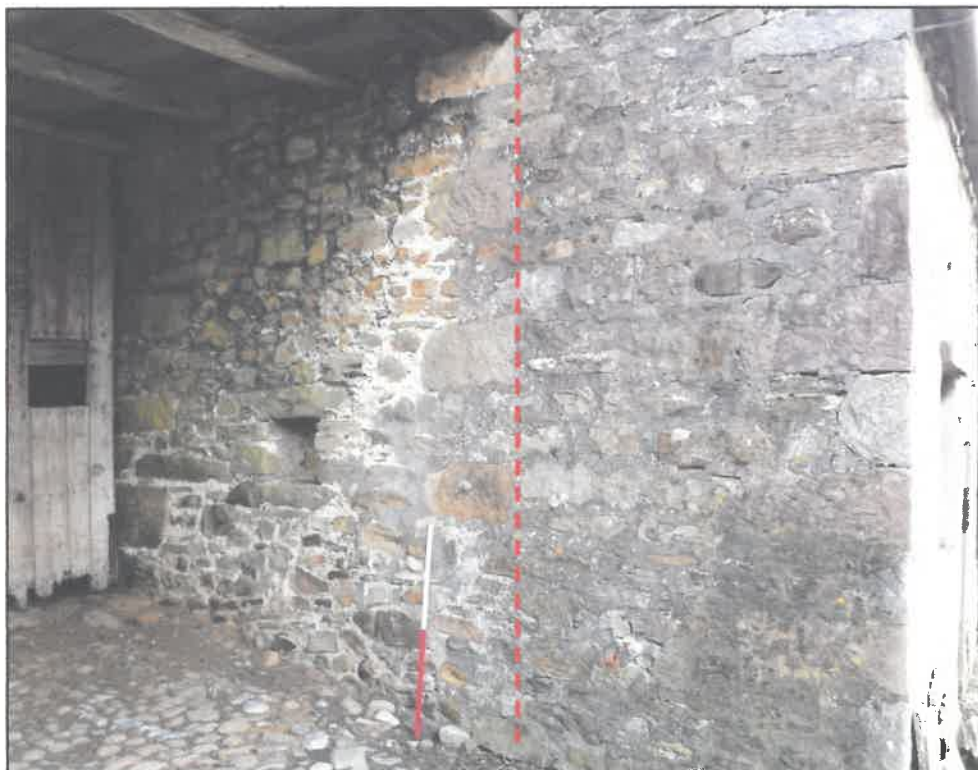
Plate 6. Lantern niche & butt join of Phase II extension, looking NE, scale 1m

- 4.10 The western cart porch retained a lantern niche on its eastern side (Plate 6), a similar one would be expected in the eastern cart porch but later alterations have probably removed it (Plate 7). The cart doors in all four entrances were harr-hung which probably reflects their original configuration.

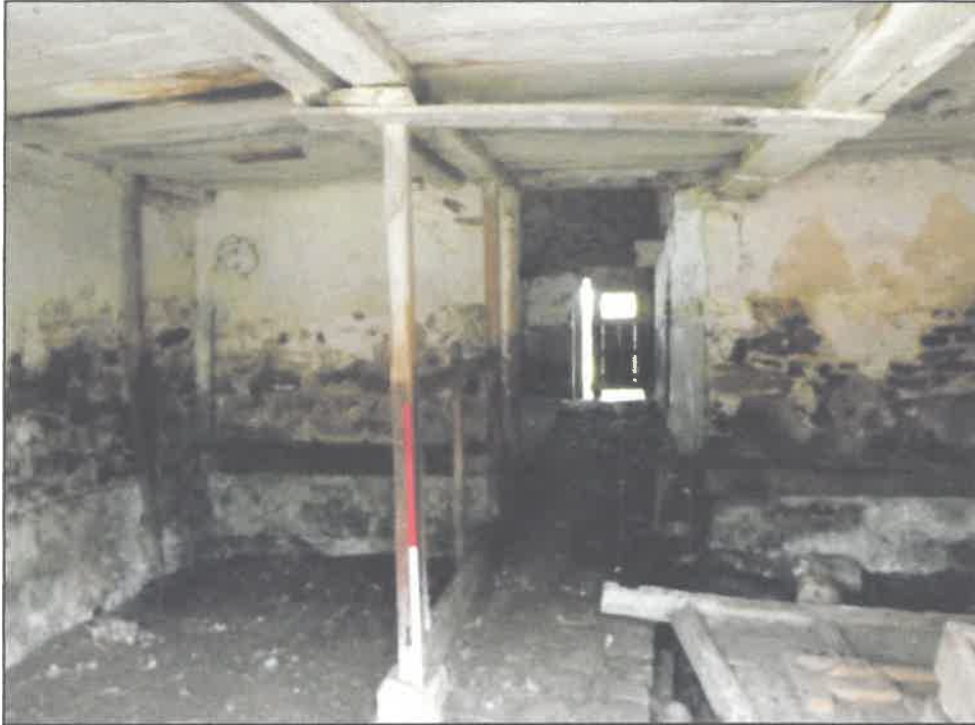
Plate 9. Infill room between porches, looking north, scale 1m

- 4.12 The infill between the cart porches was used for livestock, as seen by the lantern niche in the southern wall (Plate 10) and the collapsed boskins. The ceiling timberwork for this room contained a number of reused elements which may have derived from the reconfiguration of other parts of the building.

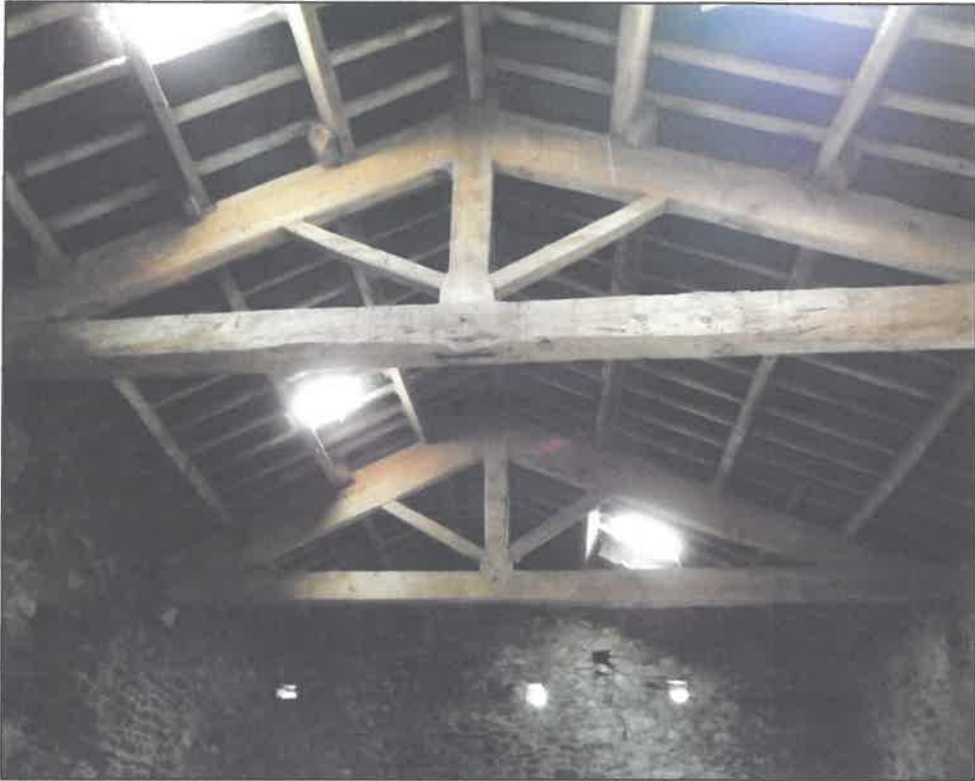
Plate 11. Later trusses at the eastern end of the barn, looking east

- 4.15 It would seem probable that the early 19th century changes also saw the replacing of the original/earlier trusses with the more substantial ones seen today (Plate 11).

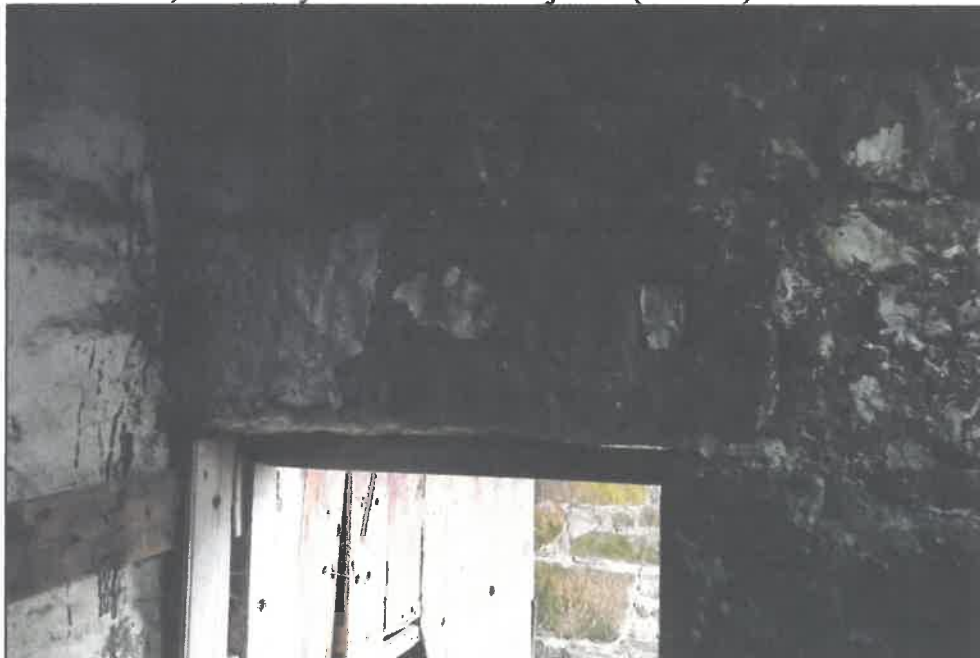
Plate 12. Reused door sill as a jamb, looking east.

- 4.16 The last significant change to the building that can be identified is the infilling of the gap between the cart shed to the west and the western end of the barn. From historic mapping (Figs 6&7) this would seem to be between 1890 and 1908. The only notable feature of this room was the reused door sill as a lintel over the door, as seen by the holes for door jambs (Plate 12).
