RE: Proposed development at 23 Chatburn Park Drive, Clitheroe, BB7 2AY

Thank you for your request for a bat survey in relation to a proposed development at the above site. I understand the existing building will be extended along the side (north west) elevation.

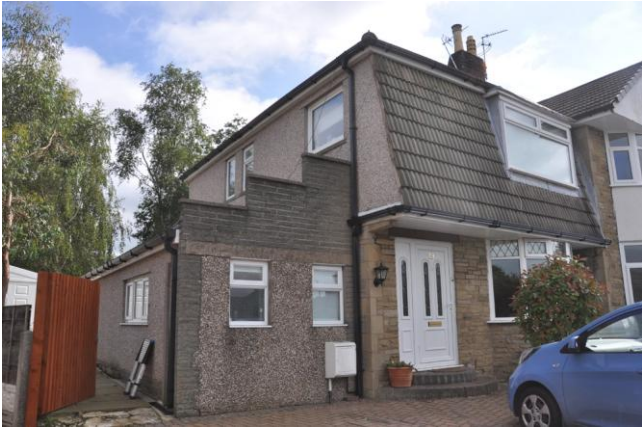
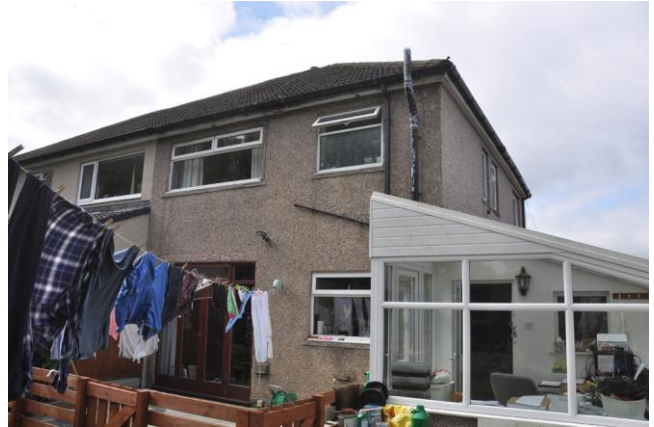
23 Chatburn Park Drive is an occupied, semi detached dwelling house with an adjoining converted single garage and small glass conservatory porch to the rear of the property. The walls are constructed of brick and stone, with pebble dash render to the side (north west) and rear (north east), as well as hanging concrete tiles on the first floor, front (south west) elevation. All windows and doors are upvc and sealed. There are no gaps associated with any of the external walls, door and windows that are suitable for use by bats.

View of front and side elevation (location of proposed extension) (lhs) and rear elevation (rhs)

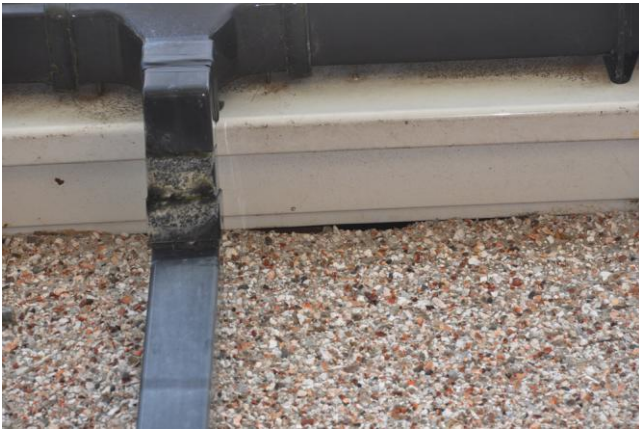
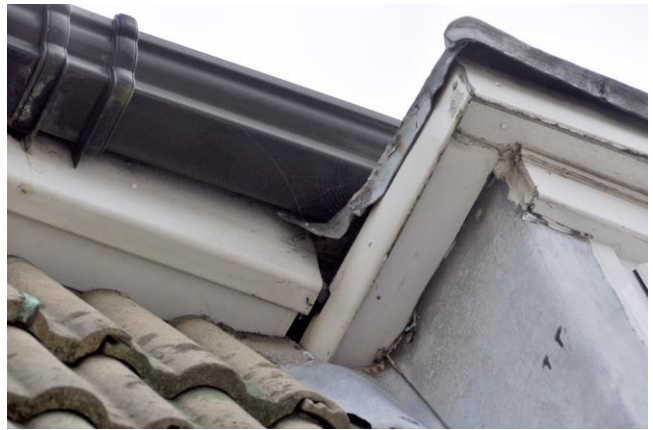
Along the roof edges are upvc soffits. There are occasional small gaps below the soffits, including a larger gap where the soffit and first floor window (front elevation) join. These gaps have some potential for use by bats.

- Gaps roof coverings –low potential
- Gaps associated with soffits – low potential

Close up view of gaps associated with soffits (lhs) and gap at join with first floor window (rhs)

It is advised that when removal or disturbance of potential roost features such as soffits and roof coverings are to take place, this should be done carefully by hand.

It is advised that nesting birds, such as blue tits, could utilise the gaps associated with soffits throughout the nesting season (February to September). It is therefore advised that works are either undertaken outside the nesting bird season, or if works cannot be avoided during this period, a pre-commencement check is carried out by an ecologist.

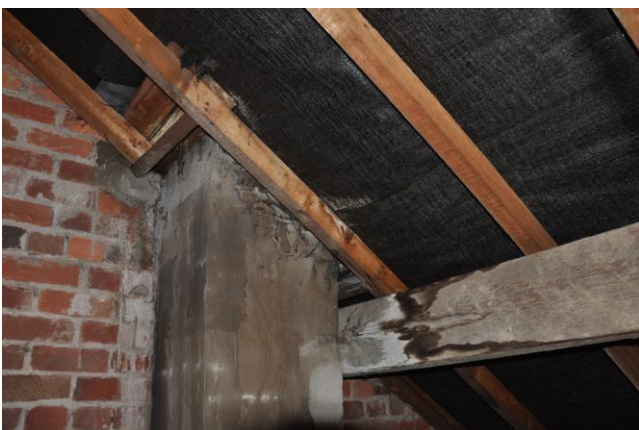
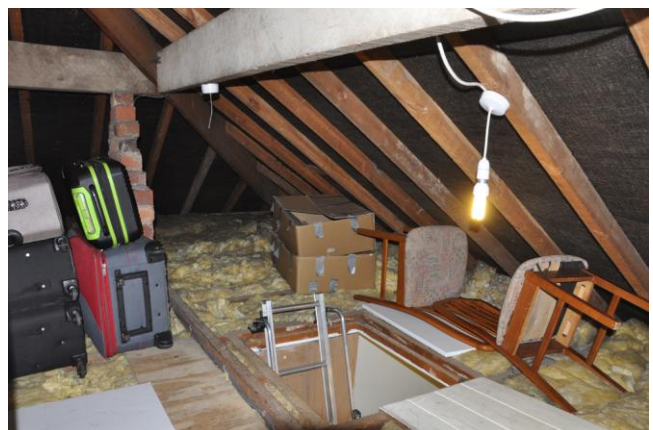
The roof void is used for general storage. The roof is supported on a timber framed structure with bitumastic hessian liner and rock wool insulation on the floor. A small amount of light incursion is present due to occasional gaps along the roof edges, but no other potential access points for bats were found during the inspection.

View of roof void (lhs) and (rhs)
