Bat Roost Assessment Report

**Falcon Cottage,
Fleet Street Lane,
Hathersall,
PR4 3YR**

02.07.2019

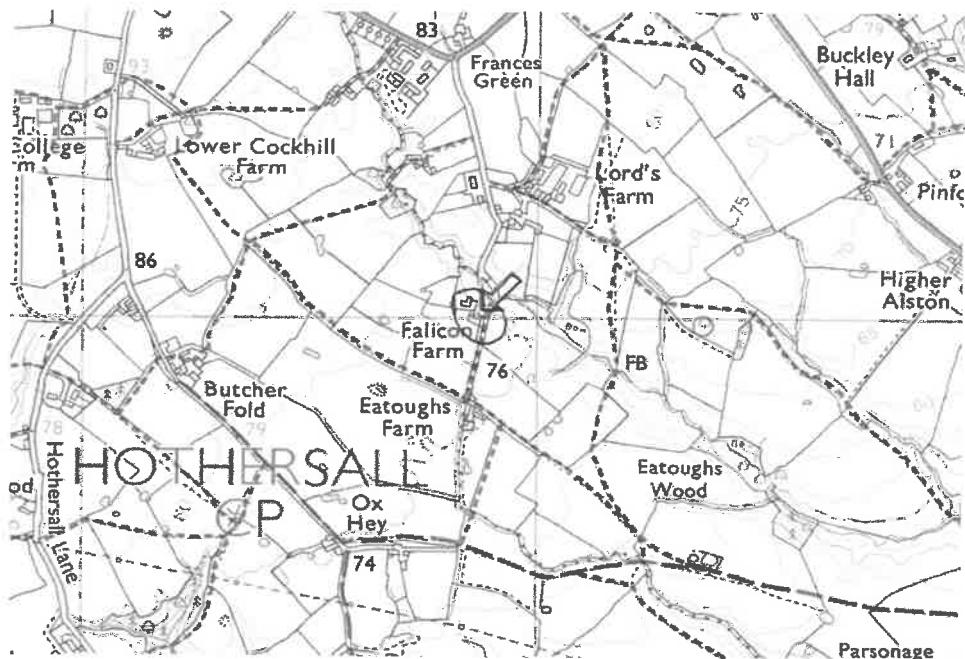
Survey site location

A central grid reference for the site is SD6286036017

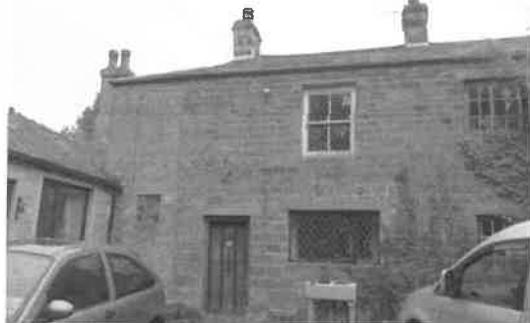
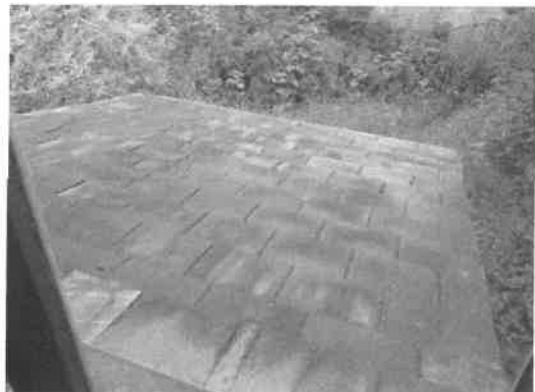
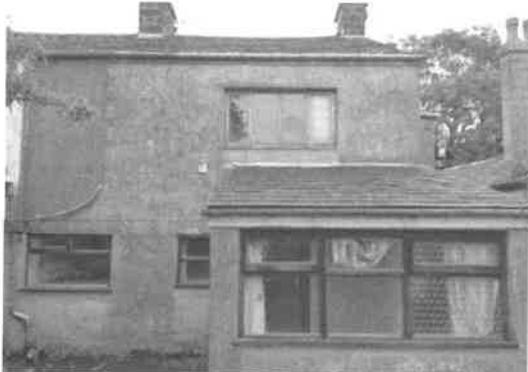
The property consists of a semi detached two storey stone built house with a double pitched slate roof. External walls are well pointed and in good condition, fascia boards are close fitting. The slate roof has no obvious missing or lifted slates, ridge tiles are pointed and well sealed. Pointing on gable end is generally in good condition, and lead flashing where present is close fitting. The roof slates are unlined, heavy cobwebbing was observed within the loft space.

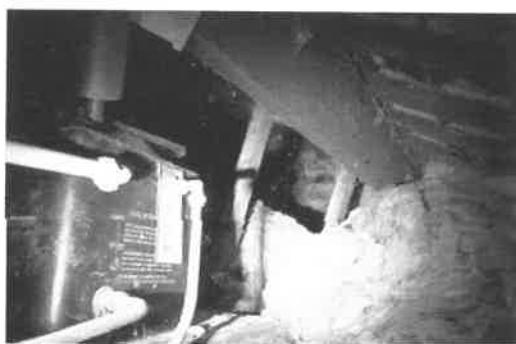
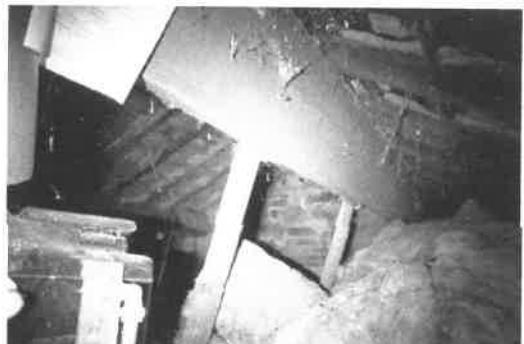
Overall the building offers negligible roosting potential.

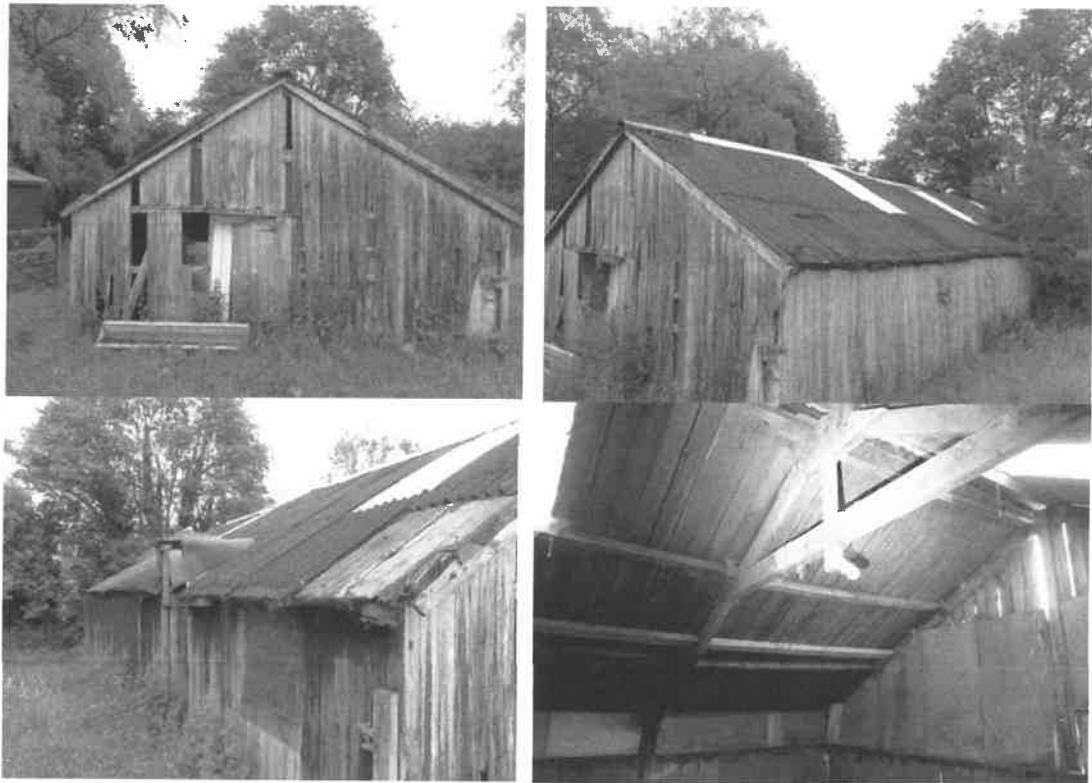
A single storey single skin former stables is in a poor state fo repair with missing sections of roof and deterioration of the ridge allowing considerable light and weather penetration. The building offers negligible roost potential.

The timber stables are in a poor state of repair with considerable weather and light penetration caused by missing areas of roof and ridge. No evidence of use by bats was recorded within the building and the single skin construction offers no suitable cavities or crevices.

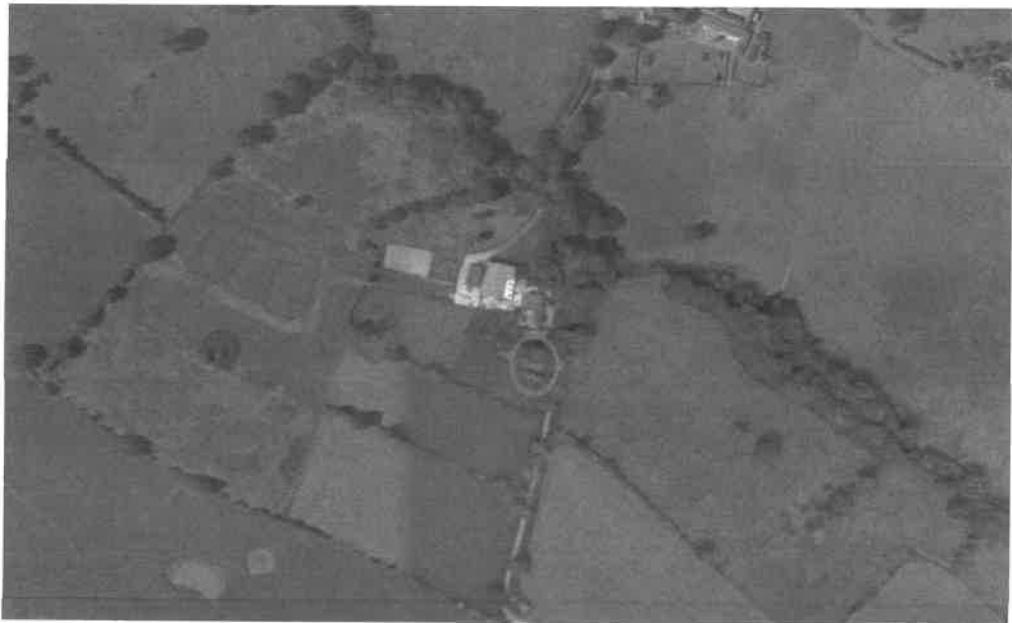
Surrounding habitat.

The property is located in a rural position in an area of predominately semi improved and improved grassland. A wooded brook to the north of the property provides connectivity to the wider landscape.

Overall foraging potential for bats can be considered moderate.
