PRELIMINARY RISK ASSESSMENT

LAND OFF CHATBURN ROAD, CLITHEROE

Report Ref BEK-19595-1

August 2019

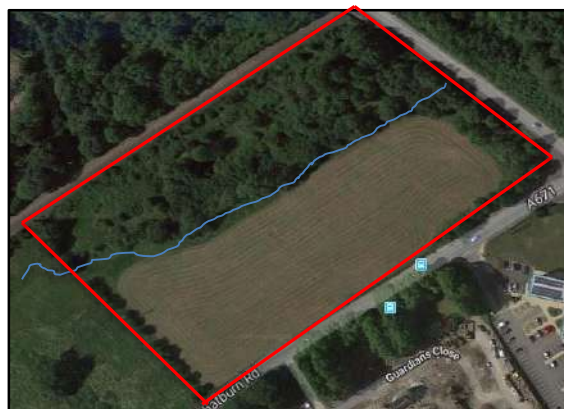
Figure 1: Site Layout

- 2.2.4 The north-west of the site is occupied by dense woodland (mature and semi-mature trees, bushes with brambles, nettles and thistles), whilst the south-east is an open field, used for agricultural purposes. The two sections are separated by a stream which flows north-east to south-west, entering the site through a culvert in the north-eastern site boundary (see Figure 1).

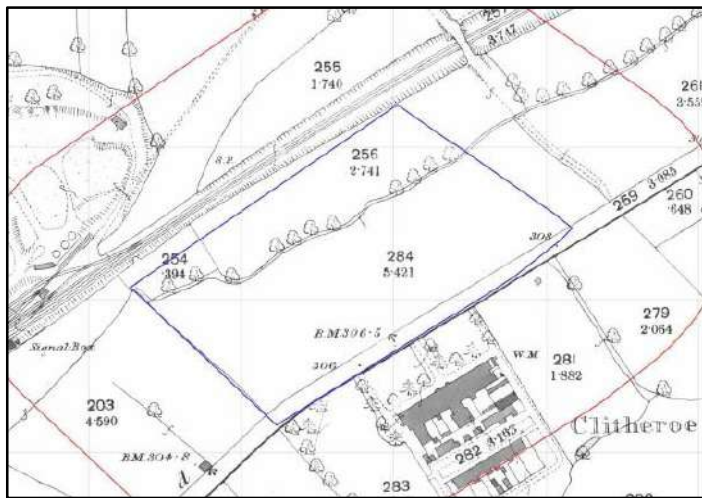
Figure 2: Extract from 1884 Historic Map

- 3.2 The earliest available maps show the site to be occupied by vacant undeveloped land (likely agricultural use). A stream is present on site, flowing north-east to south-west - See Figure 2.

- 3.3 A road marks the south-eastern site boundary and a railway line marks the north-western site boundary. A limestone quarry marked as 'Coplow Hill' is located some 30 m north-west of the site. Two large, irregular shaped buildings with a number of smaller buildings, marked as 'Clitheroe Union Workhouse' are located some 30 m south-west of the site
