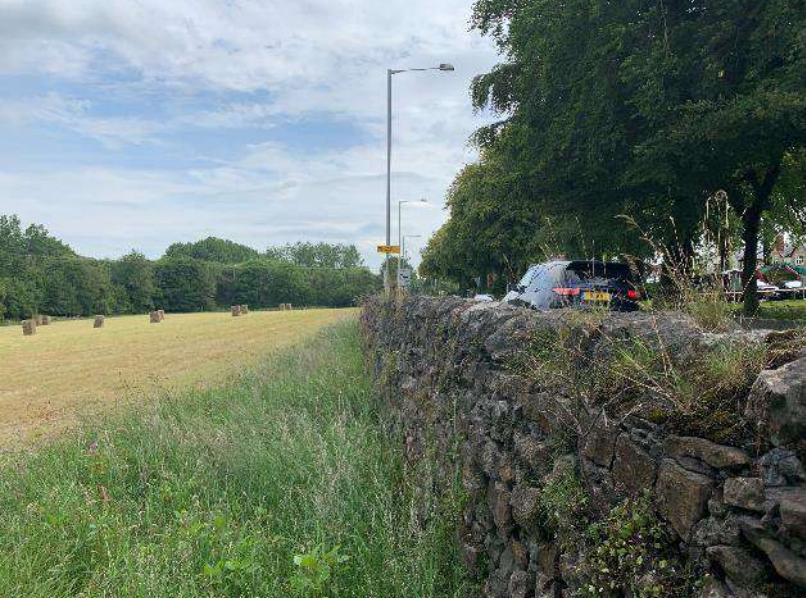
Photograph 1

| | | <p>The south-eastern site boundary, marked by Chatburn Road which is approximately 1-2 m higher than the site. Taken from the southern corner of the site, facing north-east.</p> |

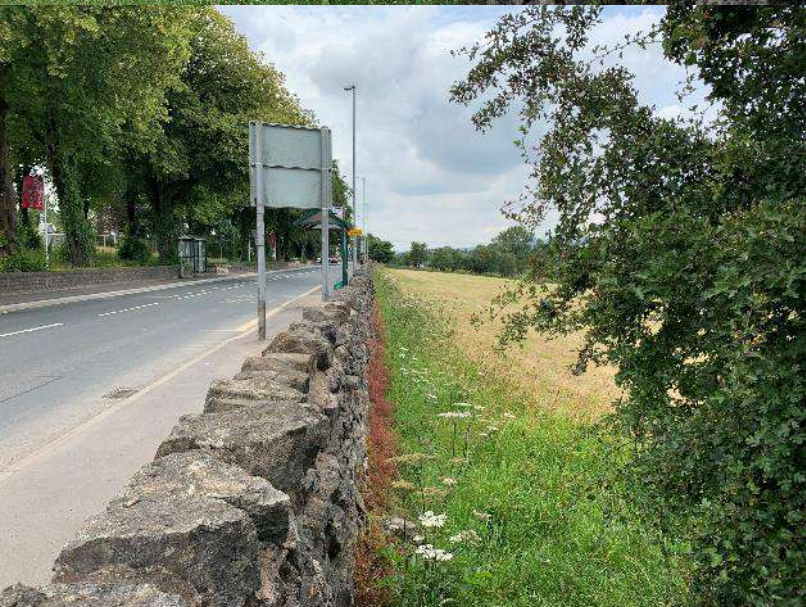
Photograph 2

| | | <p>The south-eastern site boundary, marked by Chatburn Road which is approximately 1-2 m higher than the site. Taken from the eastern corner of the site, facing south-west.</p> |

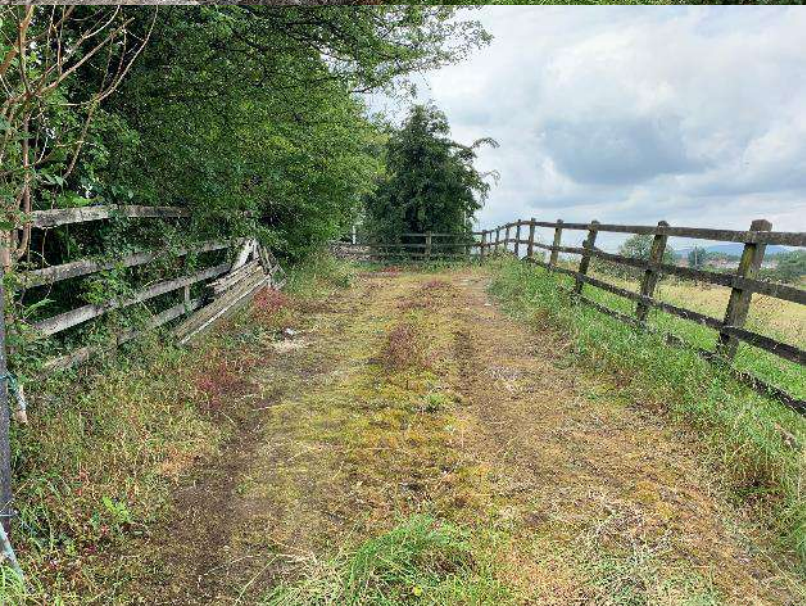
Photograph 3

| | | <p>Access to the site in the northern part of the south-eastern site boundary via a grassy access track which gently slopes onto the site.</p> |

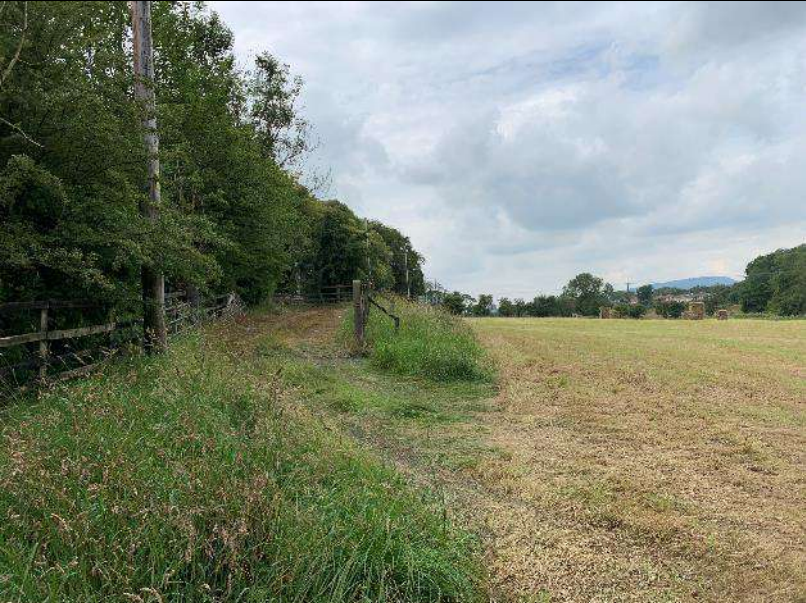
| | | <p>Photograph 4</p> |

| | | <p>Access to the site in the northern part of the south-eastern site boundary via a grassy access track which gently slopes onto the site. A telephone mast can be seen.</p> |

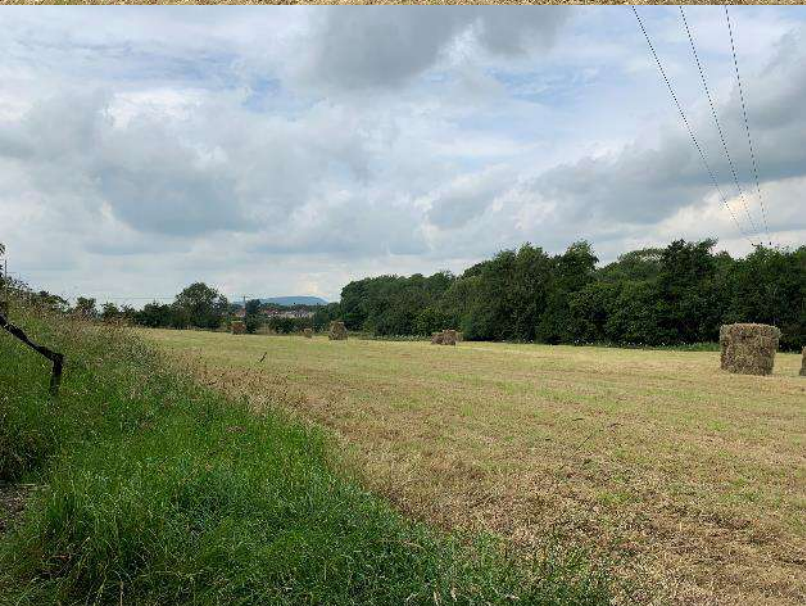
| | | <p>Photograph 6</p> |

| | | <p>The open field which occupies the south-east of the site. Taken from the eastern corner of the site, facing west. The overhead telephone line can be seen.</p> |

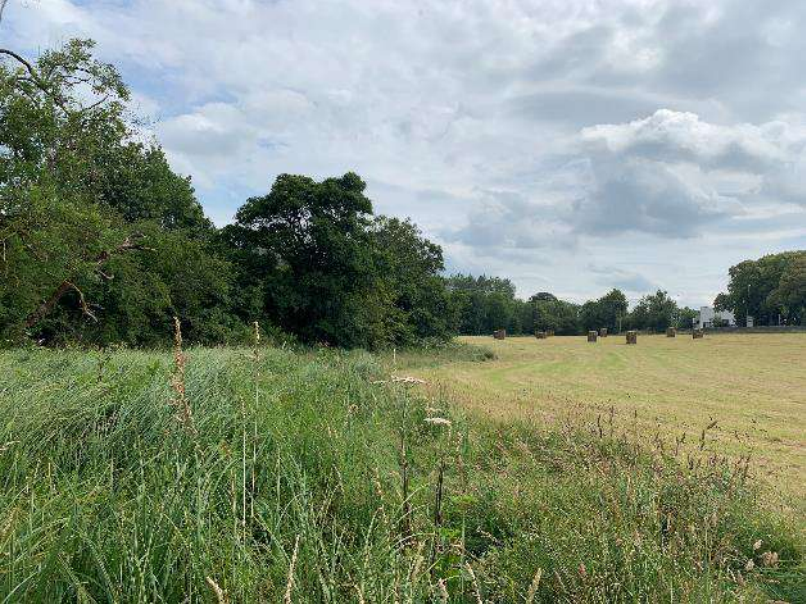
| | | <p>The centre of the site. The two different sections of the site can be distinguished, with dense woodland and an open field, separated by a stream. Taken from the south-western site boundary, facing north</p> <p>Photograph 7</p> |

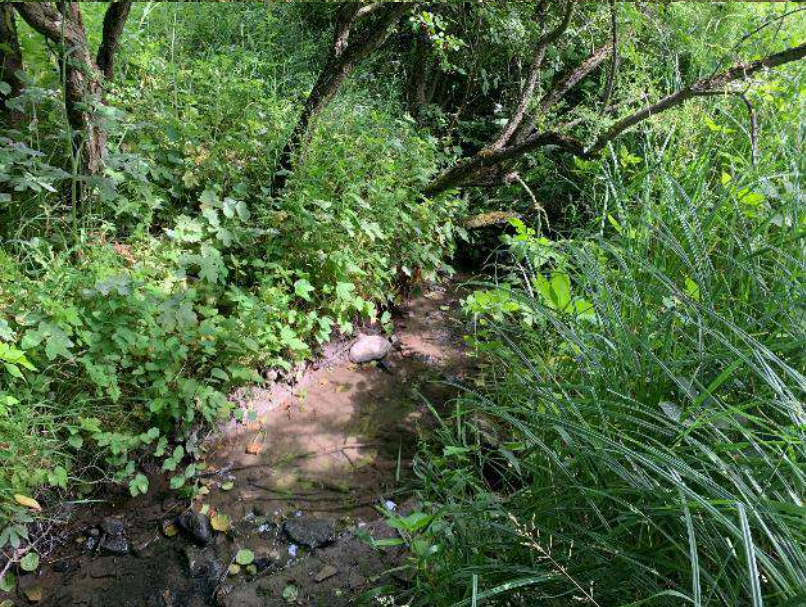
| | | <p>The stream which flows north-east to south-west through the site.</p> <p>Photograph 8</p> |

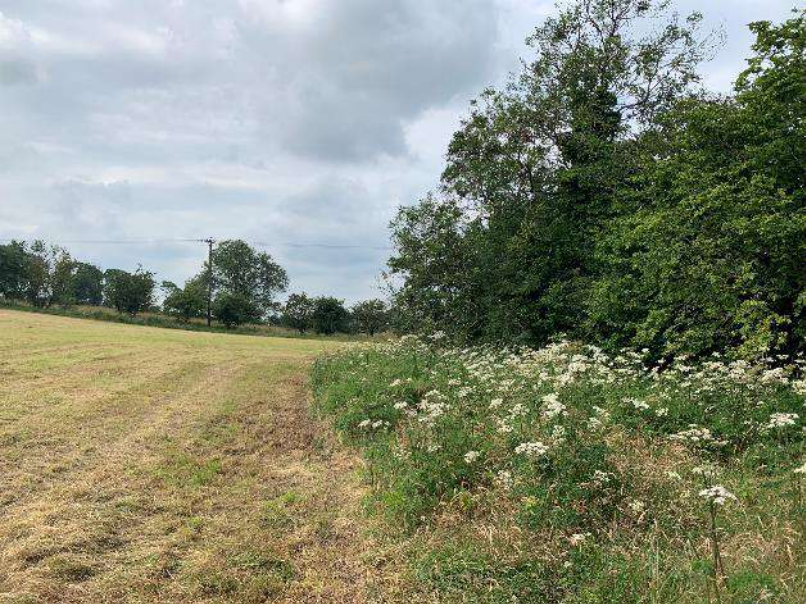
| | | <p>The centre of the site. The two different sections of the site can be distinguished, with dense woodland and an open field, separated by a stream. Taken from the centre of the site, facing south-west.</p> <p>Photograph 10</p> |

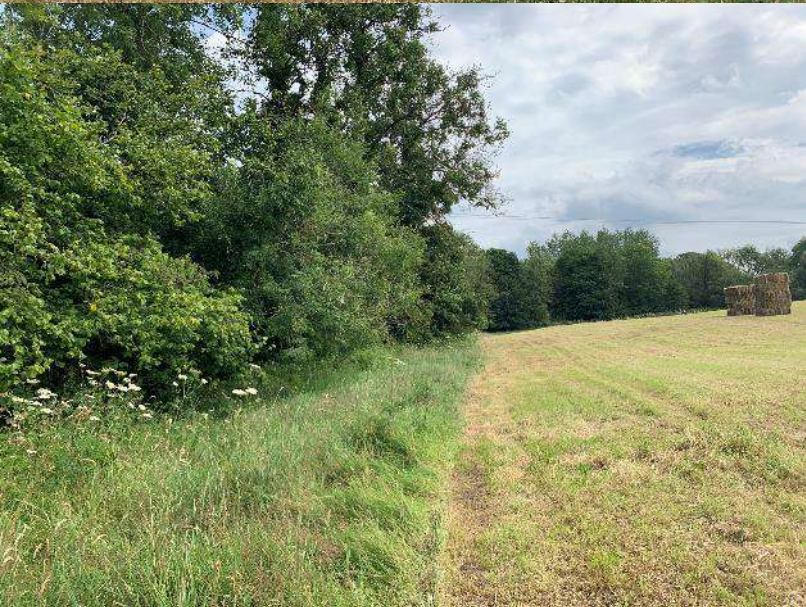
| | | <p>The centre of the site. The two different sections of the site can be distinguished, with dense woodland and an open field, separated by a stream. Taken from the centre of the site, facing north.</p> <p>Photograph 11</p> |

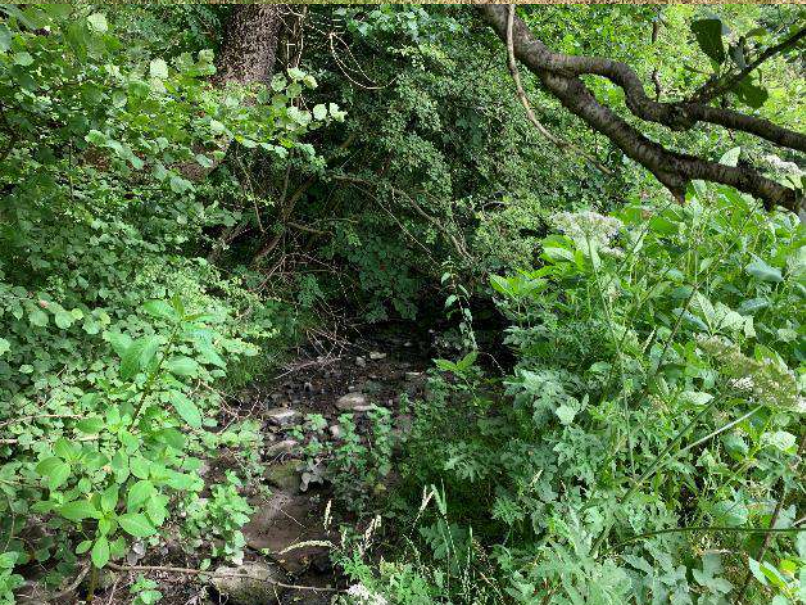
| | | <p>The stream which flows north-east to south-west through the site. The dense woodland that occupies the north-west of the site can be seen.</p> <p>Photograph 12</p> |

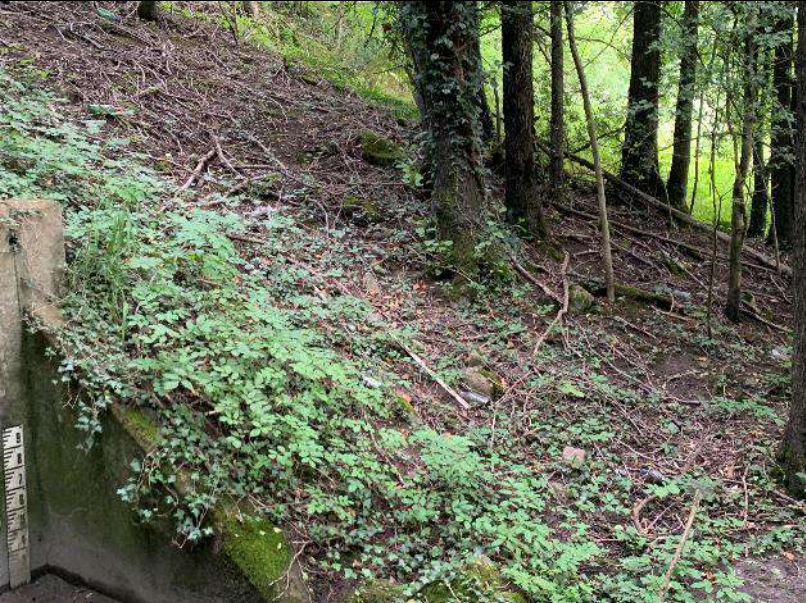
| | | <p>The steepness of the site along the northern site boundaries.</p> <p>Photograph 16</p> |

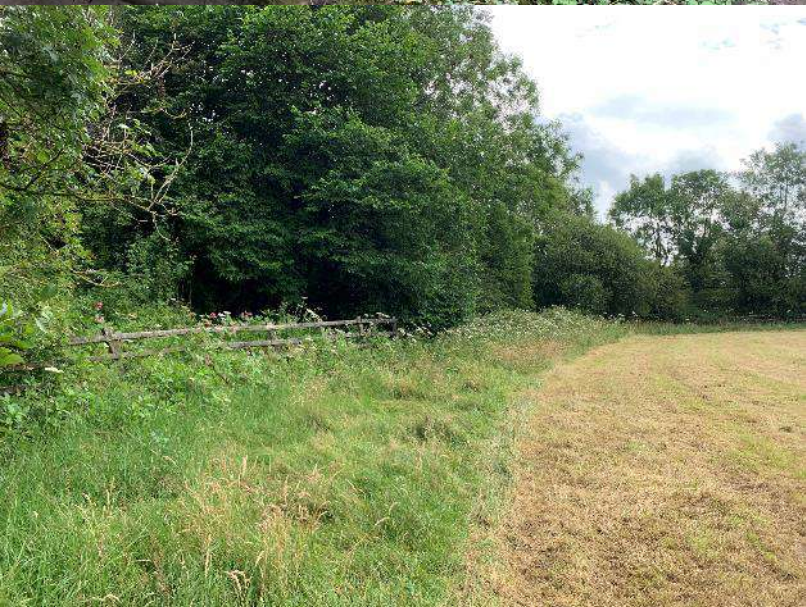
| | | <p>The north-east of the site with a strip of dense vegetation along the site boundary and possible location of a second stream.</p> <p>Photograph 17</p> |

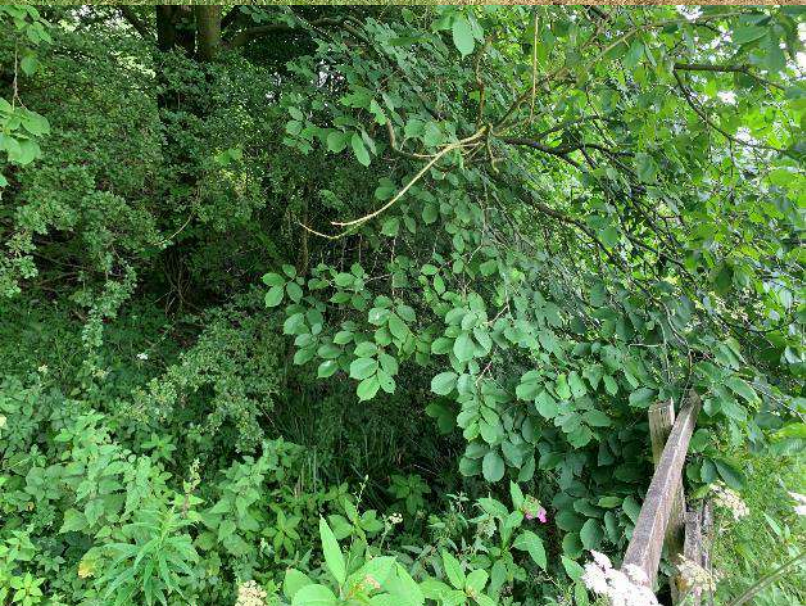
| | | <p>The north-east of the site with a strip of dense vegetation and possible location of a second stream.</p> <p>Photograph 18</p> |

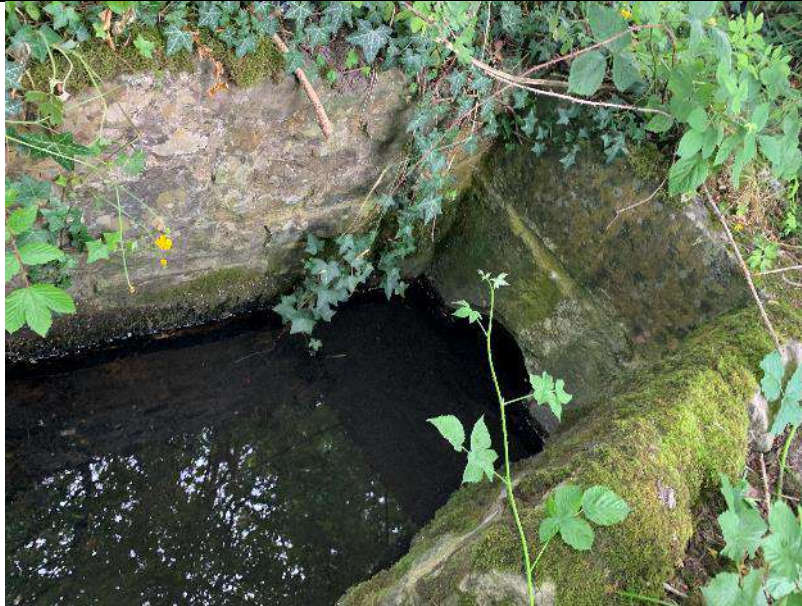
Photograph 19

A culvert located in the easternmost corner of the site, although the flow was negligible and it was unclear as to the direction the water flows.

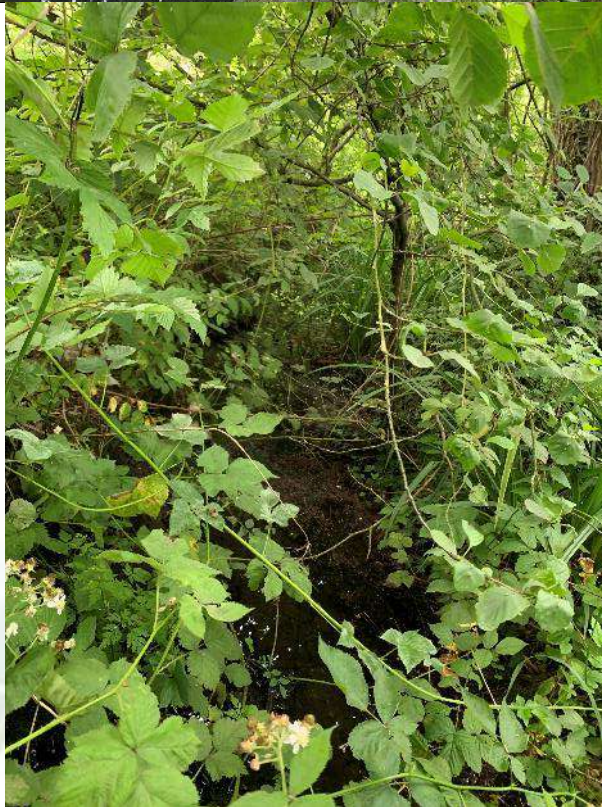
Photograph 20

The surface water discharged from the culvert in the easternmost corner of the site, although the flow was negligible and it was unclear as to the direction the water flows.
