**BAT SURVEY AT -
UNIT 1, VICTORIA MILL
WATT STREET
SABDEN**

DATE AND TIME OF VISIT
13th Sept 2019 5.30 pm
18th Sept 2019 7.30pm

SURVEY CARRIED OUT BY: LYNNE RUSHWORTH AssocRICS

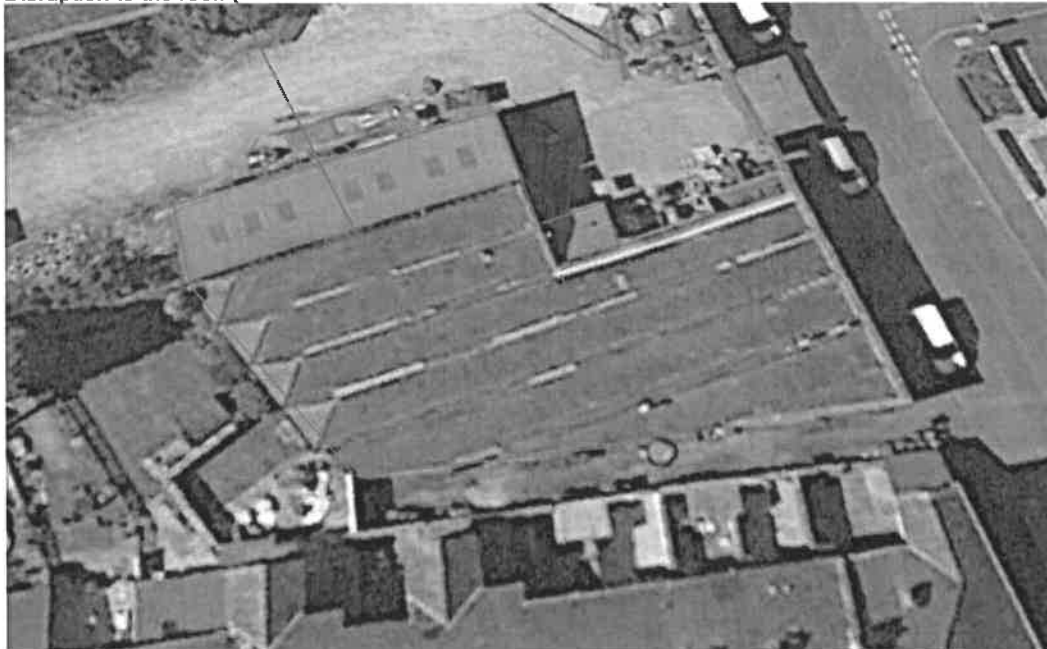
Disruption to the roof. \

The building is a semi detached ad hoc industrial unit which has functioned constantly as a workshop, formally a sheet metal workers and a future joiners workshop. The original section with its traditional north light roof has been extended at a later date with a steel portal section to the north end.

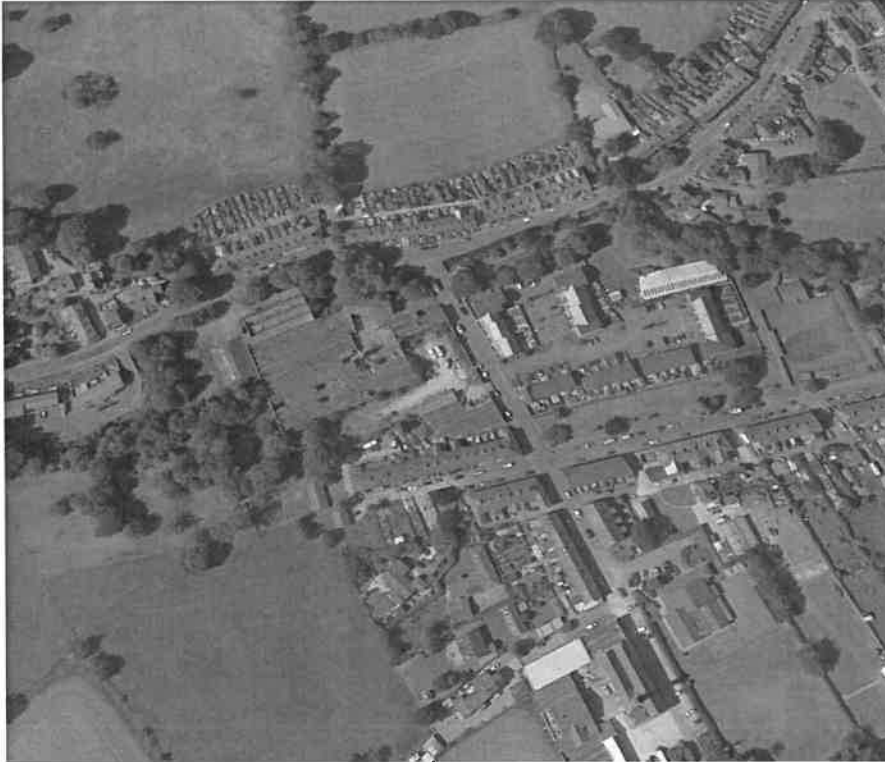
The building is located in a residential area consisting of traditional terraced houses and more recently new housing estates. A new housing estate is currently being constructed immediately adjacent to the northern boundary wall. 50m to the west is large acreage pastureland and a group of mature trees which extend to the west along Whalley road. A river runs 70m to the north and a small area of standing water is 92m to the west. The immediate locality does not provide good forage potential but the greater area particularly to the west is optimal.

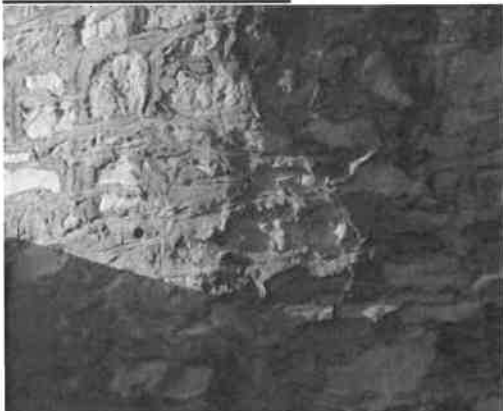
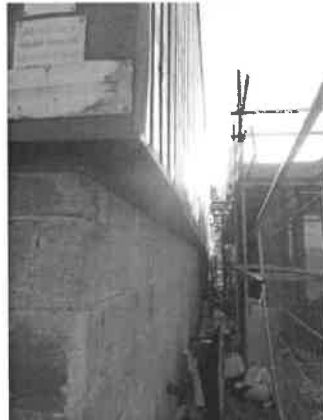
WALL CONSTRUCTION

West and south wall random stone flush pointed portal frame walls block base walls with steel cladding.(North boundary)

The walls do not have any access points all pointing is in good condition.

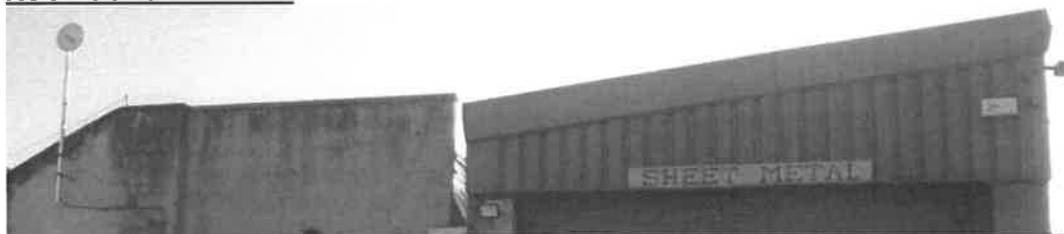
ROOF CONSTRUCTION

The roof construction consists of traditional north light structure with slate finish over timber rafters and steel beams. A steel sheet finish over steel portal frame.

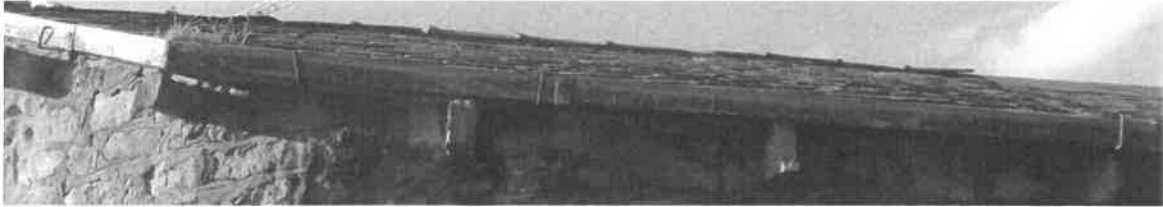
South pitch of north light.

The roof was very difficult to closely examine externally. The small section of slates visible was reasonably tight fitting but the ridge slates were lifted in places, inspection with binoculars did not reveal any signs of use by bats.

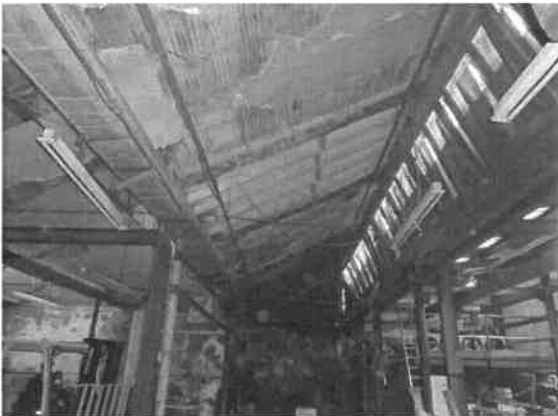
ROOF SPACE

There are no enclosed roof spaces all the structure was visible. The steel section did not provide any potential for bat roost habit. The North light section was in poor condition with signs of water ingress. The timber structure was mainly visible, inspection was carried out from the ground floor with binoculars.
