**BAT SURVEY AT -  
26 CHURCH STREET  
RIBCHESTER**

DATE AND TIME OF VISIT  
4 th Feb 2020 3.00 pm

REFERENCE. Mr and Mrs BENNETT

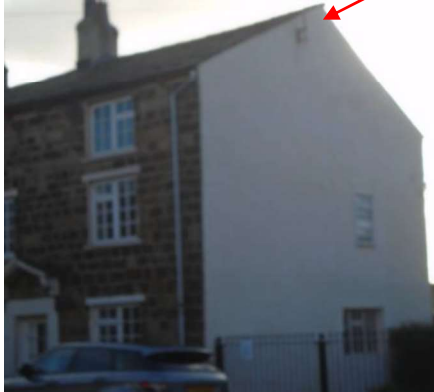
Location of proposed chimney

Reinstate a chimney on the gable wall.

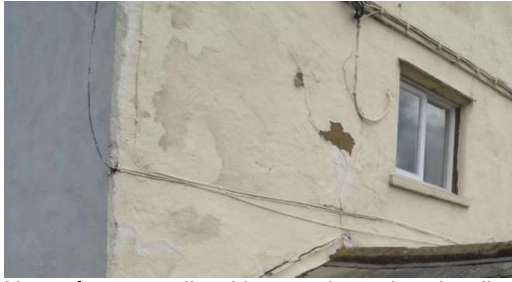
## WALL CONSTRUCTION

Natural stone walls with smooth rendered wall to the side and rear of the house.

There are no access points or cracks and crevices which might provide habitat for bats.

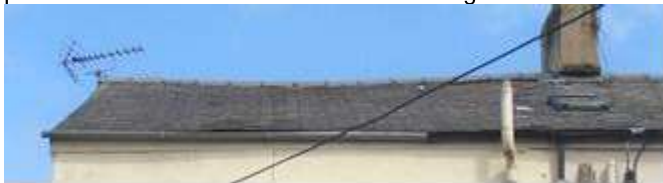
SW roof pitch.

The roof is pitched. Timber fascias are fixed against the walls with a minimal gap behind. The gable verge is pointed. The roof finish is blue slate with ridge tiles.

The roof examined with binoculars did not have any slipped slates and all were tight fitting. The ridge tiles are well pointed as is the verge to the gable. There were no visible access points.

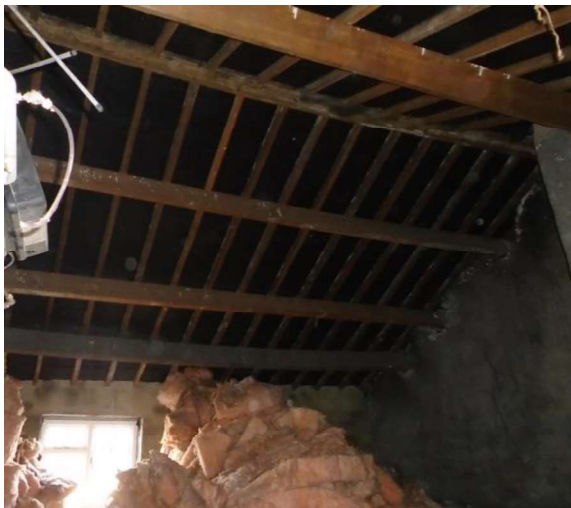
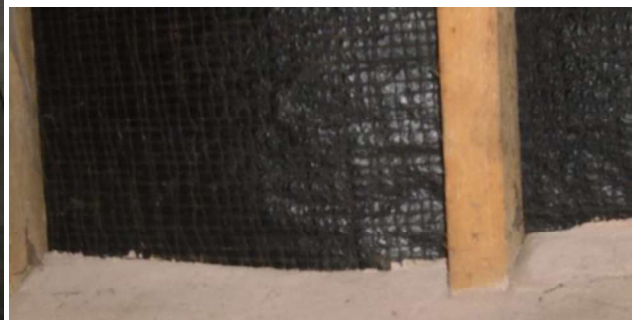
The roof space was accessible via a ceiling hatch, all the structure was visible. Close inspection was possible. Most of the timbers appeared to be relatively new without any cracks or crevices suitable for use by bats. The underlay over the rafters was in very good condition. The abutment with the wall and roof timbers was pointed with no possible access points. The floor and piles of insulation were examined for any dropping or insect remains the result was negative.
