26 Church Street  
Ribchester, Lancashire:  
Heritage Assessment

August 2019

## 26 CHURCH STREET, RIBCHESTER, LANCASHIRE, PR3 3XP:

### HERITAGE ASSESSMENT

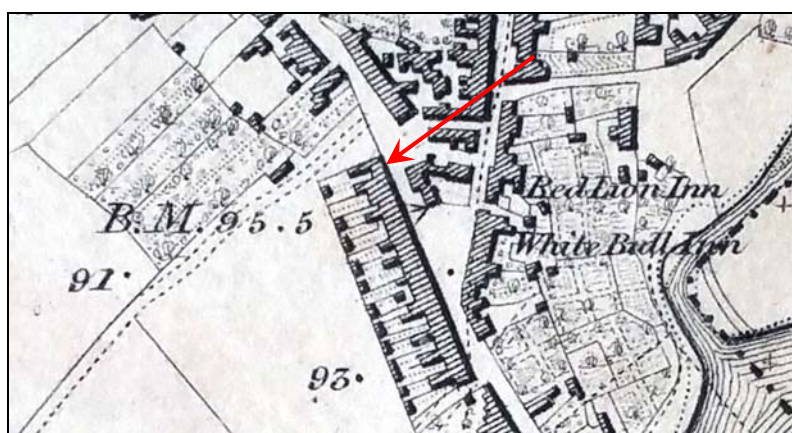
Figure 1: Ordnance Survey map, 1847<sup>4</sup>

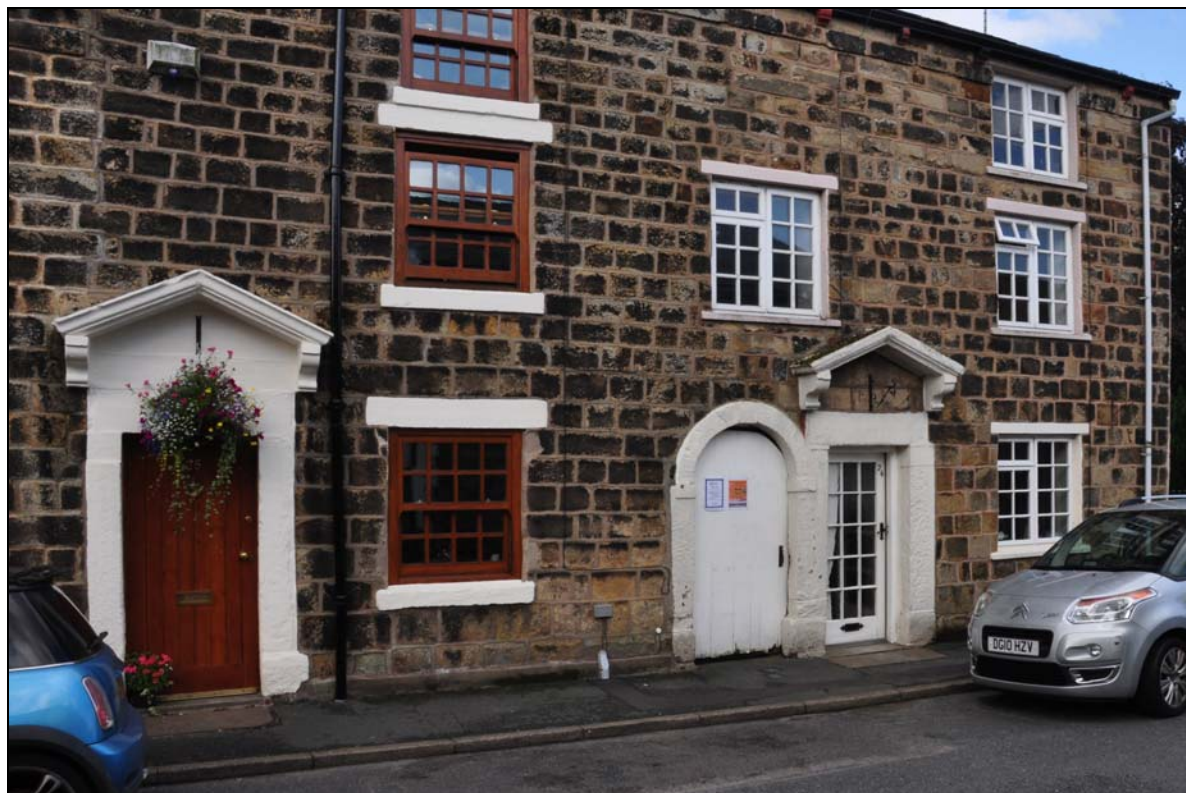
- 5.1 Nos. 25 and 26 Church Street form a pair of three-storey houses, which appear to have been added to the north end of no. 24, and share many architectural details with that two-storey antecedent. The front is faced with squared sandstone laid in deep courses, and although the top storey of no. 26 has been rebuilt in the 20th century (with its inner leaf of concrete block), the rebuilt work has re-incorporated the plain eaves band and shaped corbels which support the guttering.

- 5.2 The main doorways to both houses have heavy, upright sandstone jambs, over which are triangular stone hoods or canopies, borne on shaped corbels: these appear to be early 19th century additions. A third doorway, immediately next to the entrance to no. 26, has a semi-circular arch with keystone and leads to a shared through-passage ("tunnel").

- 5.3 All the front window openings to no. 26 have been enlarged slightly at top and bottom, and have modern sills and lintels, contrasting with the original ones to no. 25, which retain their deep stone dressings. The window frames have modern, small pane casements. Although the listed building entry describes one of the first floor windows as having been inserted, this seems highly unlikely.

Photo 2: Front elevation of nos.25 and 26 (at right)

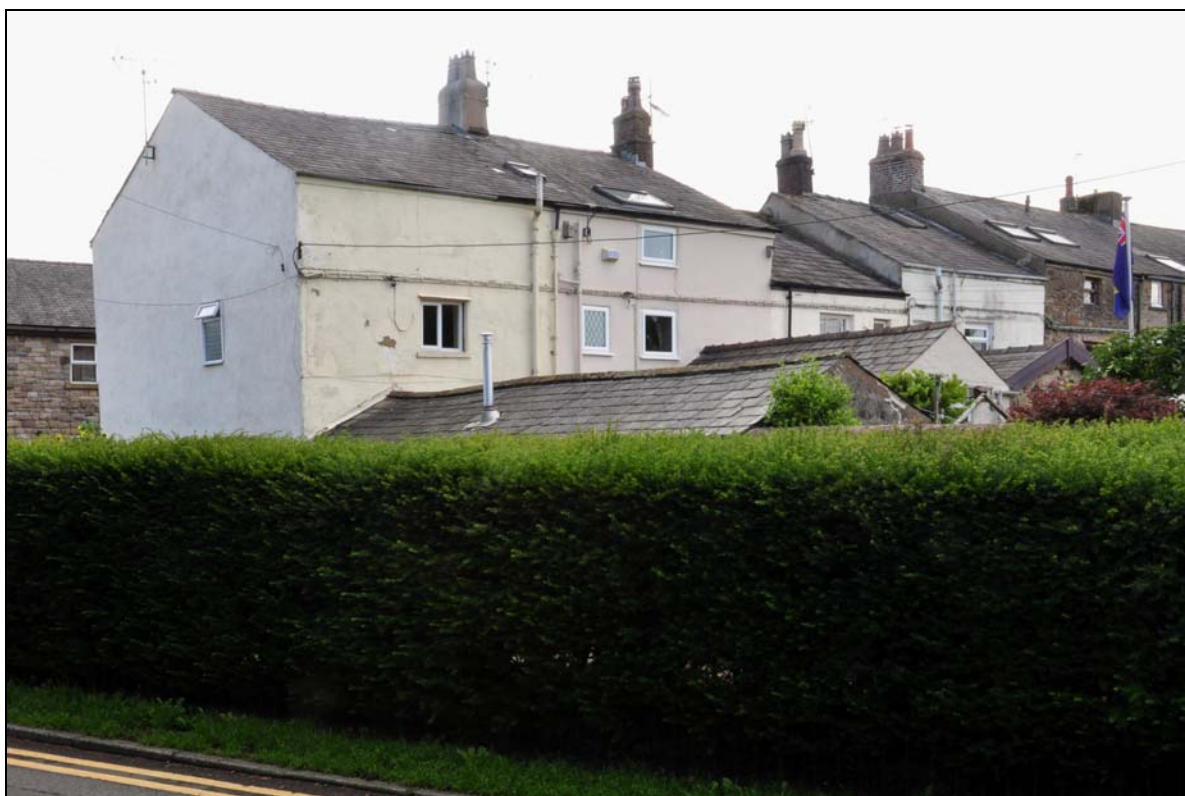
- 5.4 The north gable and rear of the house have painted cement render, concealing the stonework, and the two windows in the former are likely to be 20th century insertions. The rear has a ground floor window to the side of the wing; this

might have been a doorway historically. There is a first floor window with modern dressings, and the position of a blocked second floor window over it, evident externally as a pair of vertical joints.

Photo 3: Rear view (no.26 at left), with roof of wing visible

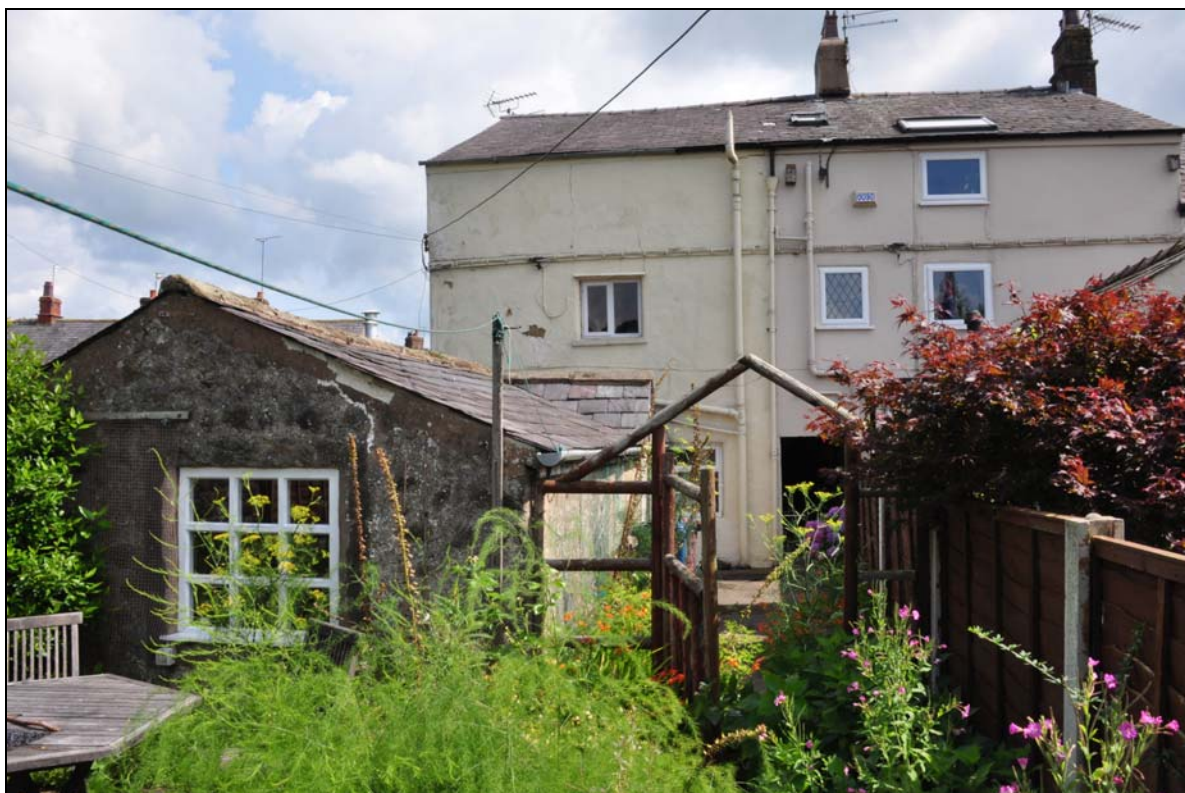
- 5.14 The rear wing comprises a narrow, low, single-storey structure, some 8.5m long, so is almost as long as the house is deep; it is believed to have been built as a workshop for cotton weaving. Domestic cotton loom-shops were usually located on the ground floor or in basements, in order to maintain high levels of humidity required for the process. In Ribchester, loom-shops are generally found to be at the rear on the ground floor in houses on Church Street, although two basement loom-shops are known at nos. 61 and 62; the high water table and risk of flooding seems to have dissuaded weavers from building subterranean loom-shops elsewhere in the village. Upper floors are not likely to have been used for weaving (as they were in woollen-producing areas), but may have accommodated related processes such as yarn preparation or storage<sup>7</sup>.

- 5.16 The wing is built from random rubble, which contrasts with the front of the house, although only the wing's north side has exposed stonework, the two other sides being rendered to varying degrees.

Photo 4: Rear view (no.26 at left), with rear wing in foreground

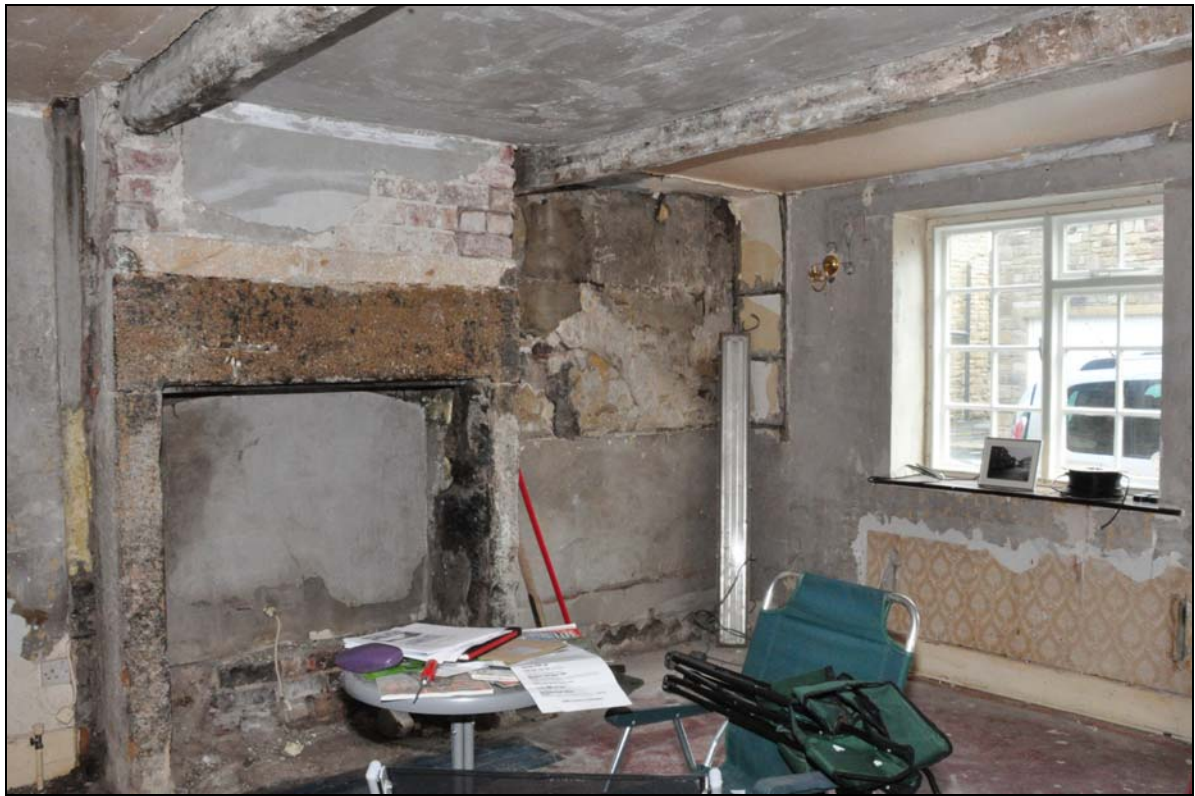
- 5.6 The ground floor formerly comprised a front and a rear room, once separated by a thin masonry wall, but removal of the wall in the 20th century means that these now form one large space, with only a small 20th century vestibule to the front door. The chimney breast and a plain fireplace recess (intended for an iron range) survive in the gable wall of the front room, but those in the rear room have been removed, their absence permitting the insertion of the modern north window.

Photo 5: Front fireplace on ground floor

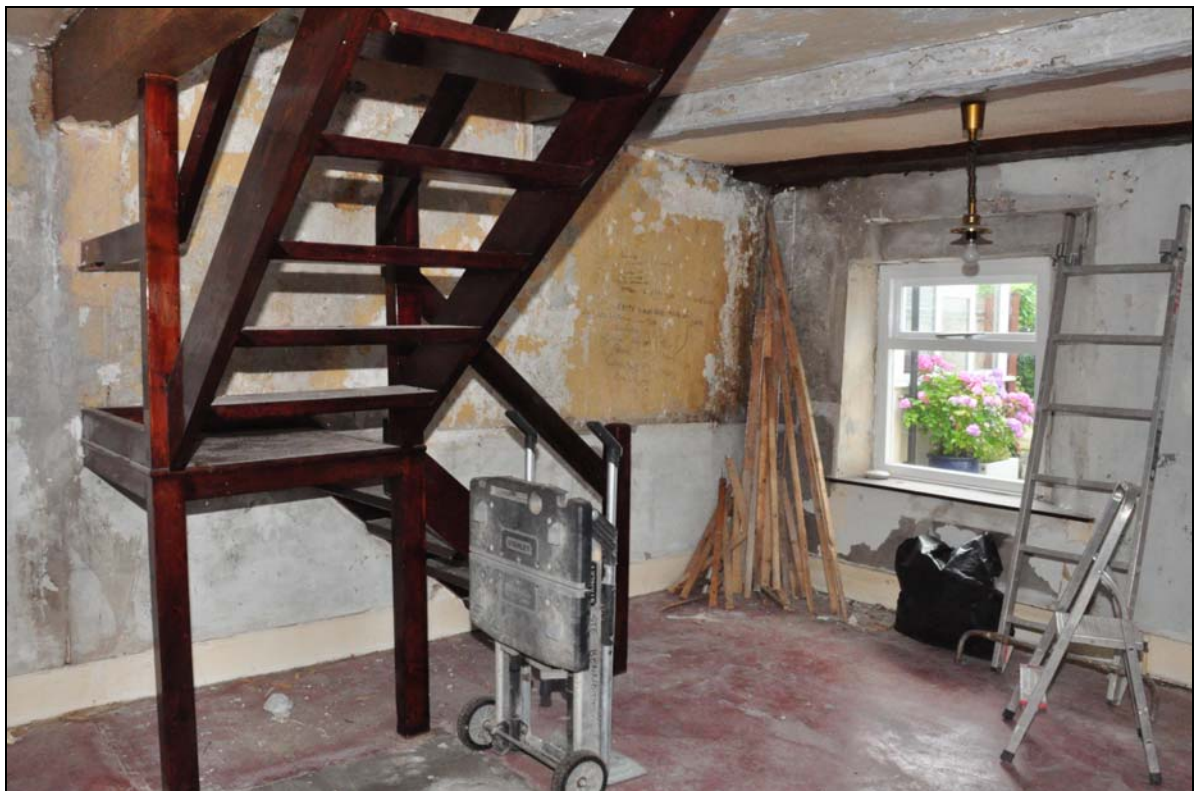
- 5.8 The present open-tread staircase to the first floor is mid to late 20th century. It replaced an earlier staircase (details unknown), formerly situated against the south wall, whose removal has left a scar in the plaster and infill within the concrete floor. To judge from these, and the position of the former wall in relation to the parallel ceiling beam to the rear, the stair was entered from the north, and underwent a quarter-turn before continuing up towards the rear of the house.

Photo 6: Present staircase, within former back room, ground floor

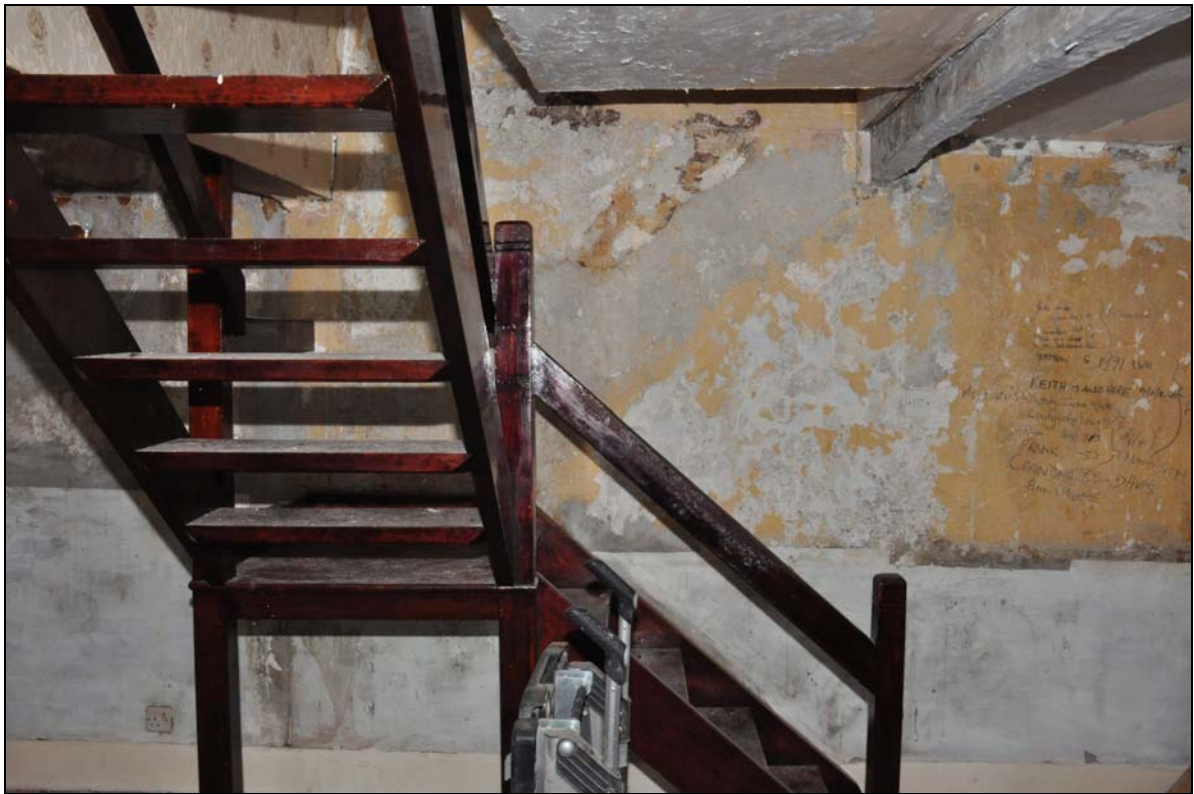
Photo 7: Present staircase, within scar of predecessor in plaster behind

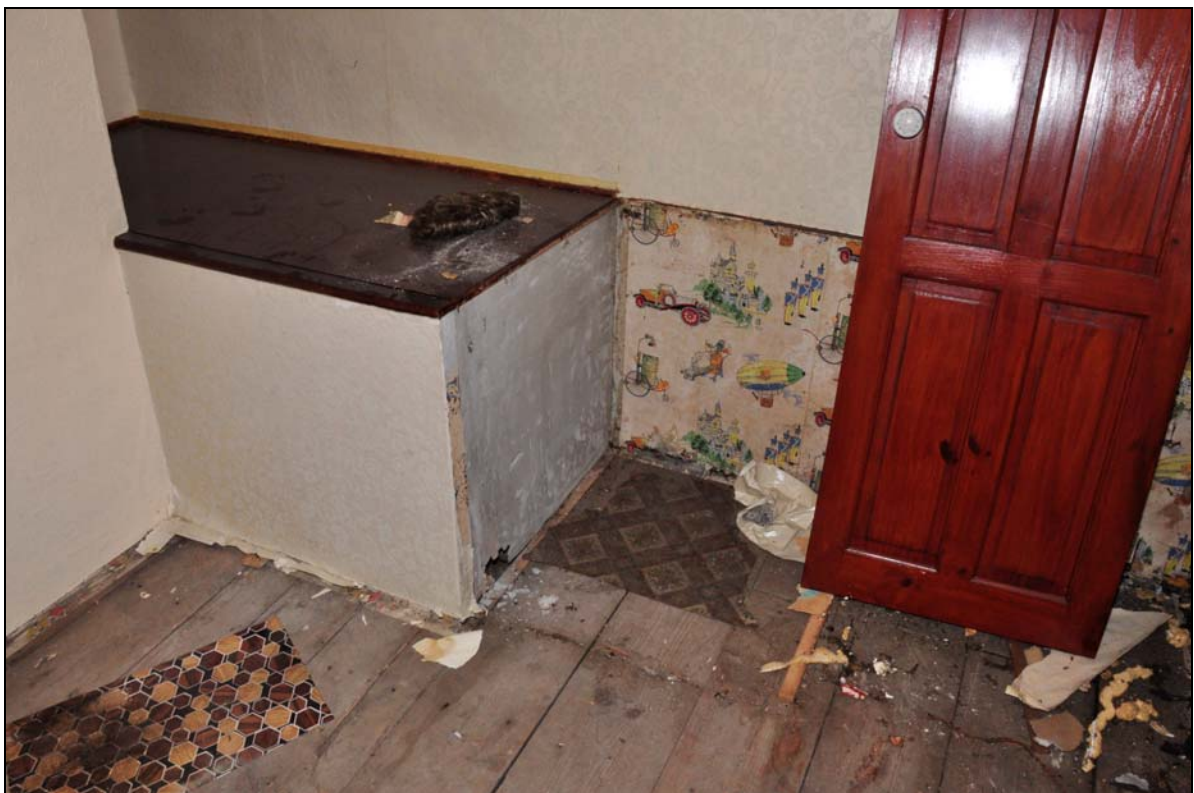
- 5.9 The earlier staircase from the ground floor would have entered the rear of the first floor through the aperture now covered by the raised boxing for the modern staircase.
- 5.10 On the first floor, the cross-wall dividing front and back has been partly removed, and a number of modern partitions have been installed to create the present arrangement of three bedrooms and bathroom, though there may have been some historic partitions in addition to the masonry wall. There would formerly

Photo 8: Site of former staircase aperture, within first floor

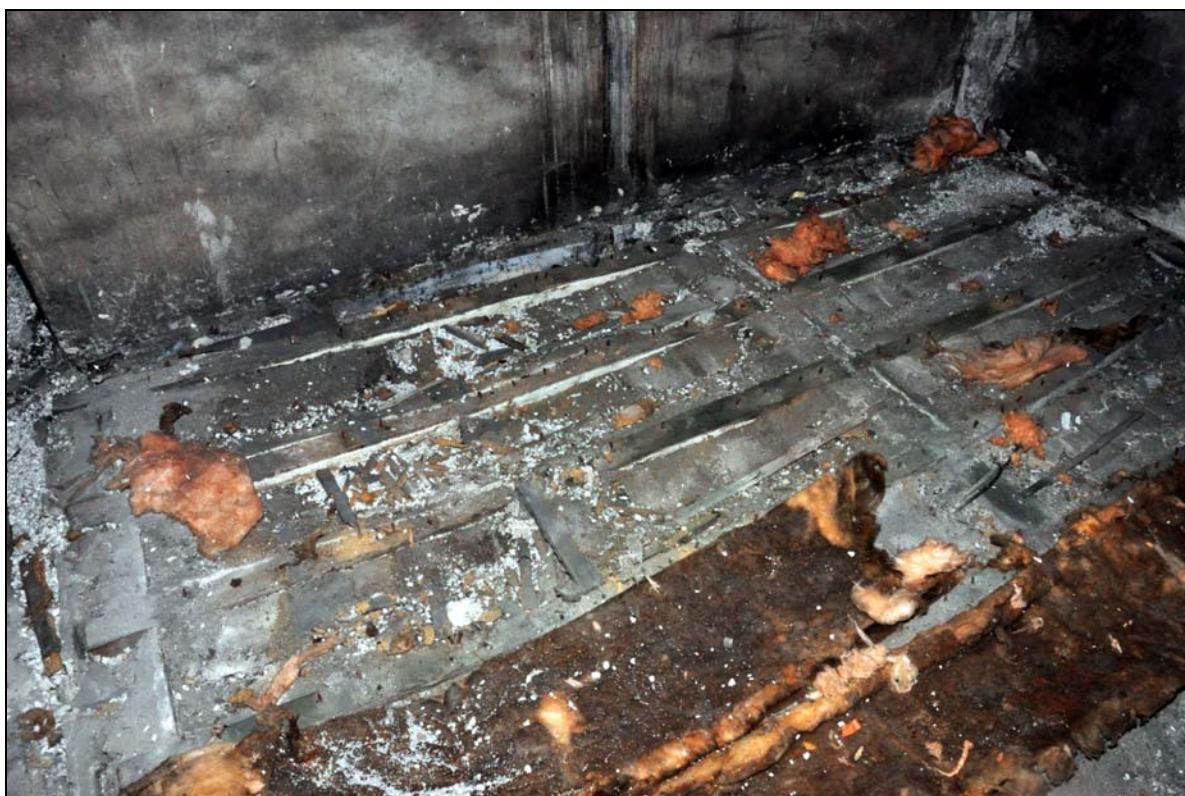
- 5.11 The second floor was a habitable room originally (as it remains in the adjoining house), but has fallen out of use, and is presently only accessible through a small trapdoor. An investigation for a larger opening which would have accommodated a staircase has not proved fruitful, but the infilling of an opening for a stair, once removed, may only have involved the insertion of a single joist across the aperture, and the making good of the ceiling.

Photo 9: Upper view of joists on second floor

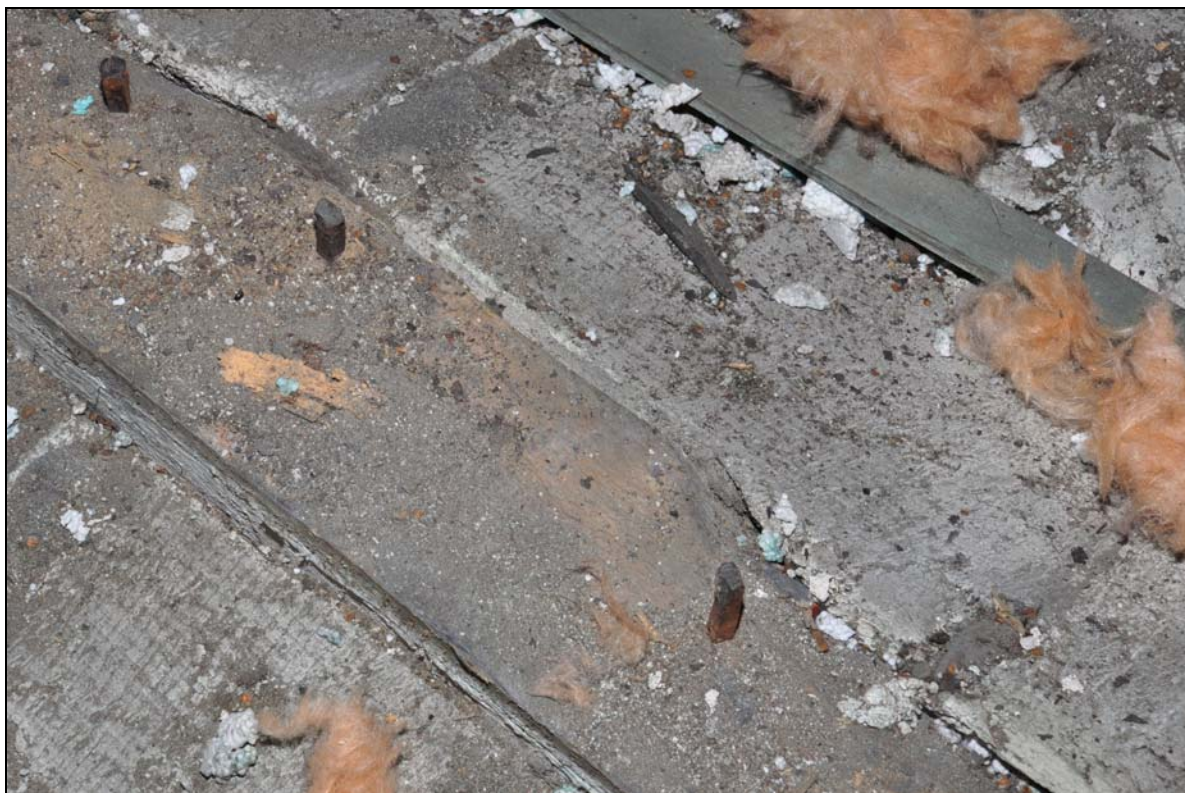
- 5.12 Apart from any opening for a staircase, the second floor was fully boarded with wide pine boards, indistinguishable from those on the first floor, but only remaining in fragmentary condition around the perimeter of the room, where they are in very poor condition. The extent of boarding throughout the second floor is indicated by square nails standing proud in the joists.

Photo 10: Close-up view of nails for floorboards, in joist on second floor

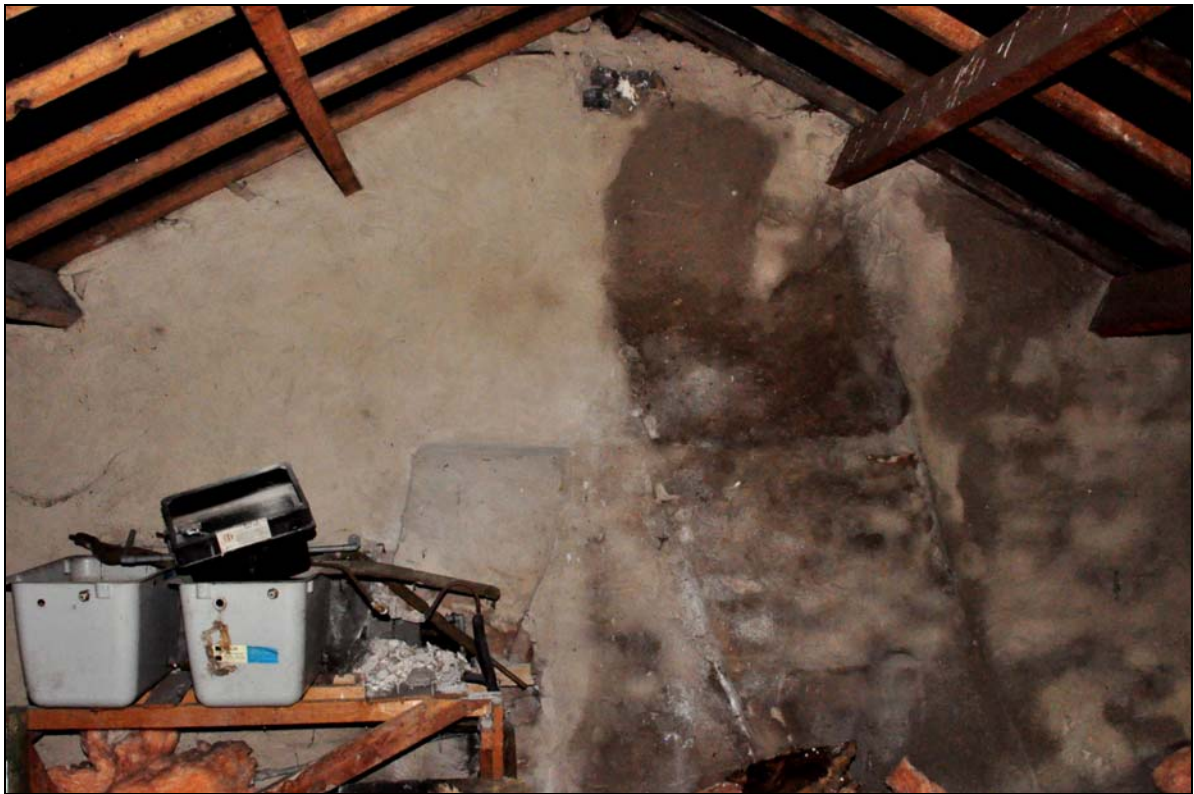
- 5.5 The roof of the three-storey house is blue slate with tile ridge, coverings which are likely to be contemporary with the modern rebuilding of the front wall at second floor level, and to have replaced original stone slate and stone ridge. A chimney stack at the north gable has been removed, probably at the same date: the pair of flues it served can be seen inside the house.

- 5.13 The outer walls of the second floor contain a window to the east, within the rebuilt fabric, and one to the west, now infilled with concrete blocks. The west and south sides are finished with lime plaster, while the east and north walls have modern plaster; the pair of flues once connected to the gable ridge stack show within the latter. The roof timbers are all modern replacements.

Photo 11: North gable, second floor, with pair of flues (stack over removed)

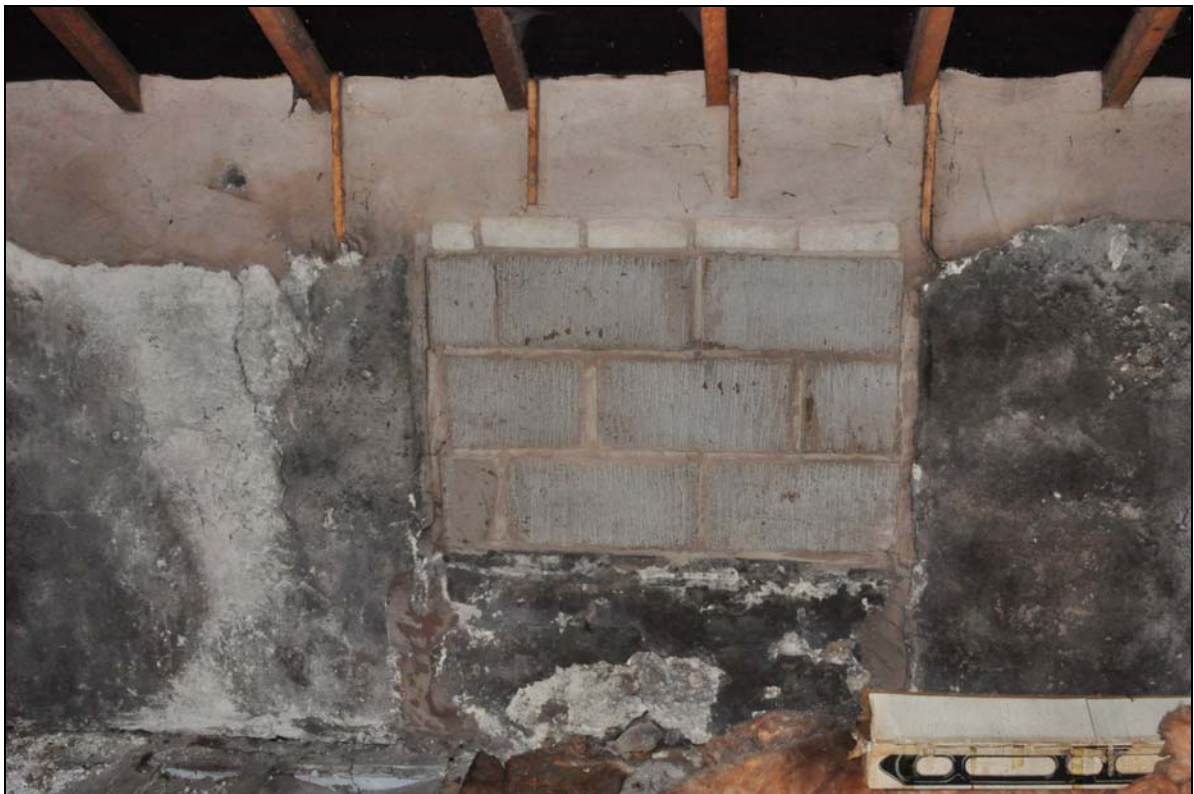
Photo 12: Blocked window, west side of second floor

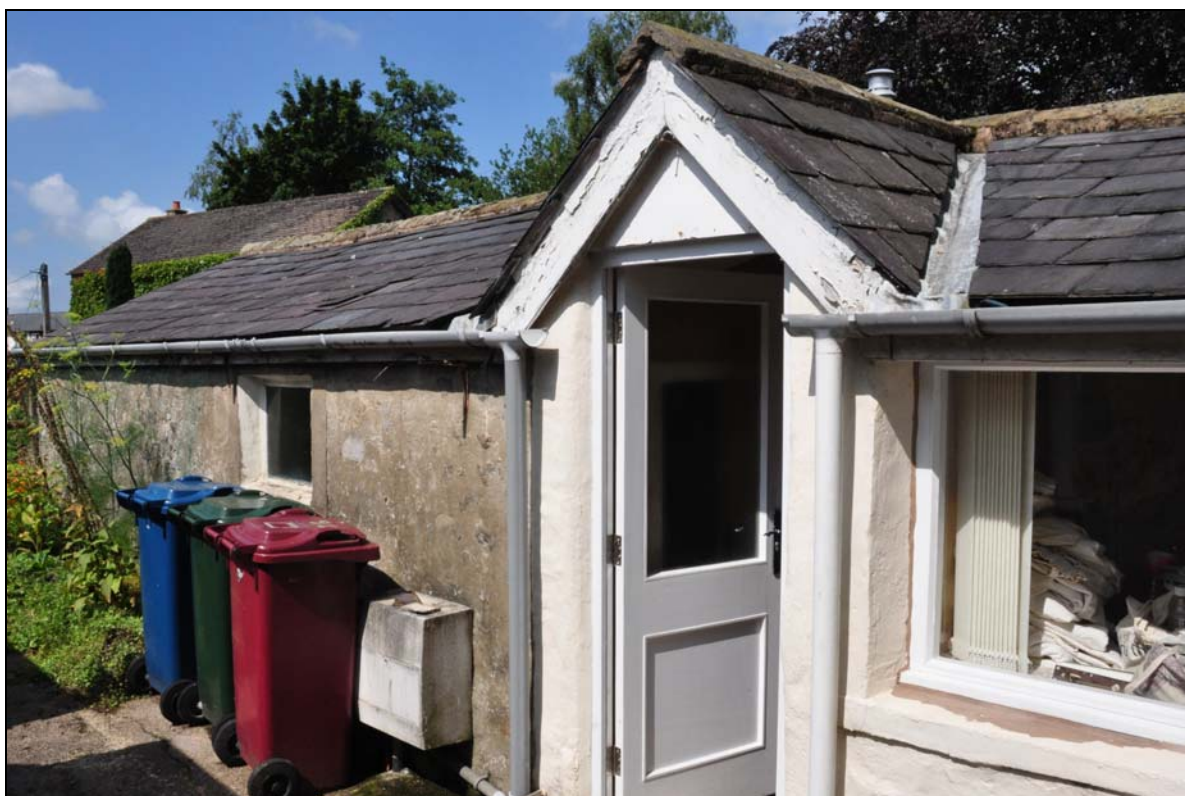
- 5.18 The present arrangement of openings in the south side of the wing appears to have been altered to some degree, and the doorway has been heightened, through the addition of a small gablet in the roof. The large window to the present kitchen may have been enlarged, but the smaller window to the back room may be unchanged except for the rendering of its surround. There is also a window in the wing's west gable.

Photo 13: Rear wing (former loom-shop): south side, with altered doorway

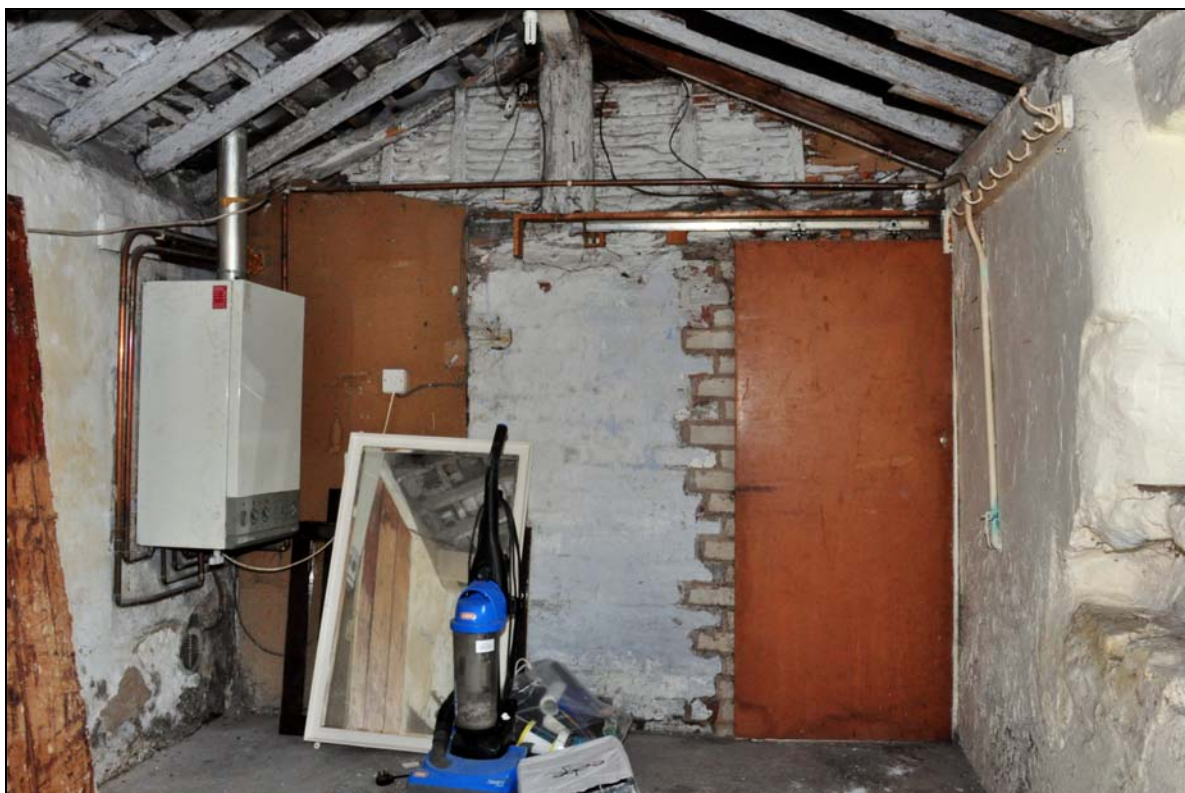
- 5.19 The wing is of three unequal bays, with two rather crude king-post oak trusses, the east one closed with lath and plaster. The masonry wall below this truss is very probably secondary, as may be the lath and plaster, and it is likely that the wing contained one large room originally. The west truss has a later softwood truss alongside, and rafters are also softwood, probably late 19th or 20th century replacements, contemporary with the blue slate covering. The ridge is the original, whole-tree member.

Photo 14: Rear wing : truss and cross-wall, looking east (part of former loom-shop)

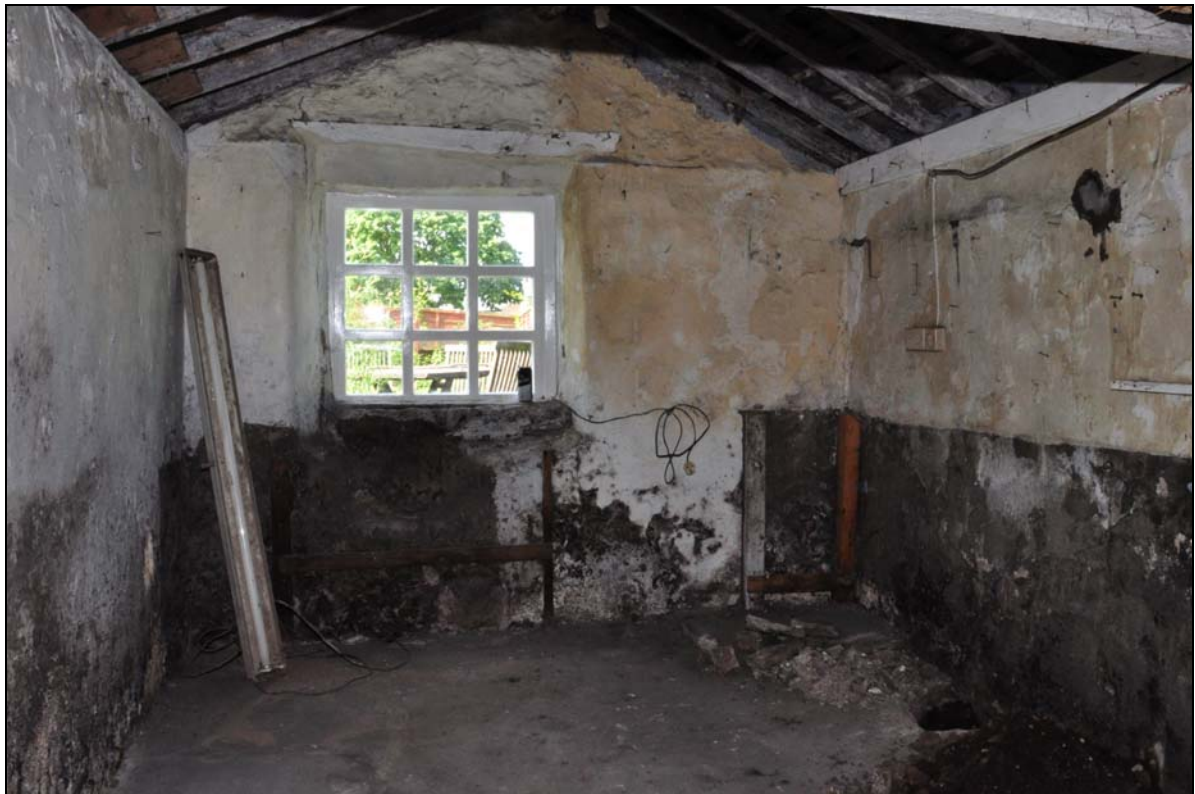
- 5.20 The present kitchen has an asphalt floor, the west room a concrete floor (recently a back kitchen or utility room). Investigations by the owner indicate that this concrete, and an underlying layer of hardcore, are approximately 300mm deep, and that the wall coating extends to a similar low level. The floor level has therefore been raised, perhaps in an attempt to relieve damp, although that inconvenience was probably an original intended aspect of the wing, when built as a cotton loom-shop, and lower floor levels would have provided greater head-room than at present.

Photo 15: Rear wing: west room (part of former loom-shop)

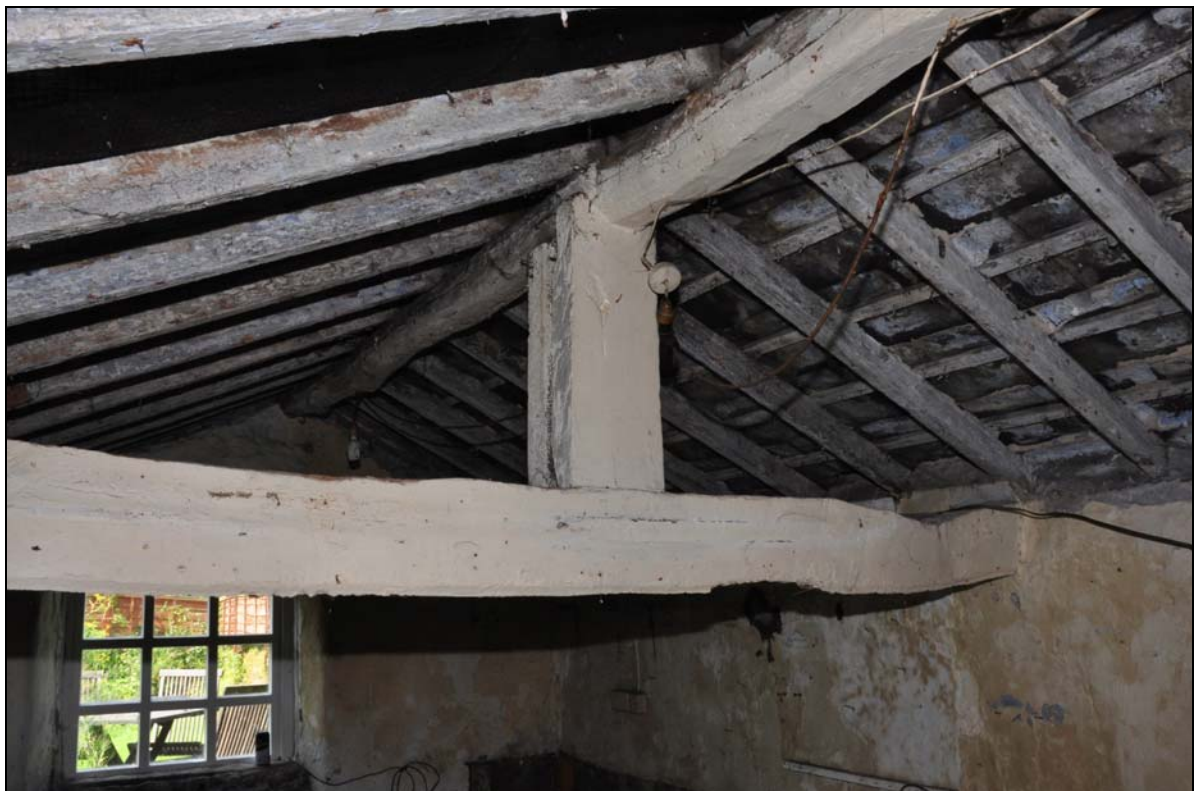
Photo 16: Rear wing: west truss, and other roof members
