HERITAGE APPRAISAL
FOR
PROPOSED CONVERSION OF FORMER LODEMATIC PREMISES
AT
PRIMROSE MILL,
PRIMROSE ROAD
CLITHEROE
BB7 1BS

THE PREMISES OF LODEMATIC LTD, NOS 1, 2 & 3 WORKS, PRIMROSE MILL, CLITHEROE:

HERITAGE ASSESSMENT AND STATEMENT OF SIGNIFICANCE

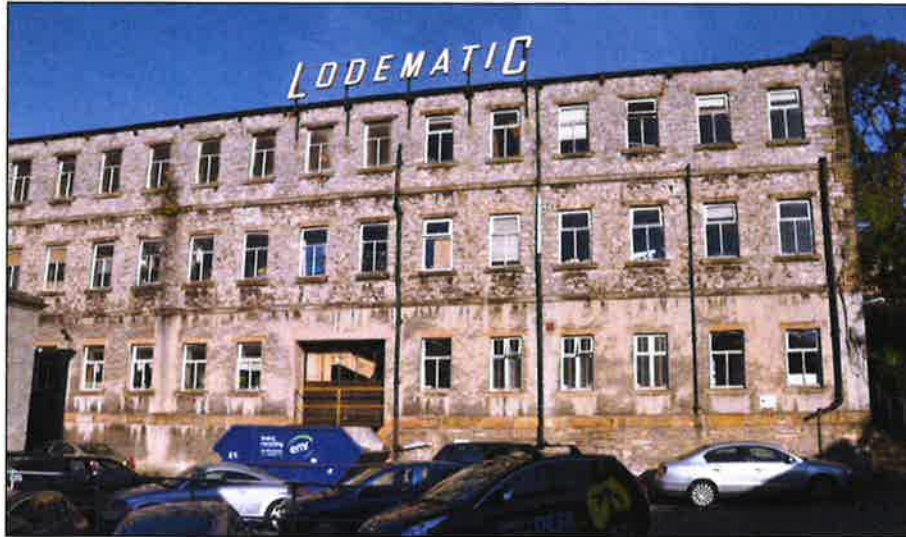
- 5.1 The main block, building 1, can be dated by the maps above to the period between 1815 and 1842, and was quite probably added *circa* 1827, as part of the expansion of the calico or cotton printing works, and is described by Rothwell as a former "print shop". It is a long, narrow building, of three storeys, twenty

bays long and two bays wide, whose walls are of limestone rubble with sandstone or gritstone dressings, including bands between storeys, and rock-faced quoins. The present entrance is in the north-east gable at lower ground floor level, but the arrangement of openings at this level is modern. The five-light gable window to the upper ground floor is original however and is a motif used elsewhere at the site, as is the circular opening within the gable, though the latter is decorative only, as it is located over the valley between the twin spans of the roof which this gable conceals. The openings to the long south-east elevation are plain and repetitive, though disturbed by the inserted loading entrance on the lower ground floor; the pattern is repeated in the north-west side of the range, facing into the infill block (building 3), where it has also been disturbed, but it also lacks lower ground floor openings, due to the rising ground.

Photo 1: Building 1, main block

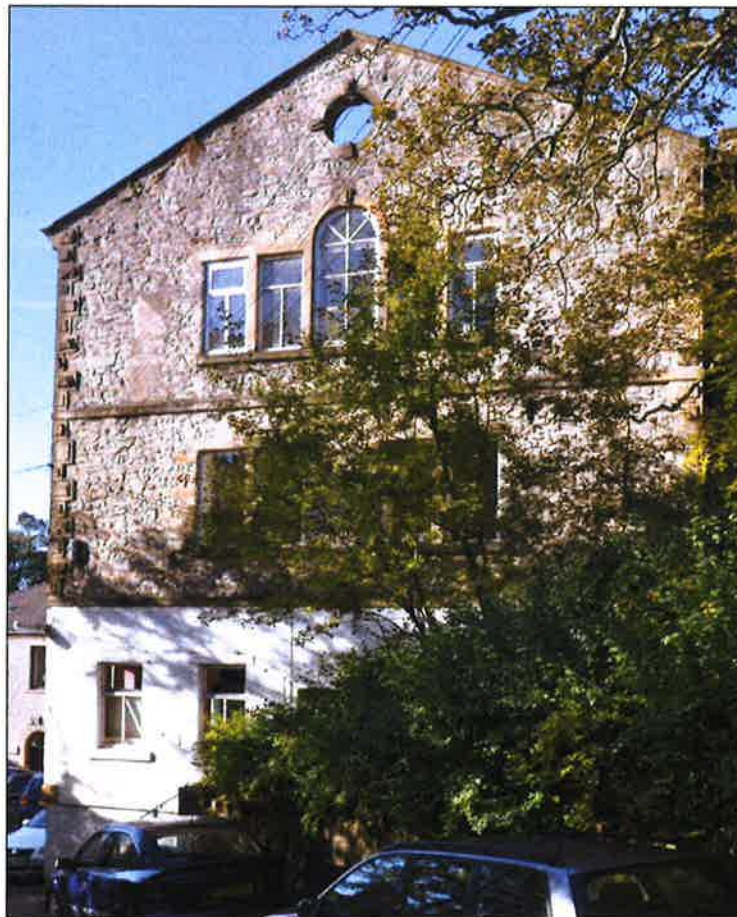
Photo 2: Building 1, north-east gable

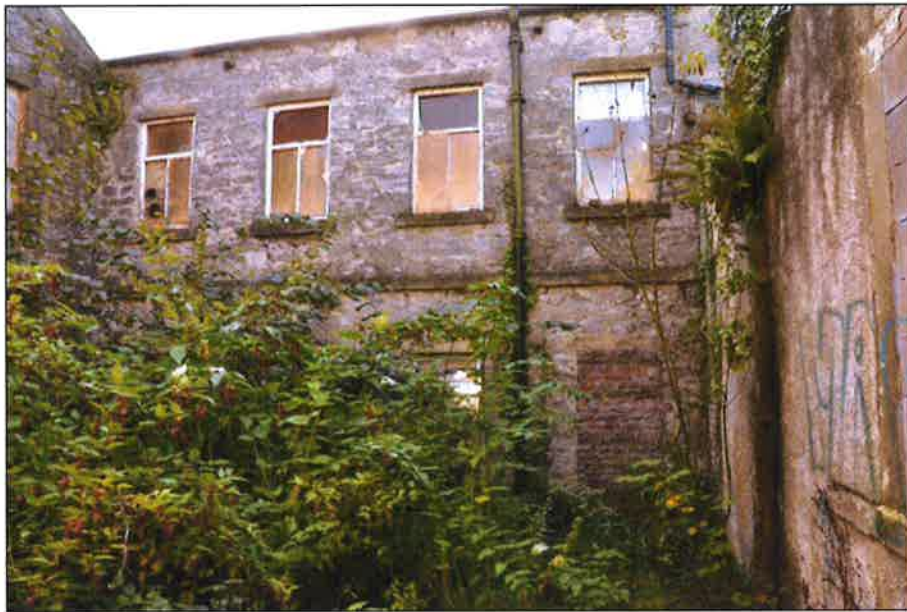
Photo 3: Building 1, main block, north-west elevation

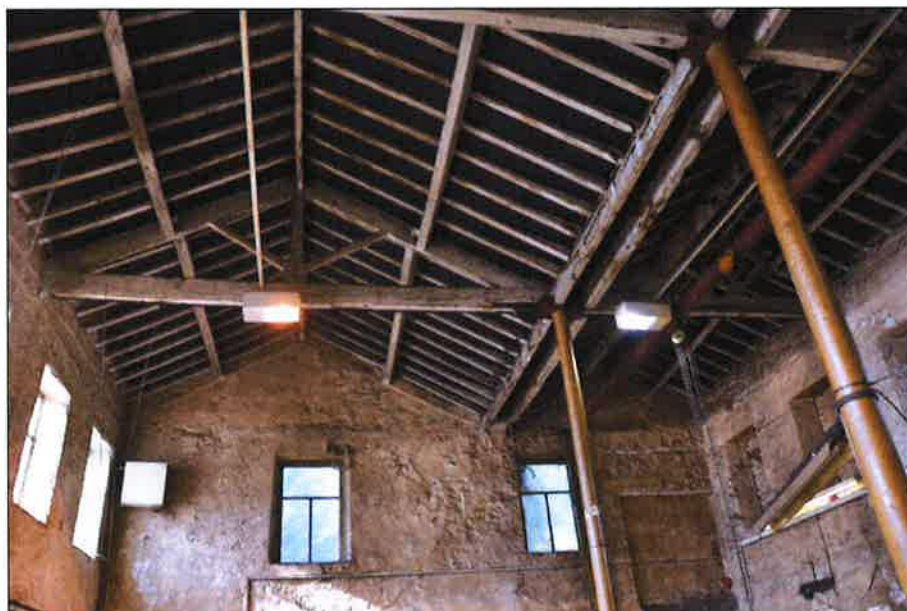
- 5.3 The interior of building 1 has very little of historic interest. The lower ground floor (narrower than the upper floors, and lit only on two sides) has modern partitions of timber and blockwork at its north-east end, and twentieth century steelwork forms the structure of the ceiling above. Now part of the engineering workshop, there is nothing of historic character visible, except for the basic form of the window openings along the south-east side.

- 5.4 The two upper floors of building 1 now form a single space open to the roof, though there are also modern partitions at the north-east end. The removal of the historic first floor was accompanied by the replacement of the (presumed) central line of cast iron columns by the existing taller ones, though the roof structure, of bolted, softwood king post trusses, is probably original.

Photo 4: Building 1, main block, interior

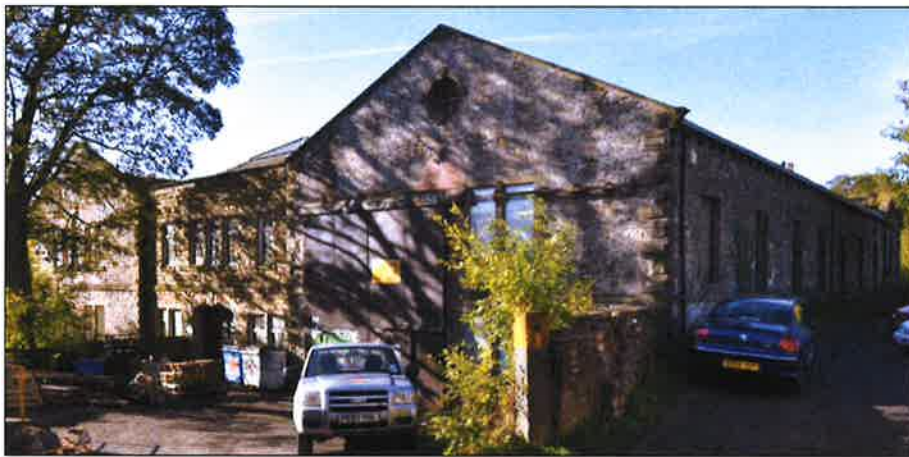
- 5.5 The north-western range of the Lodematic site (building 2) lies approximately parallel to building 1, and was formerly separated from it by a yard, subsequently roofed over to create building 3. The north-east gable shares the same fenestration pattern as that of the main range (albeit with a large modern doorway inserted), but other aspects, principally the predominance in the masonry of squared sandstone with jumpers, rather than limestone rubble, suggest that the building is significantly later in date, or has been substantially

rebuilt. There is however a distinct difference in the fenestration between its south-west and north-east elevations, the former being similar to that in building 1, while the latter has far fewer windows, so perhaps rebuilding was confined to that side. The shortening of the building between 1854 and 1883 (see figures 5 & 6 above) may account for this drastic remodelling, which also seems to have included the replacement of the former roof structure by the present trusses containing iron ties. Internally there were two storeys, though the upper floor has been removed and there are no features of historic or architectural interest, though the owners recall that the north corner of the building held a stable when they acquired it in the 1960s, but this was later altered.

Photo 5: Building 2

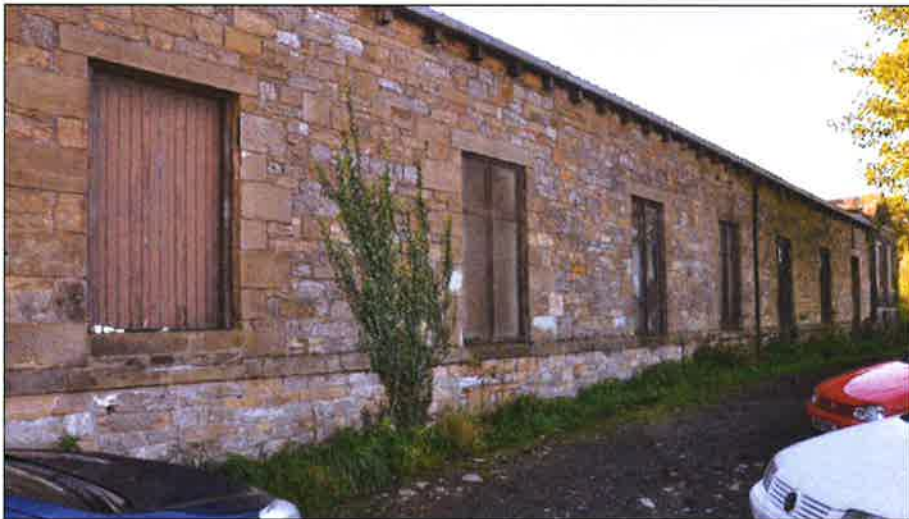
Photo 6: Building 2, north-west elevation

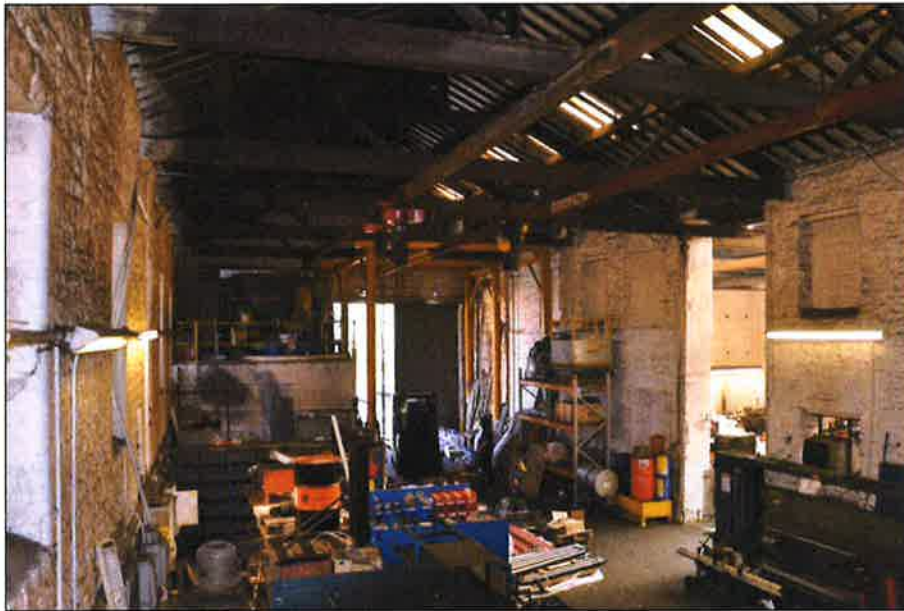
Photo 7: Building 2 interior

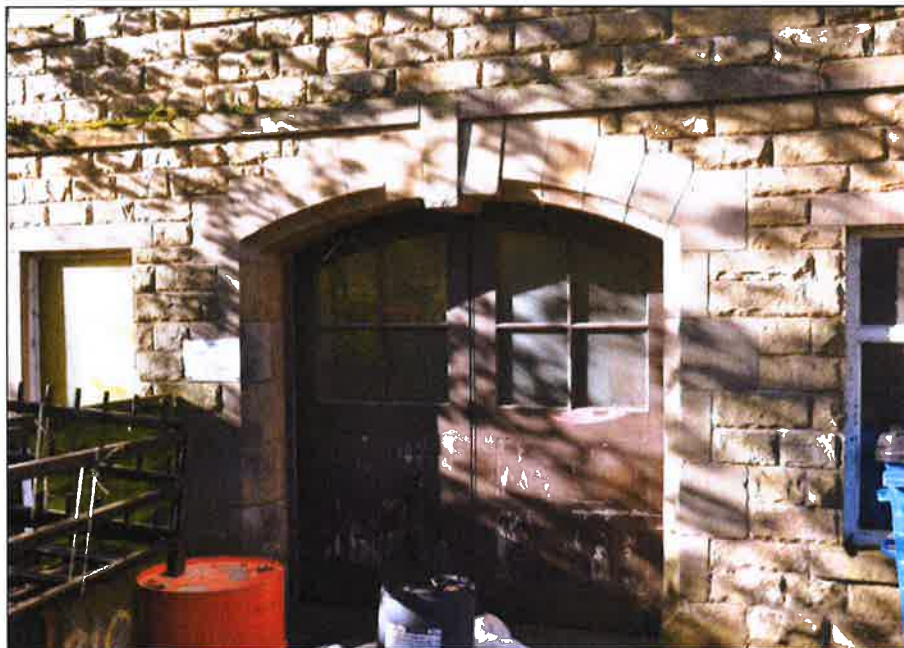
- 5.6 Added between 1854 and 1883, this component simply represents the roofing over of the yard between the adjacent ranges, though the north-east gable has some decorative quality, in the balanced façade with central arched doorway. Internally, if there was at one time an upper floor, it has since been removed.

Photo 8: Entrance to building 3

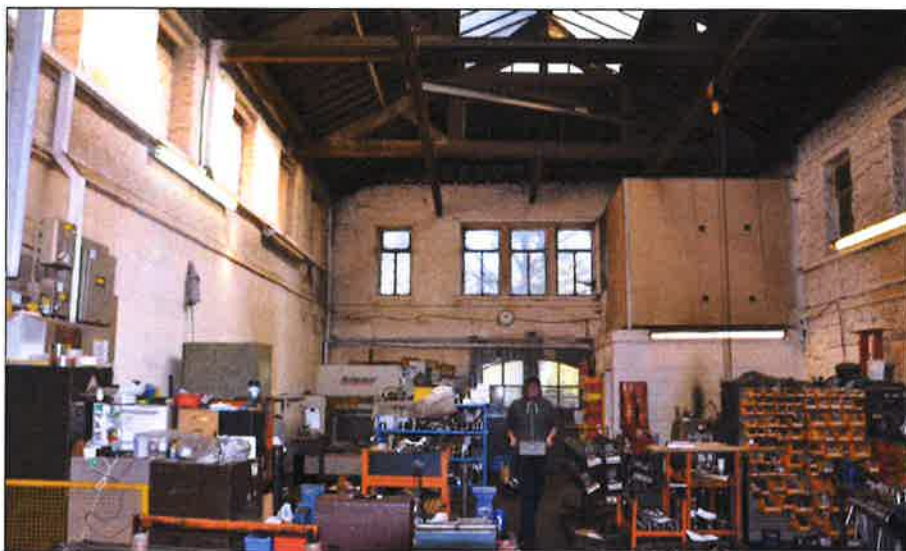
Photo 9: building 3

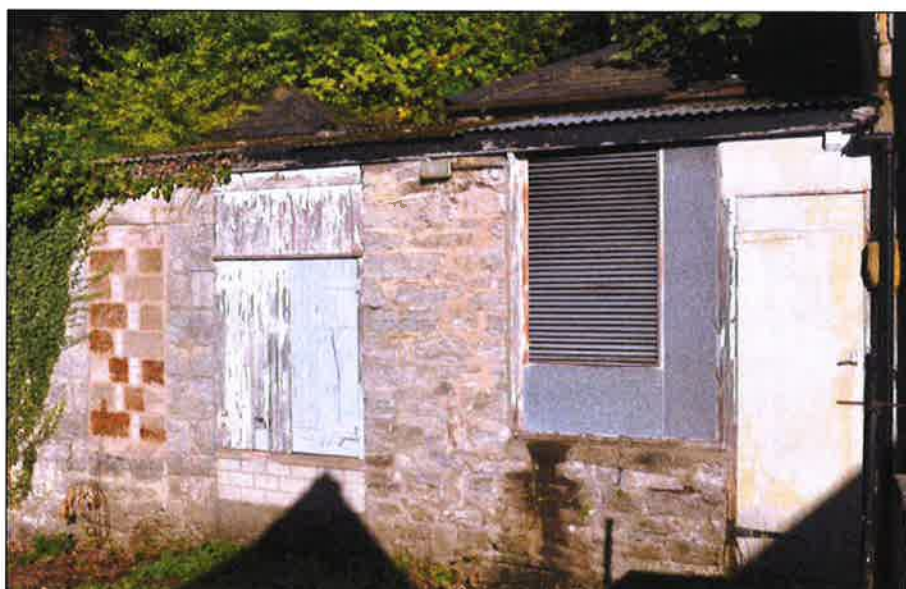
- 5.7 This minor, single storey building at the south-west end of building 1 actually comprises a pair, separated by a short flight of steps, though these are now linked by a modern roof. They have limestone walls and otherwise the roofs are of blue slate. That closest to building 1, but not the other one, is shown on the 1842 map. They have no distinguishing features and former functions are not known.

Photo 10: building 4

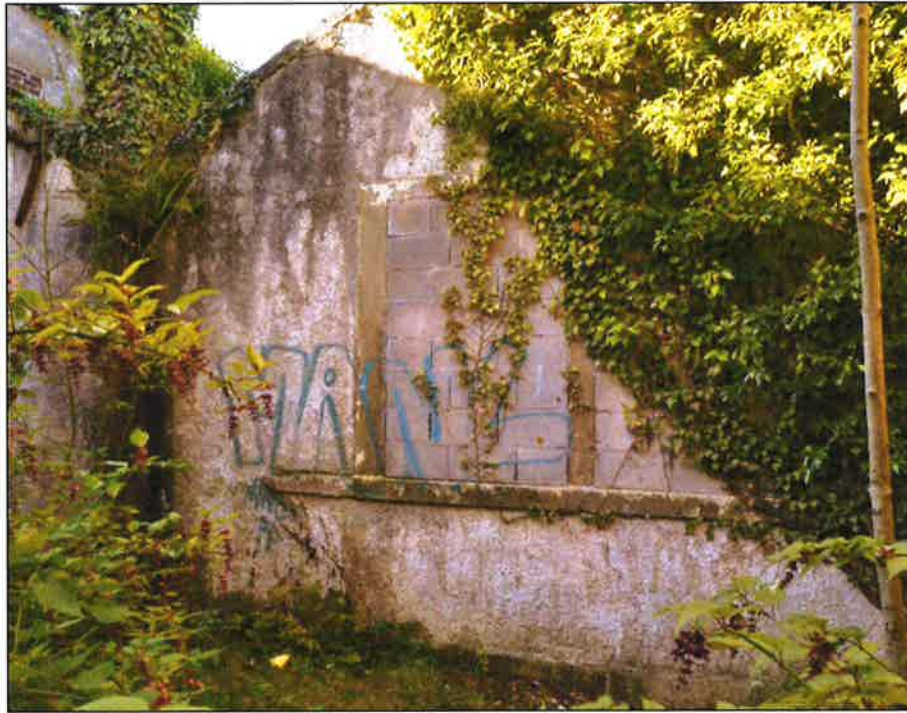
- 5.8 Building 5 is another small, single storey building, much overgrown and with all openings blocked so no internal access is possible. It has monolithic surrounds to the openings, suggesting an early to mid nineteenth century date, but otherwise there are no distinguishing features. It appears to be shown on the 1842 map.

Photo 11: building 5

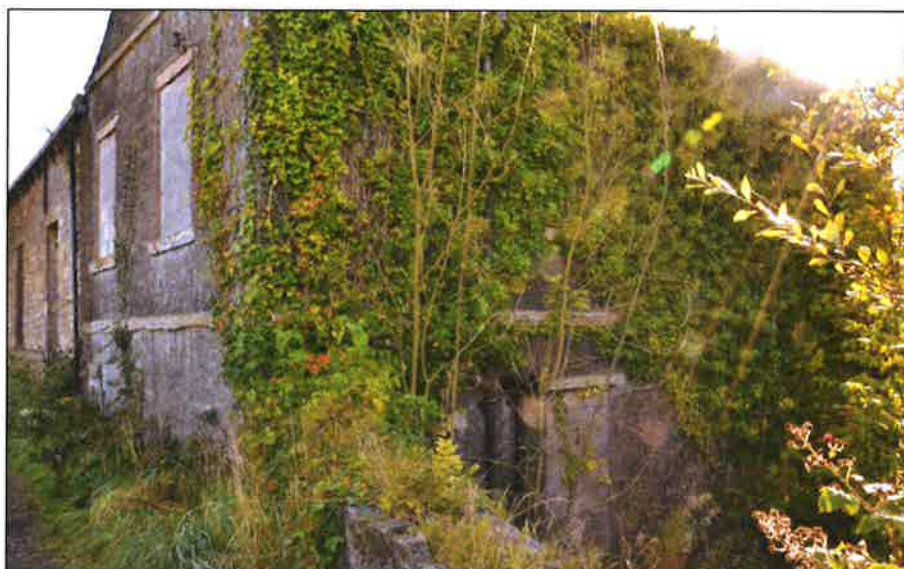
- 5.9 Attached to the south-west end of building 2, where blocked gable windows indicate that it was an addition, this two storey cottage (perhaps a pair of cottages originally) appears to date from the phase between 1854 and 1883. It has sandstone walls covered with roughcast, sandstone bands, heads and sills, and the remnants of a stone slate roof. It is plain and functional in appearance, and is believed to have accommodated a mill manager or other employees at one time.

Photo 12: building 6, cottage
