## **SITE INVESTIGATION & GROUND ASSESSMENT**

### **LODEMATIC, PRIMROSE ROAD, CLITHEROE, LANCASHIRE**

Report Ref BEK-19568-1

September 2019

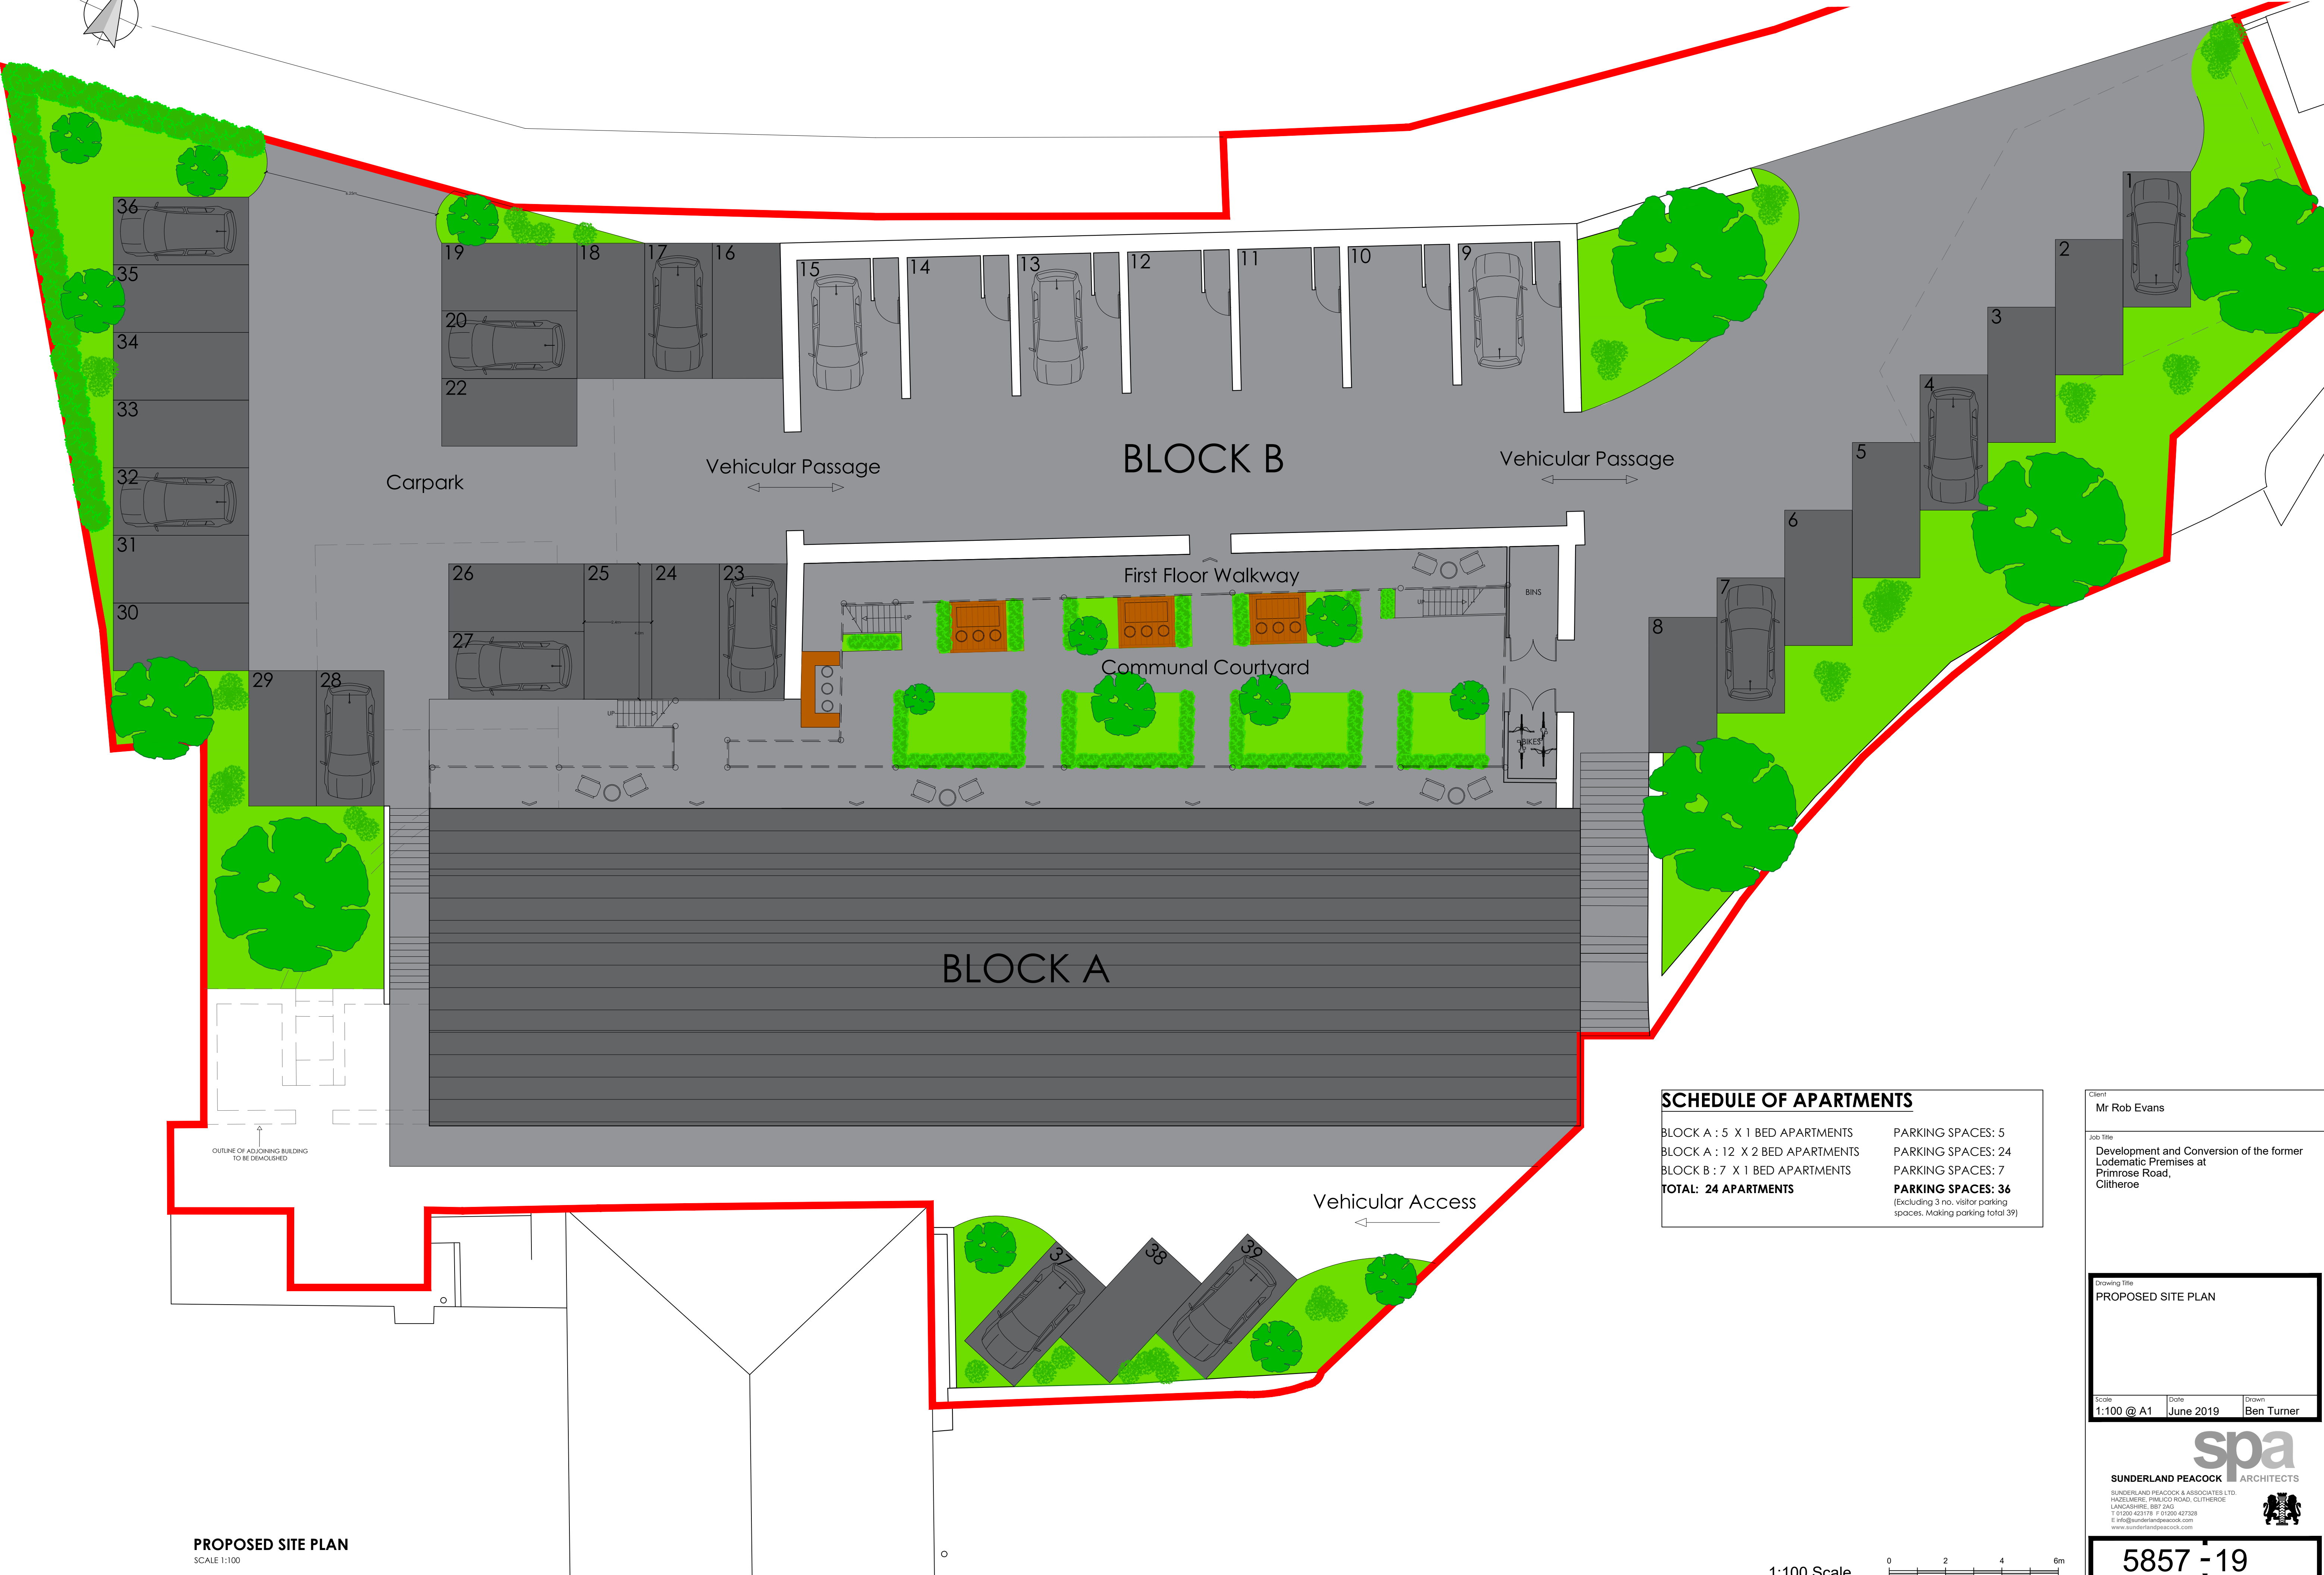
- 1.3.1 Ribble Valley Council has granted planning permission (subject to conditions) for the 'demolition of existing workshops buildings (other than workshop 3), conversion of workshop 3 to provide 14 residential apartments the erection of 4 residential apartments, erection of cycle/refuse store, laying out of parking and circulation areas, and associated landscaping.'
- 1.3.2 The proposed development is presented on Sunderland Peacock Architecture drawing titled 'Proposed Site Plan' (Drawing No 5857-19), a copy of which is presented in Appendix D.
