METHOD STATEMENT
European Protected Species (Bats)

Reasonable Avoidance Measures

**The Old Vicarage,
Shire Lane,
Hurst Green,
Clitheroe BB7 9QR**

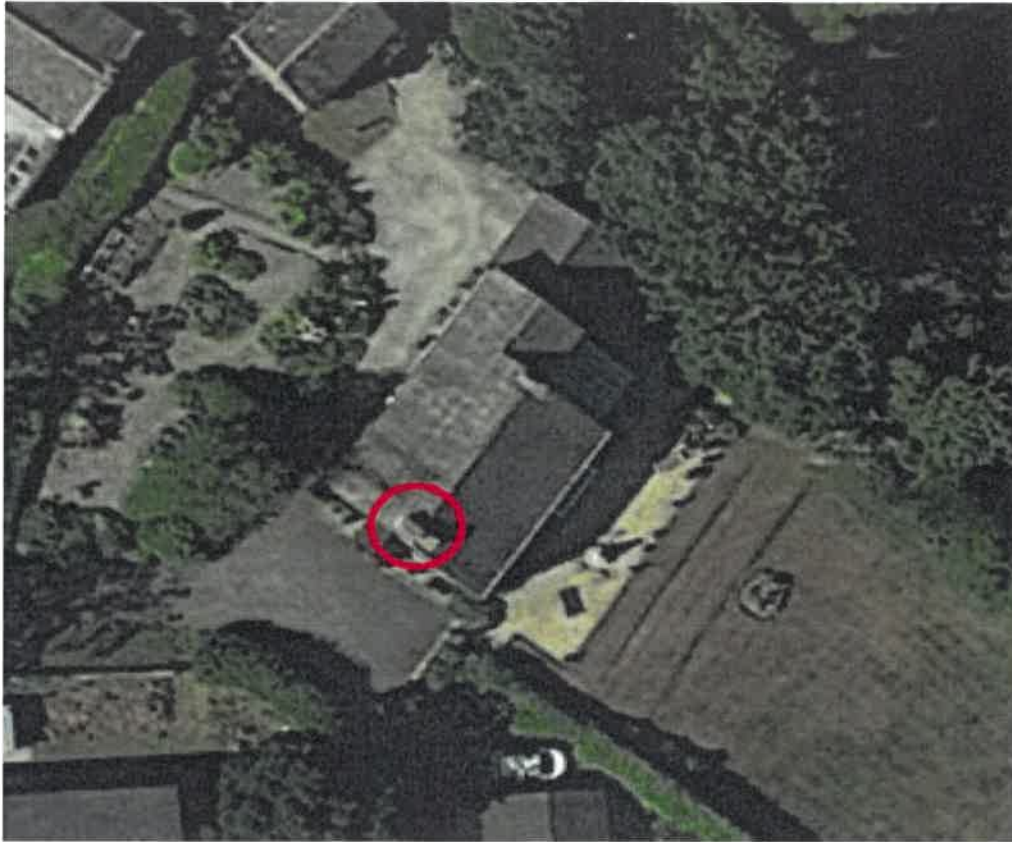
Location of droppings within loft

A preliminary visit on 25th November identified a low number of scattered pipistrelle sp droppings scattered in the southern loft of the property. Droppings were consistent with a small number of bats flying within the southern loft space and concentrated in the area of the. Due to the timing of the survey late in the season no further survey work was deemed appropriate, however evidence observed ruled out any potential for a maternity roost within the property and the roost has at this stage been identified as a low conservation value non breeding roost of a common species.

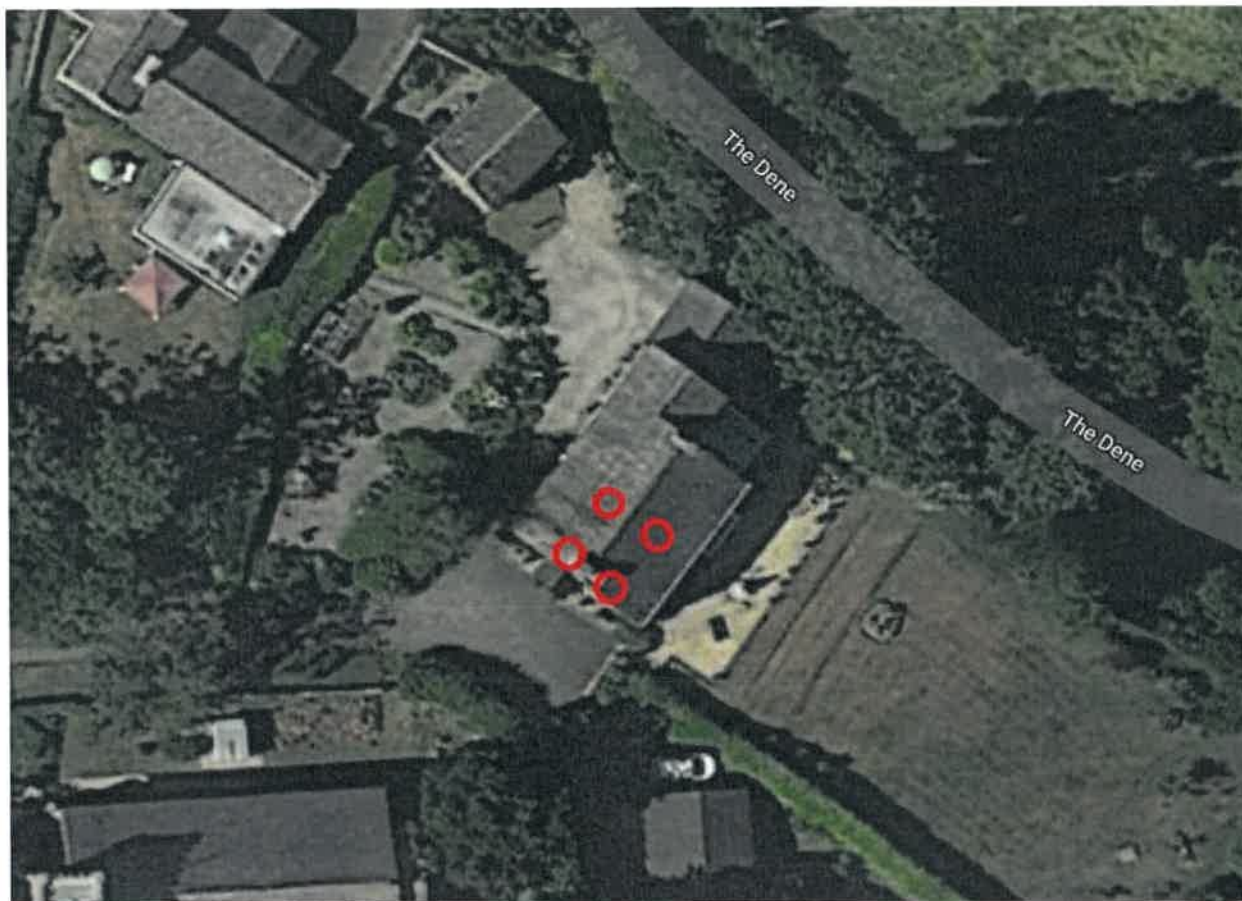
4 Bat Access Slates should be installed in the southern roof section to enable continuity of access to an existing roost feature. Bat slates should be fitted under supervision of the bat licence holder.

Location of bat access slates marked in red
