PHASE I GEO-ENVIRONMENTAL SITE ASSESSMENT

**Betty Barn
Slaidburn Road
Waddington
Clitheroe
Lancashire
BB7 3JQ**

Report Ref: 13-319-R01
Date Issued: March 2019

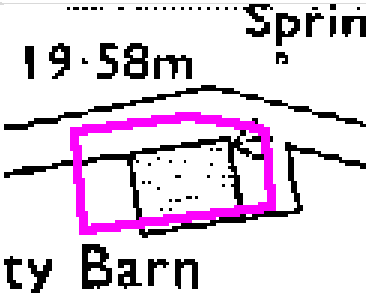
1971 1:2,500	No significant changes recorded.

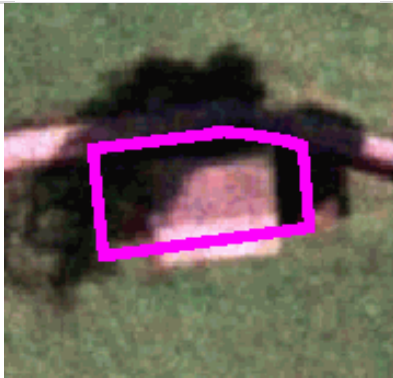
1999 1:2,500	No significant changes recorded, and the site remains in this configuration.

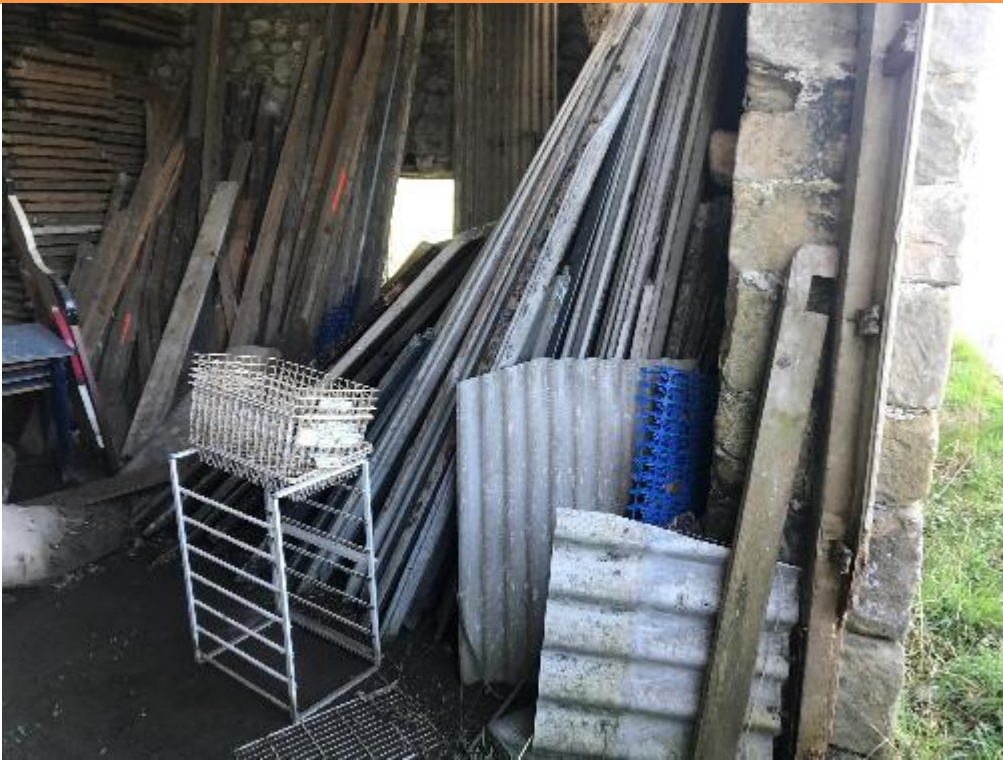
PLATE 5 – VIEW OF CORRUGATED PANELS WHICH MAY CONTAIN ASBESTOS

SITE DESCRIPTION	
Occupancy / Use	The site is located to the north of Waddington and currently comprises a large derelict barn.
Structures	The existing barn is a stone-built structure with slate roof dating from the 1880s [Plate 2].
Access	The site can be accessed via a track leading from Slaidburn Road [Plate 1 & 4].
Slope	The agricultural field around the barn slopes gently to the south [Plate 3].
Retaining Structures	None identified.
Surface Cover (%)	Buildings: 80%
	Hardstand: Nil
	Soft Cover: 20%
Vegetation / Ecology	None identified.
Invasive Plant Species	No invasive plant species were observed at the site.
Hazardous Material Storage	No Above Ground Storage Tanks (ASTs) or Underground Storage Tank (USTs) were observed at the site.
Asbestos Containing Material (ACM)	No ACM was noted within the building fabric. However, roof panels potentially containing asbestos were being stored in the barn [Plate 5].
