Pendle Hill Landscape Partnership Scheme

DOWNHAM CONCESSIONARY BRIDLEWAY

**Tree report to identify tree related issues in relation to new construction,
and proposed method statement for construction work**

**Specification for an Archaeological Watching Brief at
Field east of the Junction of Green Lane and Chatburn Road, Downham
(SD 78294443)**

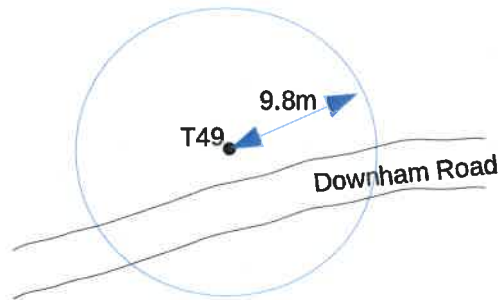
Example of a conventional RPA: Roots unlikely to extend under road

In reality the actual Root Protection Area for most of the trees are unlikely to be a concentric circle from the stem, but a polygon with a bias to rooting in the field, as there is little for the tree to gain by growing an extended root system under a tarmac road.

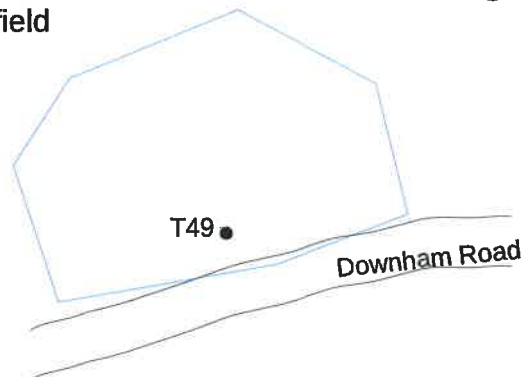
Example of a polygon shaped RPA: must have the same volume of soil protected as above, biased to rooting in field

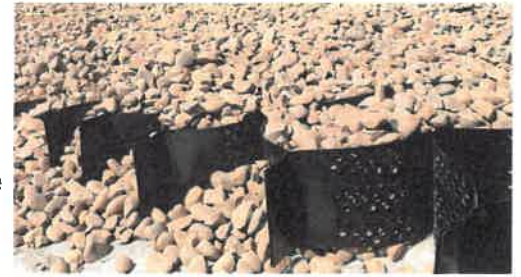
TECHCELL 75 CELLULAR CONFINEMENT SYSTEM

Techcell confinement system utilizes a three dimensional honeycomb structure to provide stabilisation across a wide variety of applications like erosion control, soil stabilisation, load support earth retention and tree root protection.

Techcell is manufactured with ultrasonically-welded virgin High-Density Polyethylene (HDPE) with Ecoloy® Formula that are expanded on-site and filled with sand, soil, rock or concrete, etc.
