**PRELIMINARY RISK ASSESSMENT**  
**PROPOSED DEVELOPMENT SITE**  
**LAND ADJACENT TO NO.5, BEECH CLOSE**  
**HENTHORN ROAD**  
**CLITHEROE**  
**BB7 2LD**  
for  
**ONWARD HOMES**

17-B-11124

20th Sept. 2017

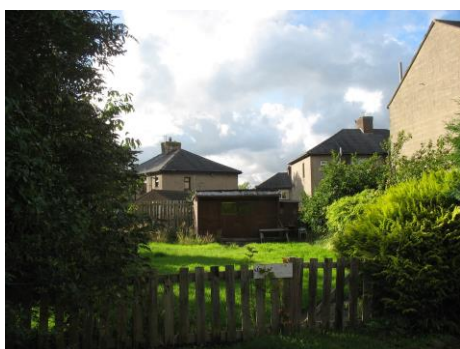
Fig.1 – Site

The small site exists as overgrown garden space (*Fig.1*) and features several trees and shrubs as well as a shed and a small paved area. The site is reasonably level and there are no watercourses present. There is an electricity sub-station (*Fig.2*) located approximately 15m from the site boundary, on Henthorn Road (*Fig.3*).
