**BAT SURVEY AT -
HYDRO LODGE
SAWLEY ROAD
GRINDLETON**

28th June 2019 9.30 pm - Emergence survey
11th July 2019 10.00 am - Scoping survey

REFERENCE NO. 5834

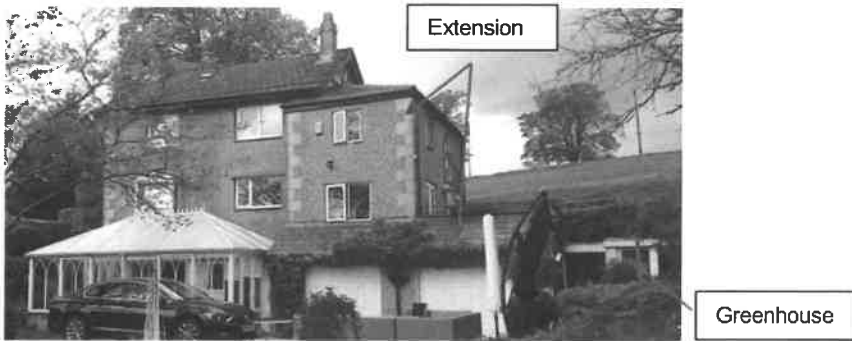
Rear south east elevation

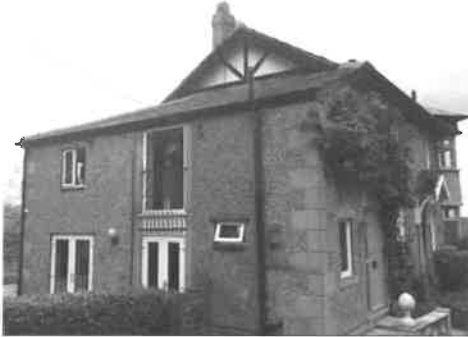
North east gable extension

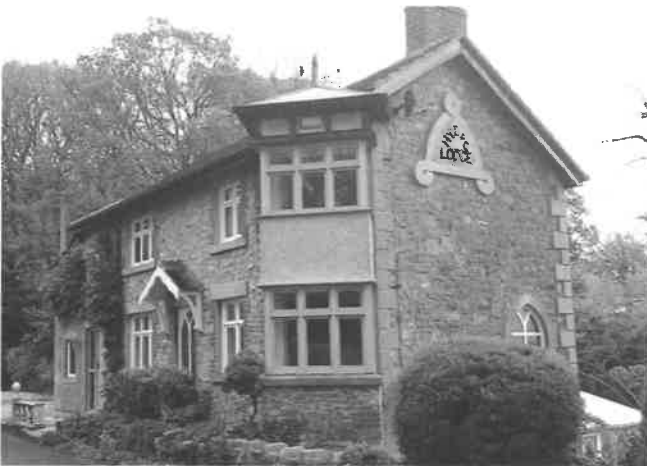
elevation

Original house. South west and north west

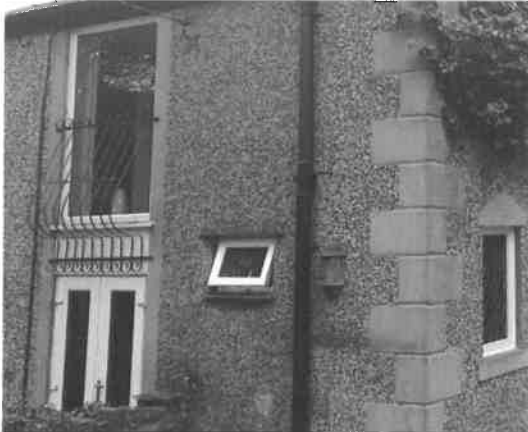
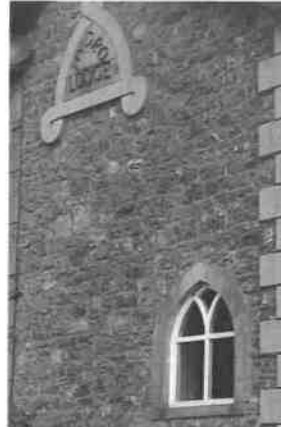
The extension walls are pebbledash render with stone quoins, the south west and south east elevations of the main house are random natural stone.

The walls have no access points all are in excellent condition with no cracks or crevices.

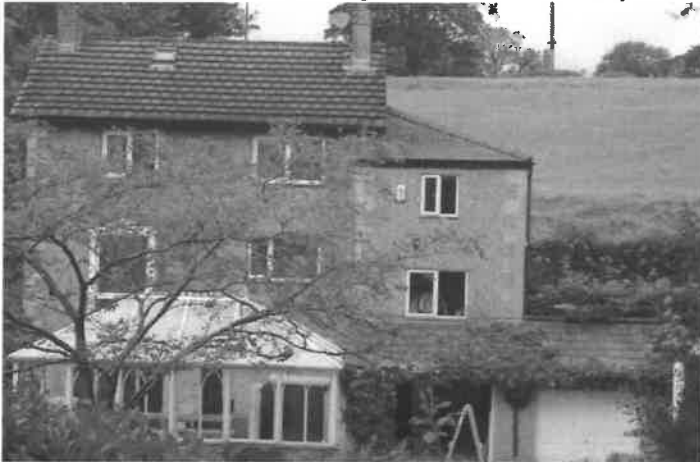
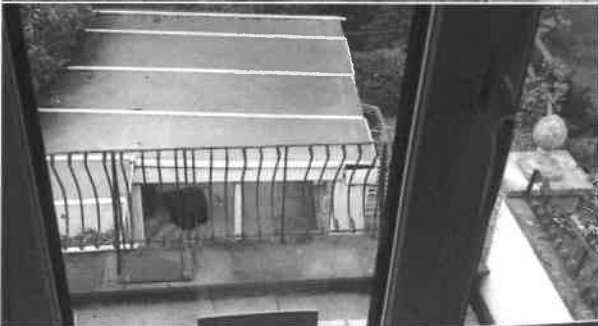
Rear south east elevation showing main roof, conservatory and extension roof. doors.

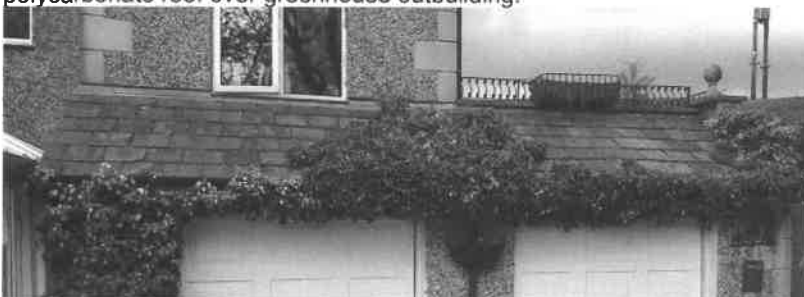
Paved roof and small mono pitch over garage and polycarbonate roof over greenhouse outbuilding.

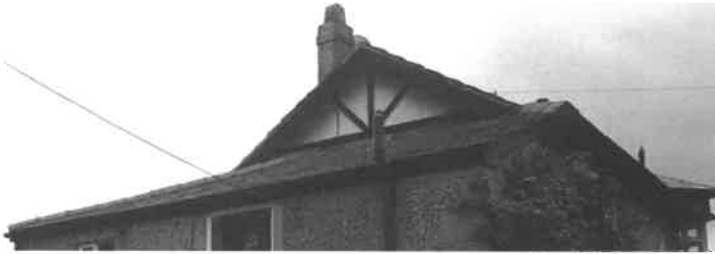
Mono pitch over garage doors

The extension roof is a lean to pitch with a full and half hip, blue slate finish. The timber fascia's are fixed flush to the wall.

The main roof is pitched with an eaves and gable overhang. The roof finish is tile with a small roof window.

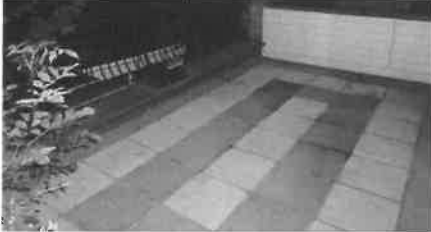
Paved flat roof over the garage.

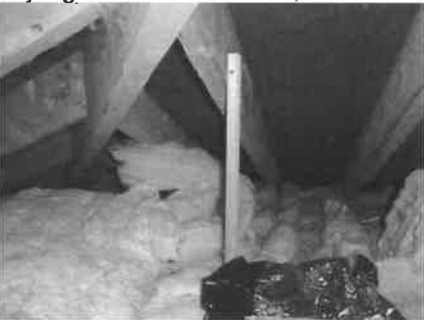
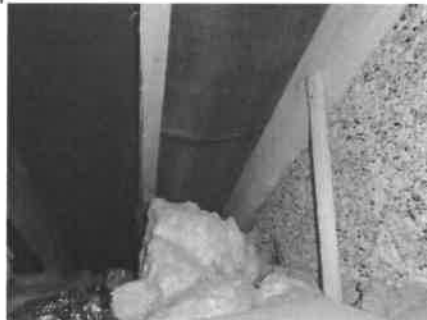
Extension roof void, timber rafters and hips with felt and quilt insulation between. All timbers in excellent condition as is the felt. The quilt is clean with no dropping or insect remain evidence. The space does not provide any high value roost habitat, bats are not present.

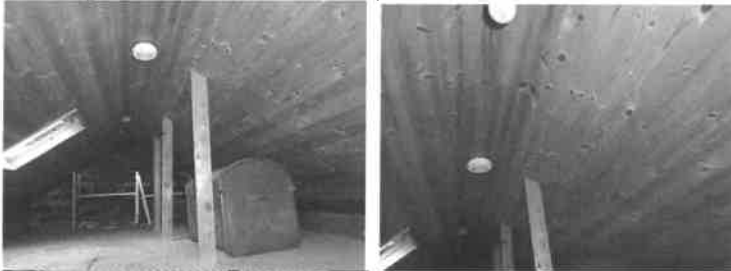
The main roof void has a boarded floor and rafters which are lined to the underside with t and g boarding. The space is light due to a roof window.

The floor is clean with no evidence of droppings or feeding remains. There are no cracks or crevices in the boarding, bats cannot access the space

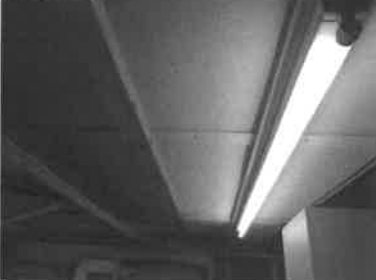
There is not an enclosed roof space in the greenhouse. The timber rafters are in reasonable condition without any crevices or cracks. The roof does not provide any potential habitat for bats.

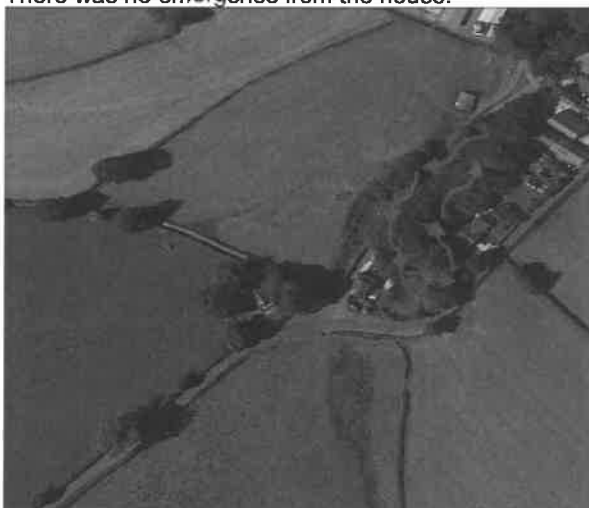
During the survey the detectors picked up some activity in the trees some time before the first siting of a single bat on the edge of the tree line at 10.05pm the activity continued in the tree line (indicated by the red line below). There was no emergence from the house.
