# Report of Bat survey

**Mearley Lodge,  
Primrose Road,  
Clitheroe,  
Lancashire  
BB7 1DR**

12<sup>th</sup> June 2020

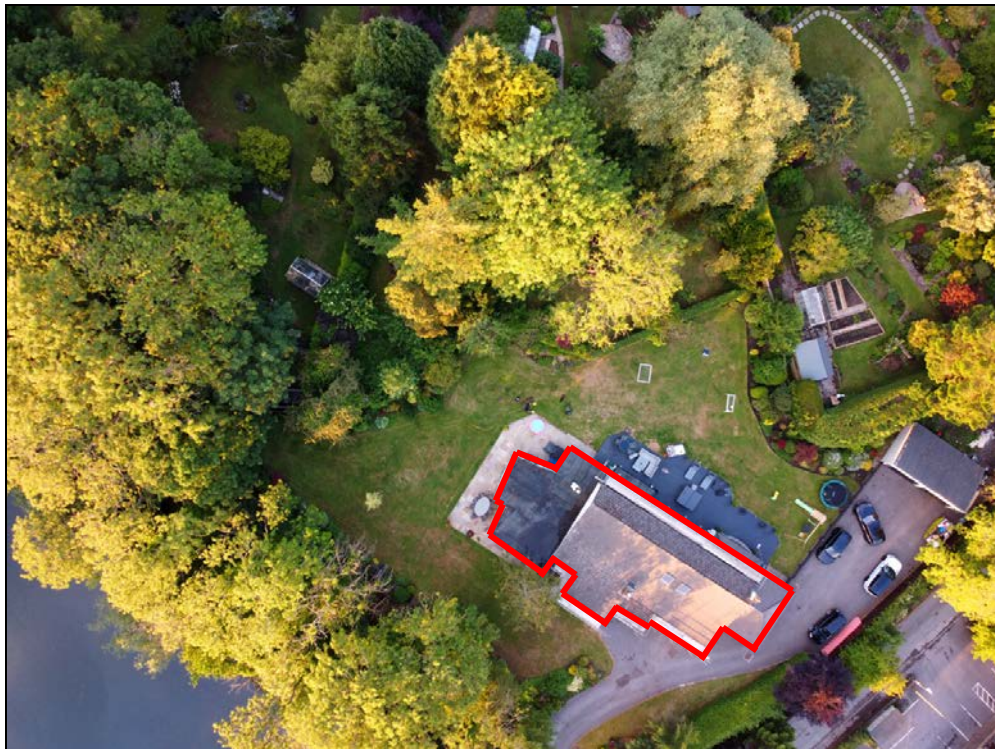
**Image 2 – Close aerial view of Mearley Lodge (outlined in red) and immediate surroundings**

The proposed development area is less than 0.01 hectares, and comprises a single building known as Mearley Lodge, as shown on the aerial image above and on map 2 below.

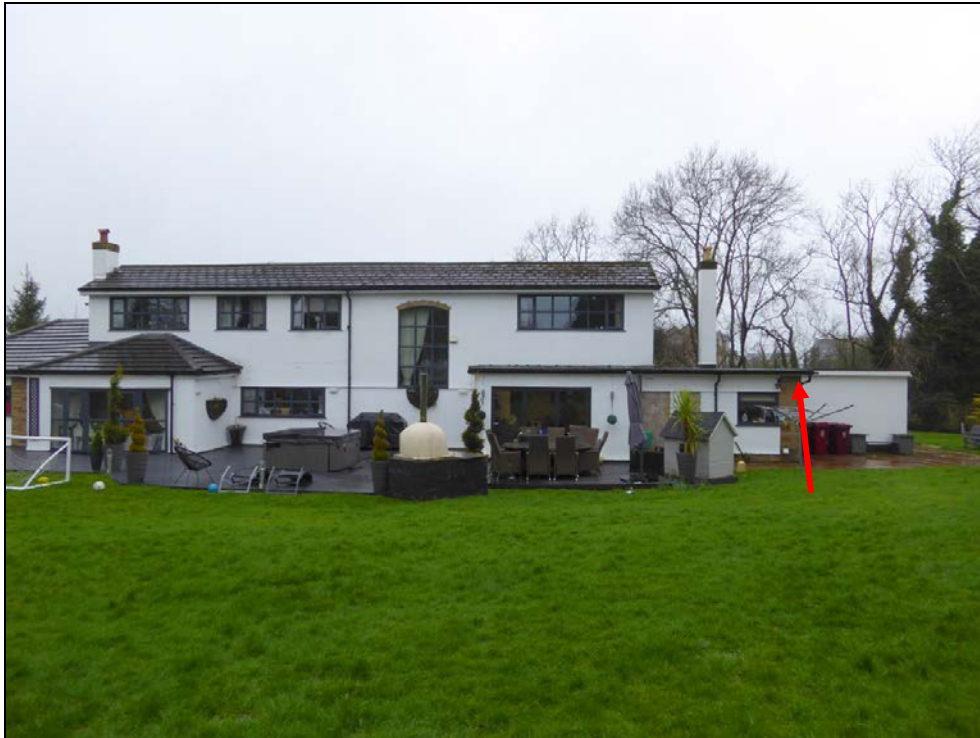
**North east elevation of Mearley Lodge. Bat emergence point marked by red arrow. Image from February 2020**

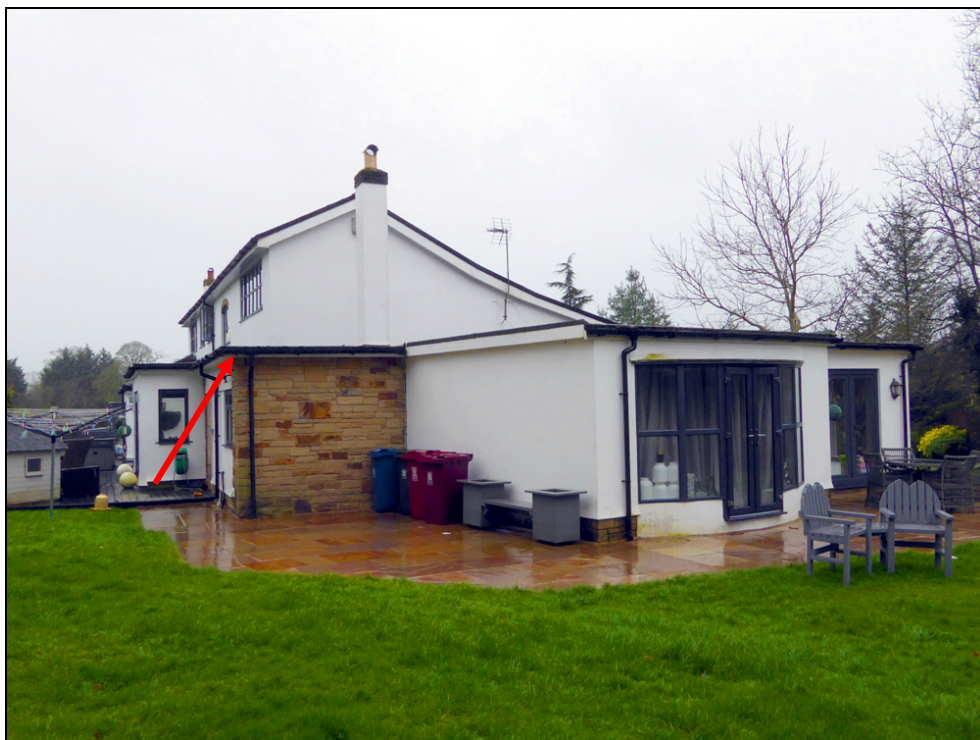
**View of Mearley Lodge from north. Bat emergence point marked by red arrow. Image from February 2020.**

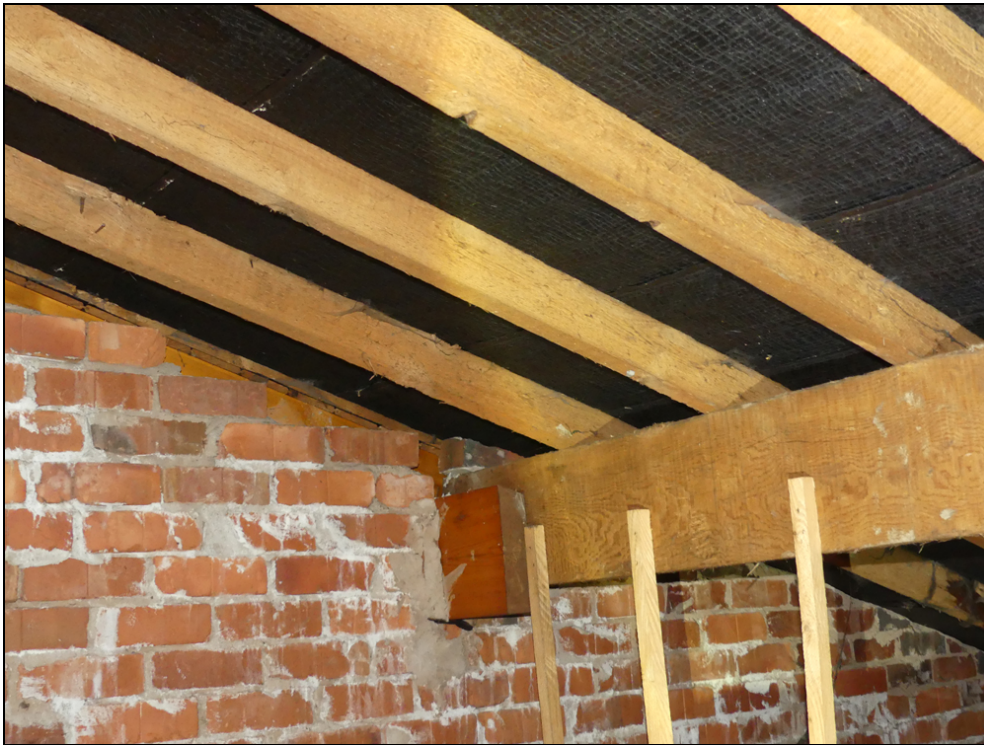
**Internal view of roof void, showing roof supports and felt underlining.  
February 2020.**

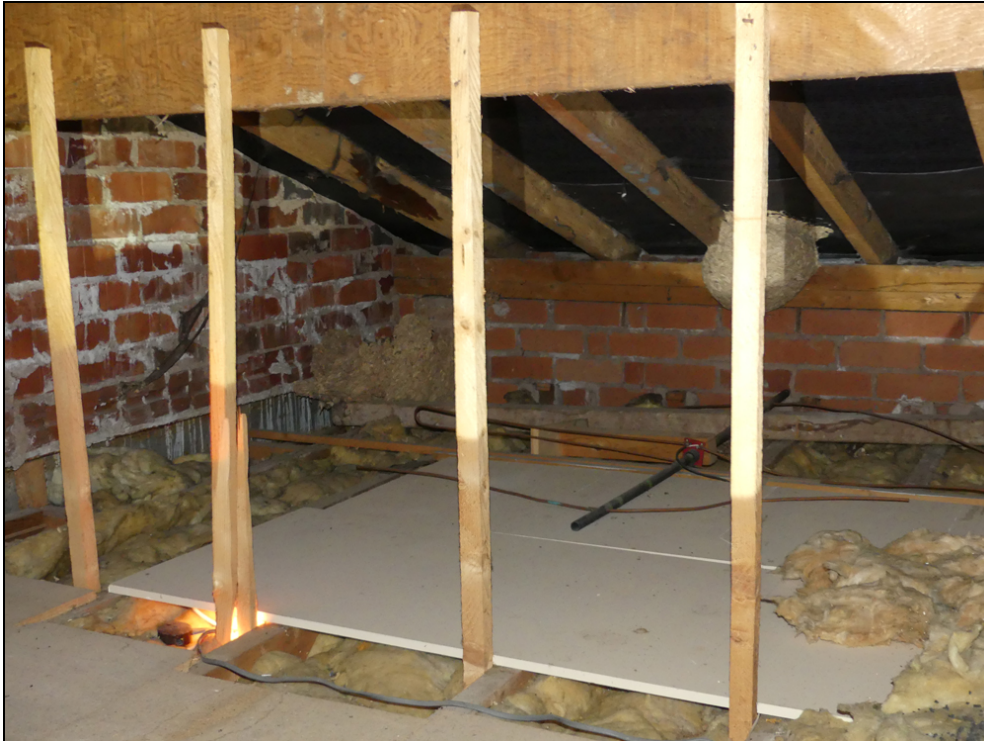
**Internal view of roof void, showing roof supports and partial boarding.  
February 2020.**

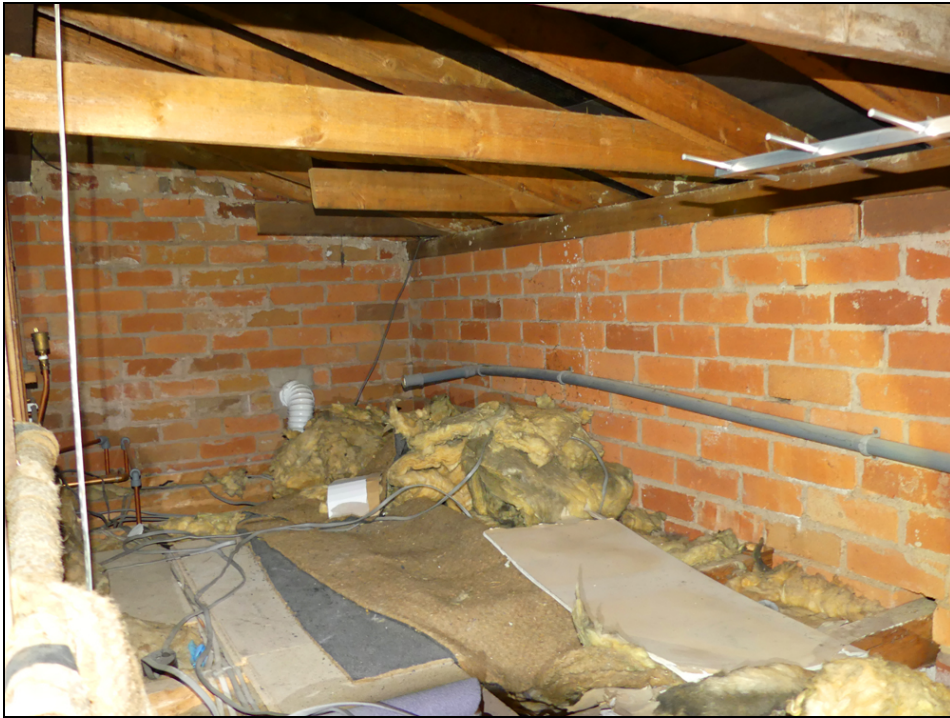
**Internal view of roof void, showing internal walls and insulation. February 2020.**

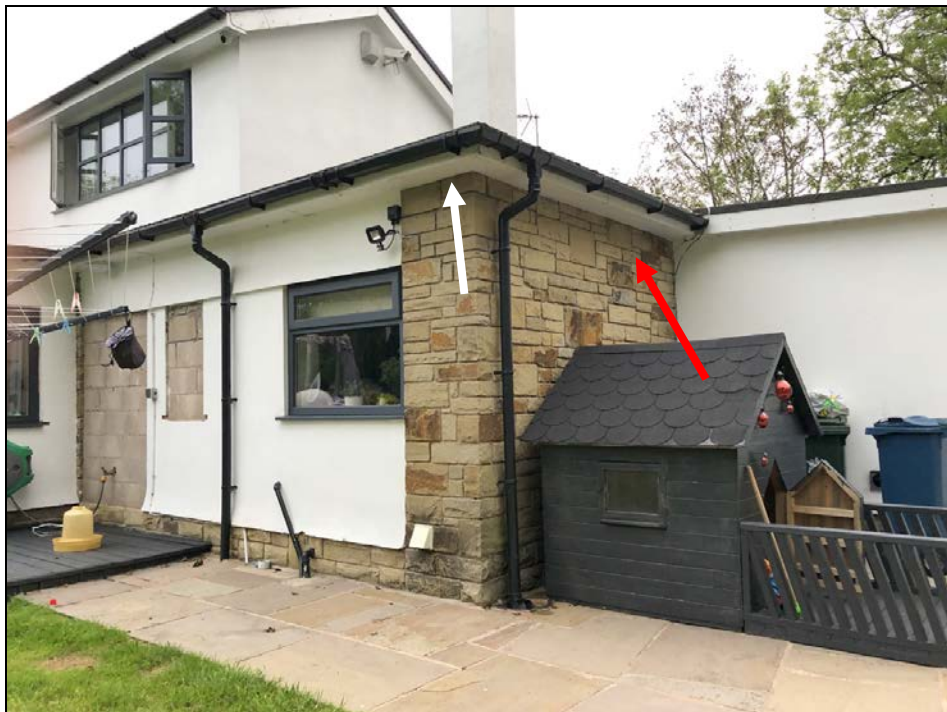
Bat droppings, typical of those produced by pipistrelle bats, were found scattered on the external stone walls on the north west and north east corners of Mearley Lodge.

**External view of north part of building. Bat emergence point (white arrow) and bat droppings (red arrow). May 2020**

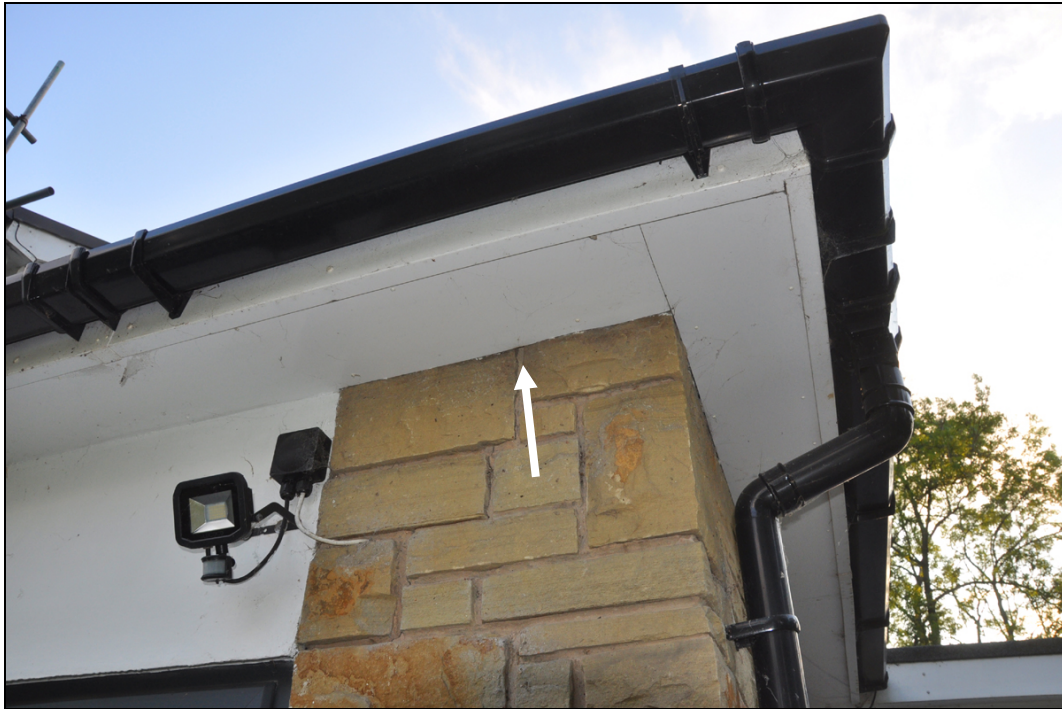
**External view of north part of building. Bat emergence point marked by white arrow. May 2020**

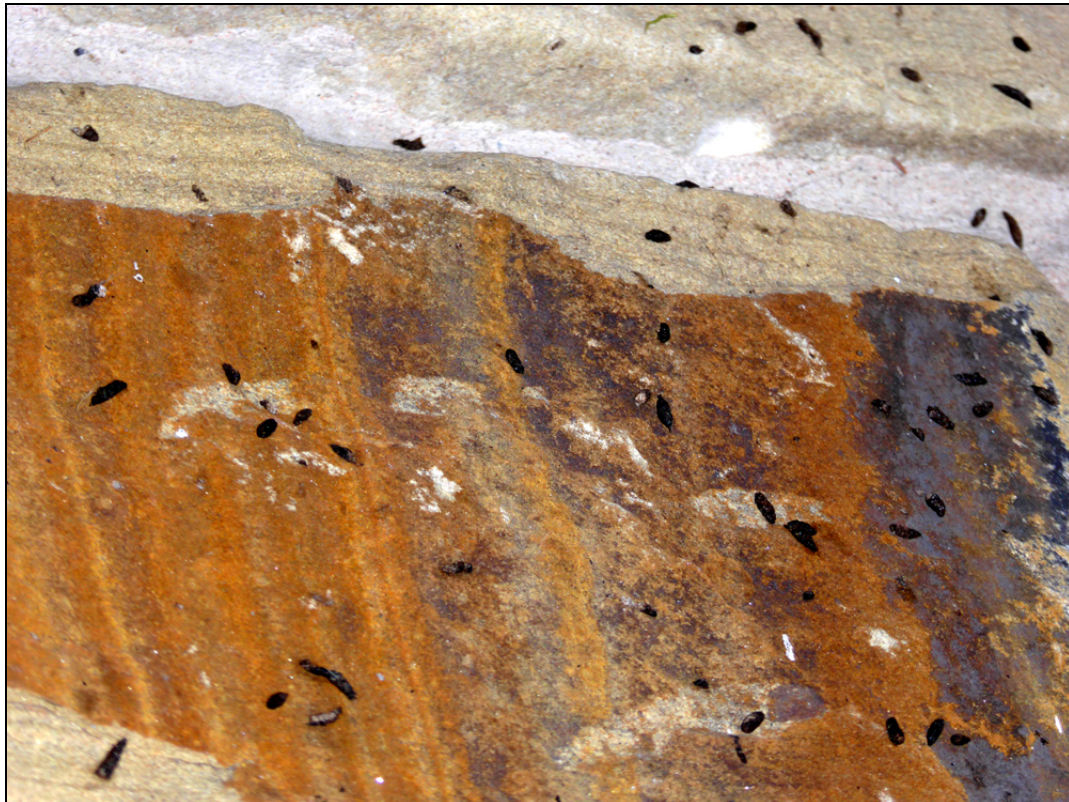
**Bat droppings on external wall to north of building. Note that colours are accentuated by rain at time of survey. Image from February 2020**

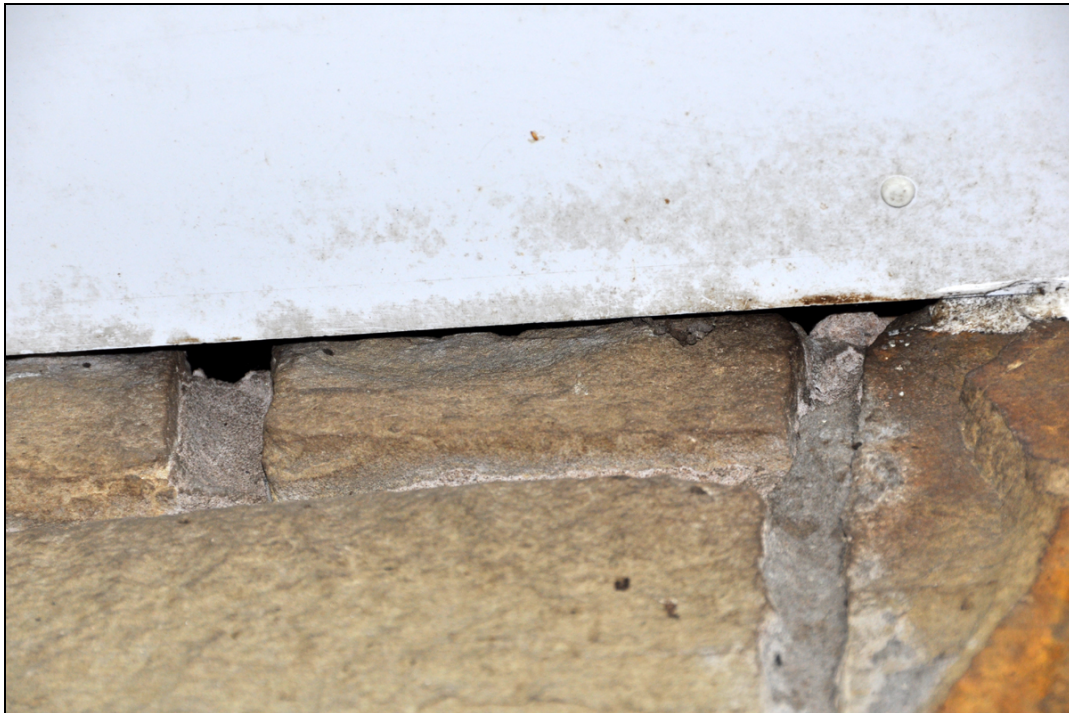
On the north west and north east walls, two of the many gaps below the soffit boards had signs of staining consistent with access points used by bats when entering and exiting a roost.

**Previous bat access point in north part of building, below soffit edge, showing clear staining from fur oils. May 2020**
