Preliminary Bat Roost Assessment Report

**Town Farm Barn and Shippon,
Pendleton,
BB7 1PT**

02.12.2019

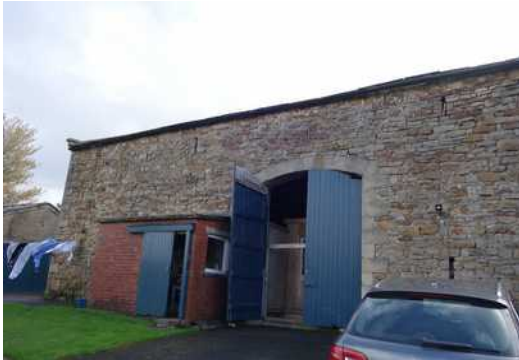
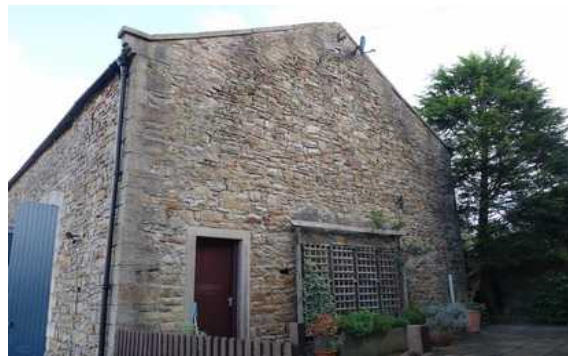
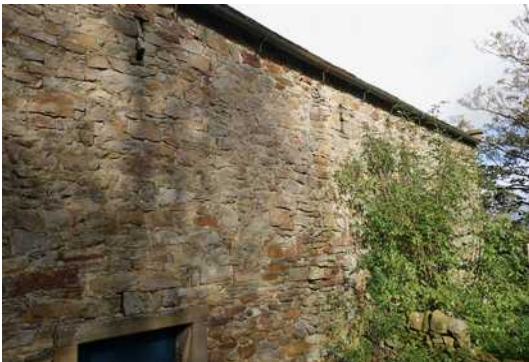
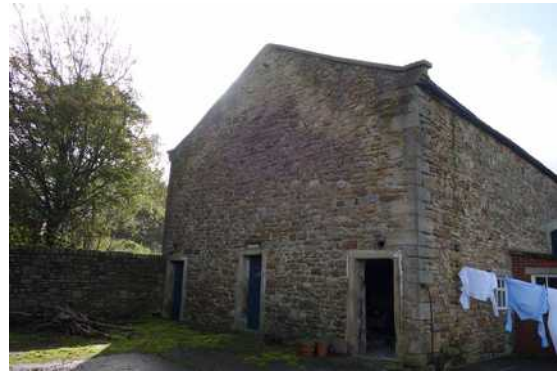
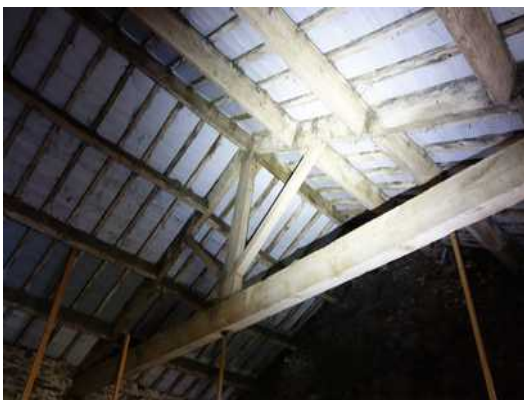
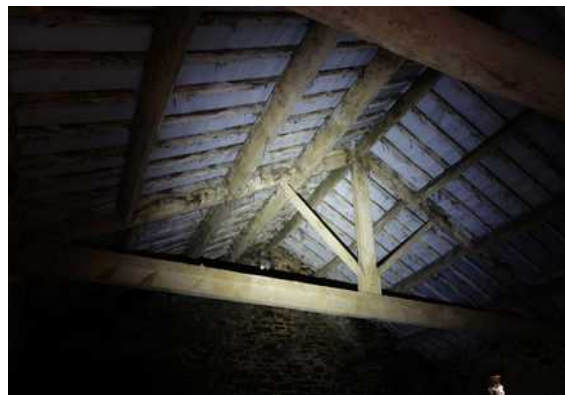
The property consists of a detached stone built barn with double pitched slate roof. External walls are generally well pointed and gable roof verges are sealed. Roof slates are close fitting with no obvious lifted or missing slates, the ridge is well sealed. The barn has no interior loft space with a modern breathable membrane exposed to the interior. Arrow slits are present on external walls allowing limited access to the interior.

Overall the building offers low roosting potential.

The barn was assessed as offering a low level of bat roosting potential. Evidence in the form of a low number of scattered pipistrelle droppings were observed scattered within the barn consistent with foraging bats.

Scattered pipistrelle bat droppings were recorded in the barn in low numbers consistent with bats in flight. Combined with the barn offering some roosting potential further survey work is recommended to confirm presence/absence of roosting bats.

Further survey work is recommended to confirm presence/absence of roosting bats within the barn

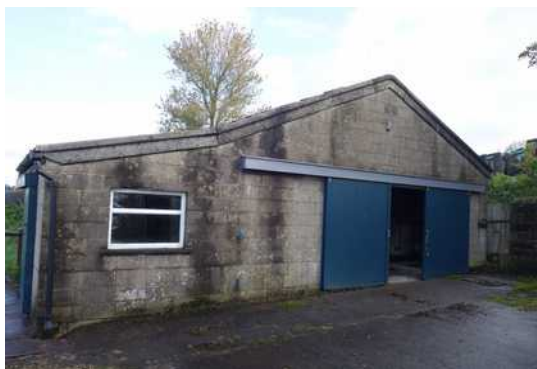
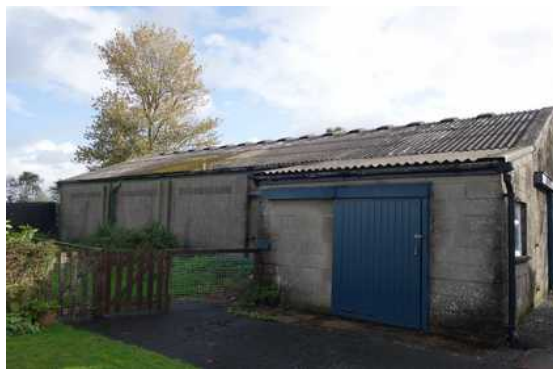
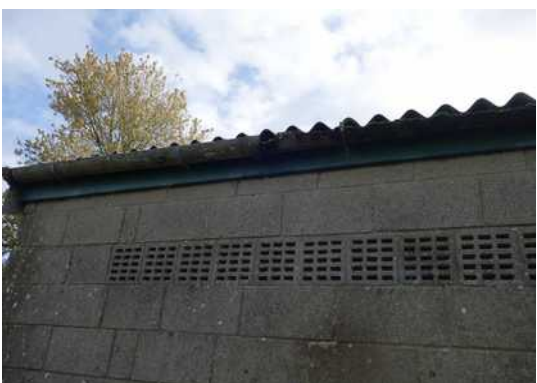
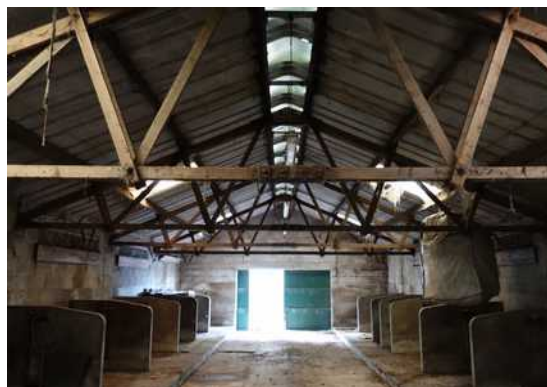
A detached single storey concrete block shippon with double pitched corrugated fibreboard roof is present to the north of the barn. The building has no obvious gaps or crevices suitable for roosting bats. Fascia boarding where present is close fitting. Roof lights are present and allow considerable light penetration.

The building is considered to be of negligible roosting potential.

The shippon was observed to have no obvious potential roost features being in a good state of repair. No evidence of bats – droppings, feeding remains, staining was observed on external features or within the building.

The shippon was generally well sealed and offered no obvious potential roost features. Due to the lack of suitable roost features, the nature of construction and the generally well sealed nature of the building it is considered to offer negligible roosting potential.
