HALL BARN S FARM

HERITAGE ASSESSMENT

REPORT
APRIL 2020

HALL BARNS FARM
STONYHURST
LANCASHIRE

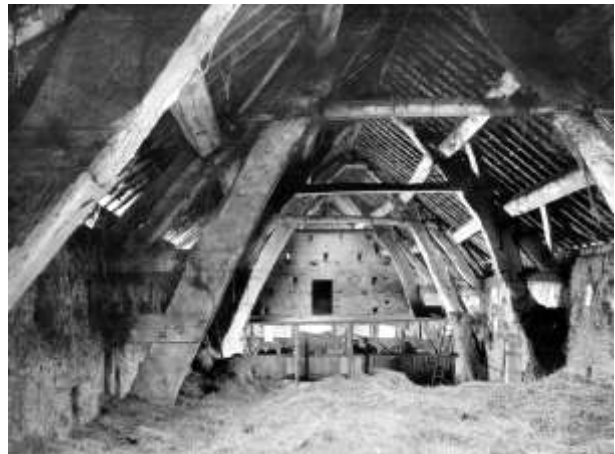
Plate 7 Interior of the 'Shireburn Barn', 1927 (Stonyhurst Magazine)

The most northerly barn forming the Hall Barns Complex is a cruck barn of possible 16th-century date (HA 4), which would suggest that it functioned alongside the principal house constructed for the Shireburn family, long before the establishment of the college at the end of the 18th century. A photograph published in the *Stonyhurst Magazine*, shows the interior of the barn in 1927, then described as the 'Shireburn Barn' (Plate 7). A short description of the barn is also included, describing the 'massive and magnificent specimen' of a crook [sic] barn. It notes adze marks on the surviving timbers.

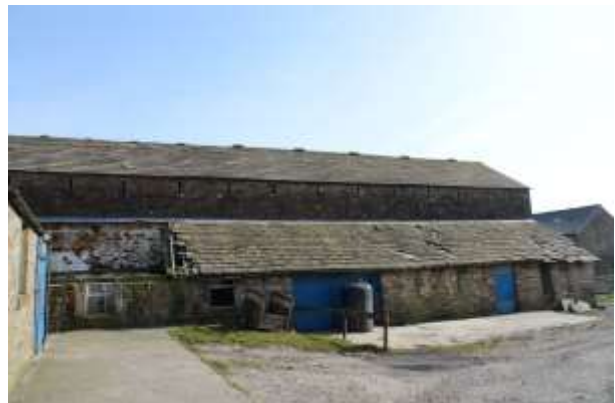
Plate 19 The southwest side of the barn

The upper part of the southwest elevation consists of the main body of the barn, while the lower part of the elevation consists of a single storey outshut. (Plate 19). The upper part is of roughly coursed sandstone rubble and incorporates a series of regularly positioned small openings intended to serve as ventilators. There are no other features of note and no evidence for any phasing in the

fabric. The roof covering of the main body of the barn is of stone slate with ventilators positioned regularly along the ridge.

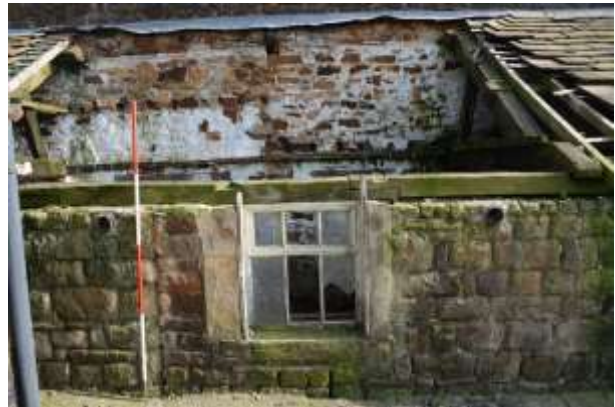
Plate 20 The southwest side of the barn

The single-storey outshut has a slightly more complex history. The elevation centres on a large double door to the north of which the fabric consists of large, well-squared sandstone blocks. Within this fabric there are three window openings; that to the immediate north of double doors appears to be an insertion, the next has been inserted into a blocked door opening (the door opening appears to be an original feature) and the window at the northern end also appears to be an insertion (Plate 20). All three windows contain timber transom frames, the two to the north of the late 19th century, that to the south of mid- to late 20th-century date. The former two frames provide a likely date for when the windows were inserted.

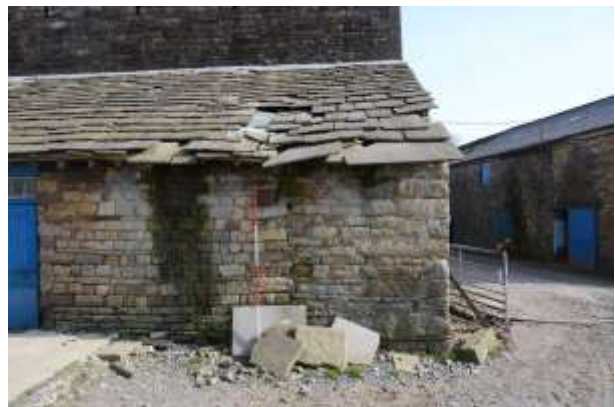
Plate 21 Vertical break in the fabric of the southwest outshut

To the south of the double door the fabric consists of much smaller sandstone blocks. These blocks are regularly coursed, until close to the south end of the building where there is a break in the fabric. The main features of note are a blocked ventilator towards the north end, a door opening and a further blocked ventilator towards the south end. The door opening contains a timber frame with overlight and a ledged and braced door. All features appear to be primary to the fabric. The break in the fabric towards the southern end of the elevation is near vertical (Plate 21). The relationship appears to be that the fabric to the north cuts into the fabric to the south, although stonework to the south does not appear to be vastly different to that to the north.

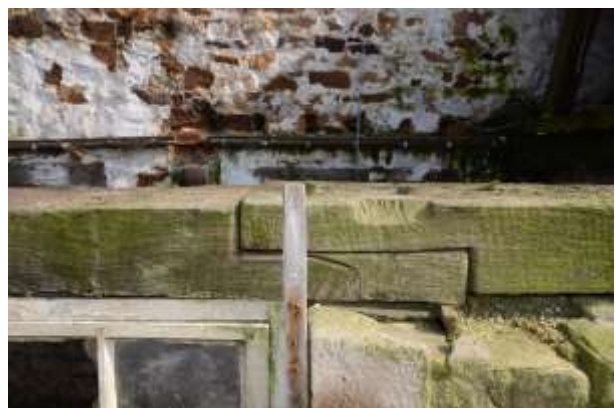
Plate 22 Wall plate towards the north end of the southwest outshut

The roof covering of all sections of the outshut are of stone slate. A section of the covering which has been removed towards the north end has exposed a section of the wall plate (Plate 22). The section exposed includes a simple scarf joint in the plate which has been secured with pegs.

The proposed works would see the removal of the roof of the outshut, and replacement with new membrane and original roof slates.

There would be some direct impact on the fabric of the building, largely restricted to removal of timbers and addition of a new membrane. However, this would be limited to those timbers that are rotten, and as such their removal is necessary to ensure the continued safe use and good condition of the building. The legibility of the structure would not be affected.

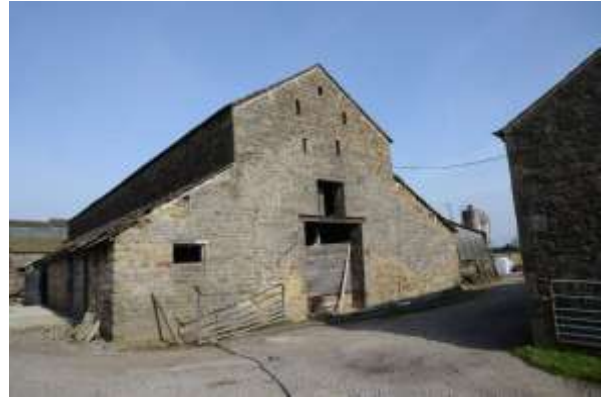
Plate 23 Southeast elevation of the barn

The southeast elevation forms one of the gables of the barn (Plate 23). The fabric of the elevation is of coursed, roughly-squared sandstone blocks. The centre of the elevation has a large door opening with a steel 'I'-section lintel. Packing around the stonework forming the jambs suggests that this door is an insertion, while the steel lintel probably replaced a timber lintel. Above the large door opening is a further small opening which would have served as a taking-in door; this appears to be an original feature. A single window with timber lintel is located on the western side of the elevation which lights the interior of the southwest outshut; the window appears to be an insertion.

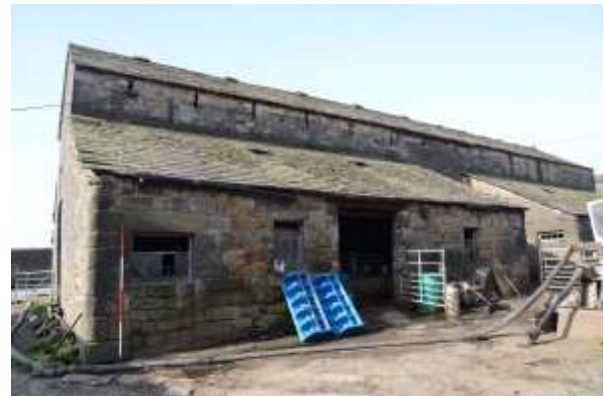
Plate 24 Northeast elevation of the barn

The upper part is of coursed squared blocks of sandstone, which contrasts with the southwest elevation (of more irregular coursing and less squared blocks) and suggests that they might not be of coeval date, and could represent some stone replacement.

This upper part of the elevation incorporates a series of regularly-positioned small openings intended to serve as ventilators. The roof arrangement is as observed on the southwest side of the building. In contrast to the southwest elevation, there is a gap in the outshut range to allow access to a central segmental-arched threshing door opening. The arch has a dropped keystone and immediately above it a stone bearing

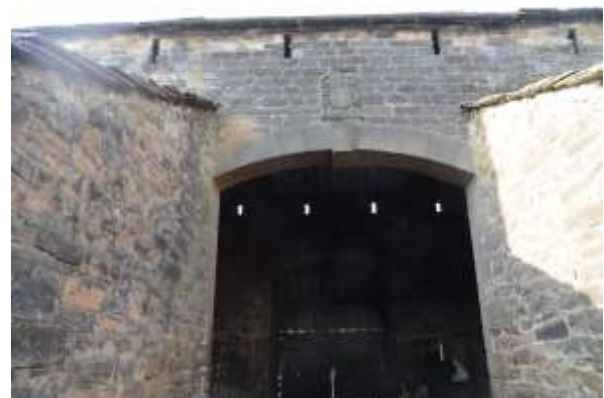
Plate 25 Threshing door opening through the northeast elevation

a heraldic shield (Plate 25). A similar threshing door opening is located opposite in the southwest elevation but externally is now concealed by a secondary door opening in the outshut.

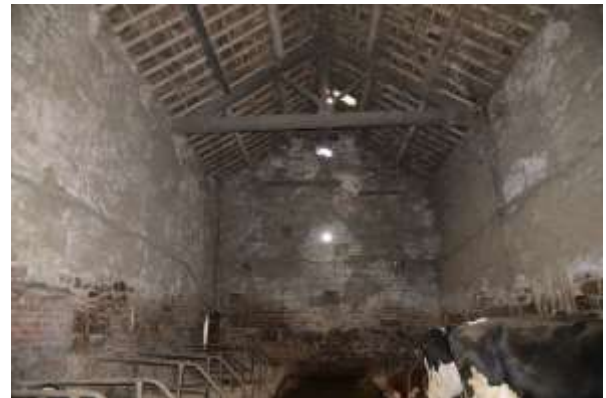
Plate 26 Interior of the barn, looking north

The roof structure is a fairly standard pattern roof of the late 18th or 19th-century date. The trusses consist of king posts with raking struts to the principal rafters. Iron strapwork and fixings are in evidence holding the timbers together. This is

probably a reroofing of the barn contemporary with areas of rebuilding of the stonework.

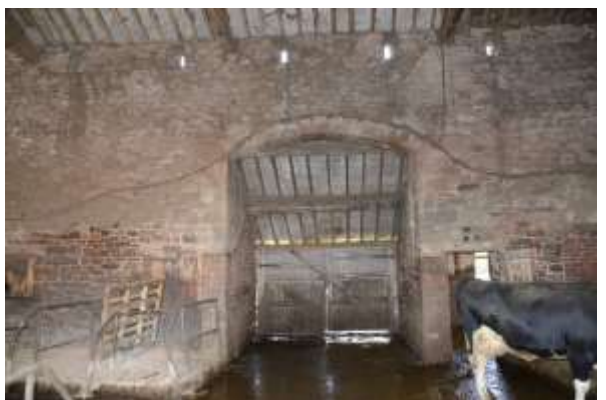
Plate 28 Interior of the threshing door opening through the southwest wall

The threshing door opening through the southwest wall is best seen from the interior, the exterior now masked by the (modified) outshut (Plate 28).

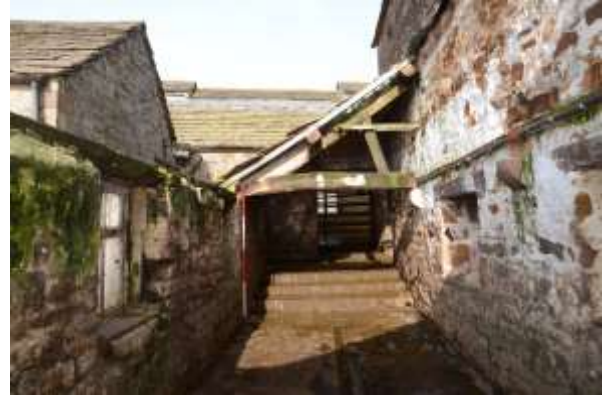
Plate 29 Interior of the north end of the outshut on southwest side

The interiors of the outshuts are generally difficult to view due to their current uses, but the northern half of the southwest outshut is typical (Plate 29). Of particular note is the arrangement of trusses. These are of simple form with a tie beam resting on the wall plate of the outer wall and their inner ends resting on stone corbels. The lower edges of the tie beams have been chamfered and stopped. The upper parts of the trusses consist of principal rafters supported by raking struts; the outer ends of the principals have mortice joints into the ties secured with pegs which the inner ends are let into sockets in the wall.

Two purlins have been provided which have been chamfered on their lower corners. The construction of the outshut roofs (other than one section in the southern end of the outshut on the southwest side) contrasts markedly with the replaced roof of the main body of the barn and would be consistent with a date in the first half of the 18th century.
