Ecological Appraisal

Chatburn Road South
Clitheroe

- 1.1.1 Envirotech NW Ltd were commissioned in February 2020 by Oakmere Homes to carry out an ecological appraisal of land off Chatburn Road, Clitheroe. It is proposed that new houses are constructed on the site.

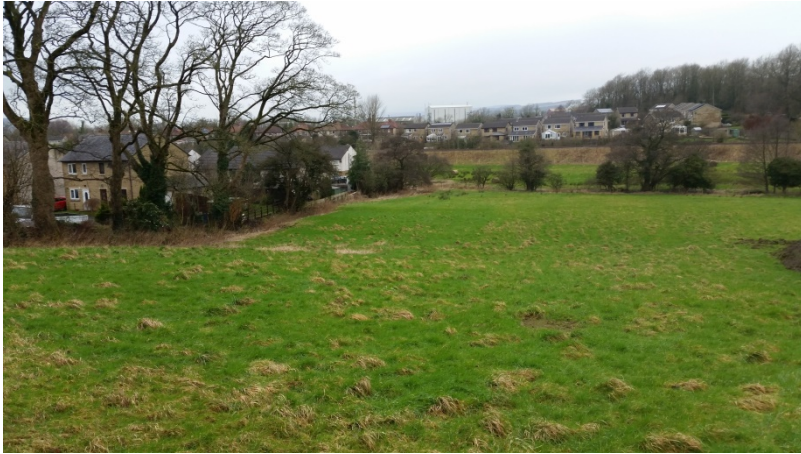
Poor semi-improved grassland covers the majority of the site. Tall ruderal vegetation grows around the peripheries.

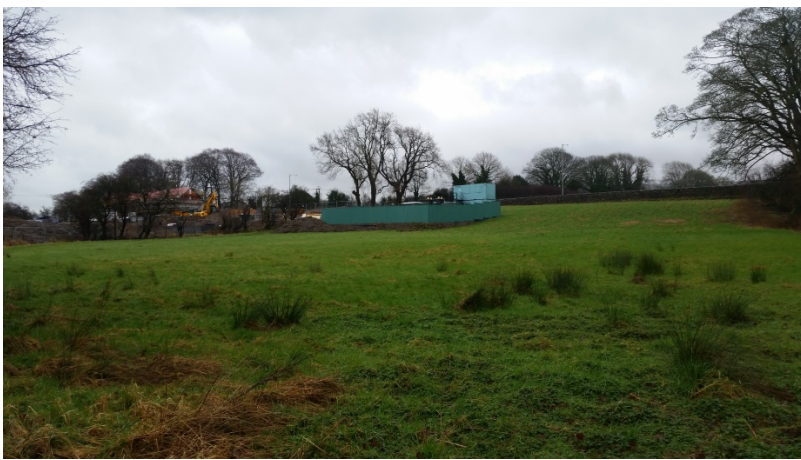
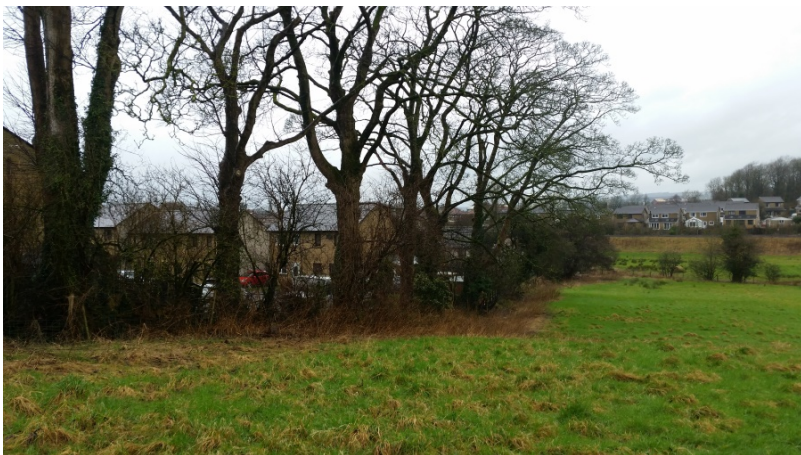
A tree line bounds the site with existing residential dwellings to the South-west. A small stream also runs along this boundary.

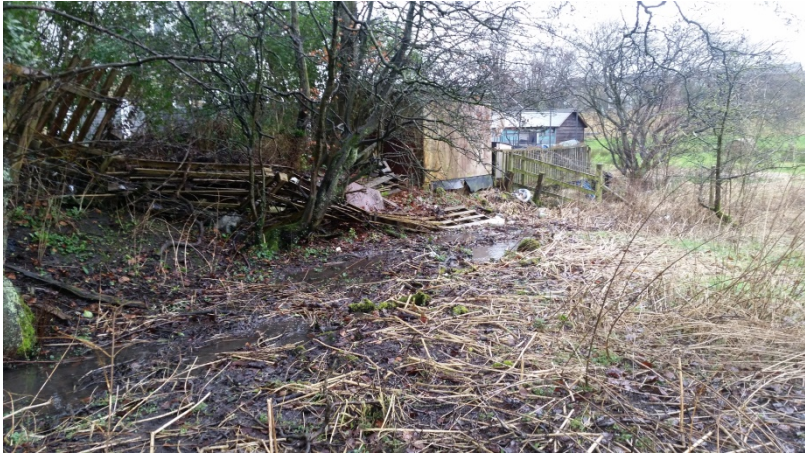
Himalayan balsam grows in the North West corner of the site.

- 6.2.5 Himalayan balsam is frequent within and adjacent to the North of the site. No other invasive or notable weed species listed on Schedule 9 (Section 14) of the Wildlife and Countryside Act (1981) (as amended) was identified within the site or adjacent land.

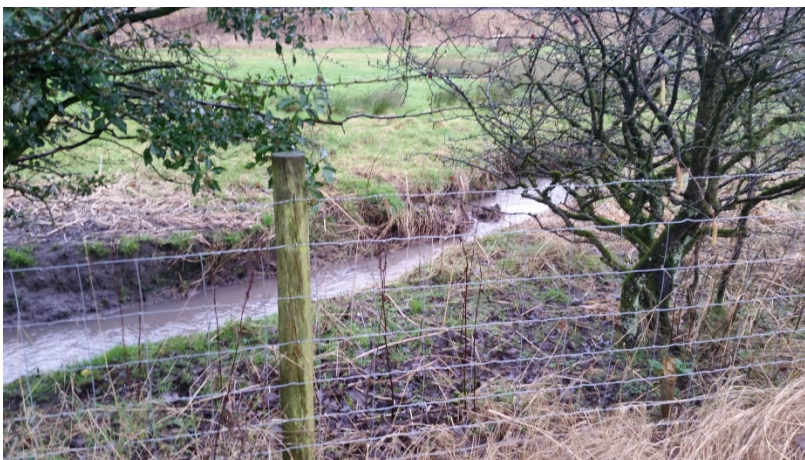
The stream on the North-west boundary.

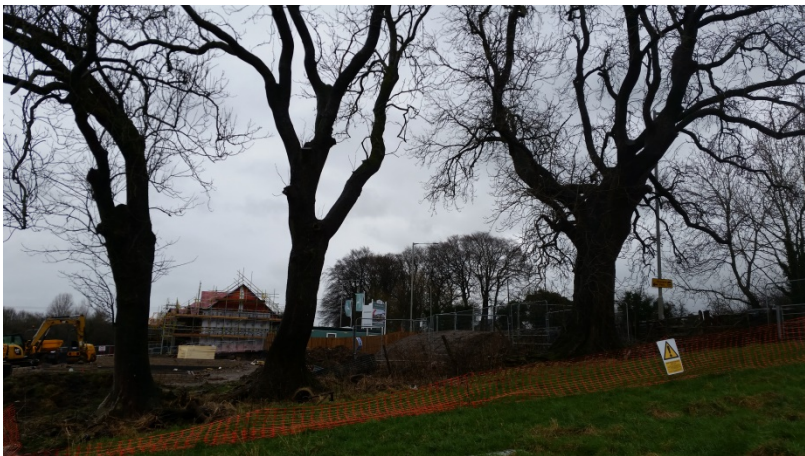
Standard broadleaf trees on the North East boundary.

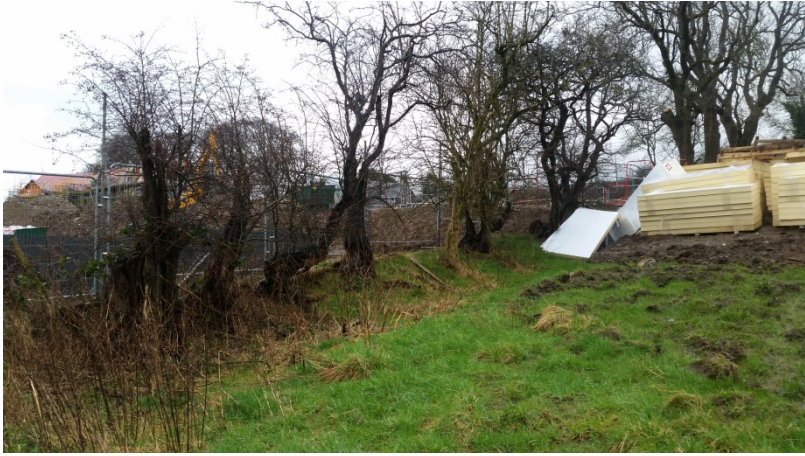
Defunct, species poor hedgerow in the North-east.

- 6.2.3 The defunct species poor hedgerow bounding the North-east of the site also has a low ecological value. It has no understory and has been significantly impacted by past livestock grazing. Should this hedgerow need to be lost, transplanting it is unlikely to be of ecological benefit. New native hedgerow planting would be suitable compensation for its loss and is likely to provide an ecological improvement in time. The hedgerow is not classified as important under the Hedgerow Regulations (1997) for its ecological value.

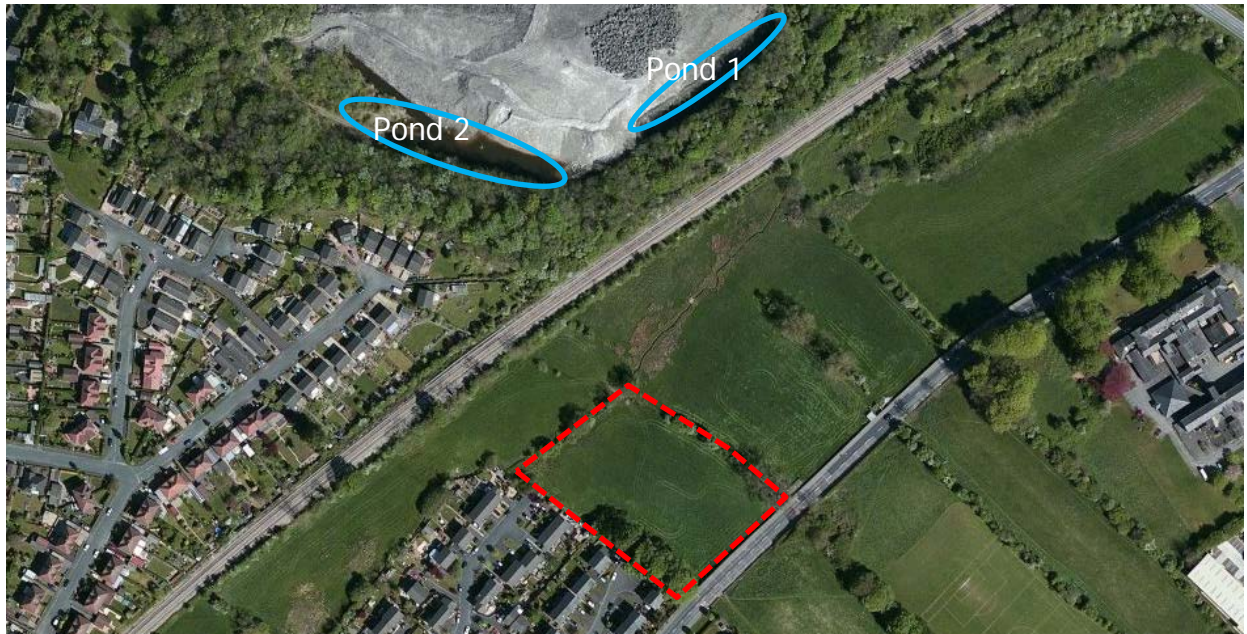
Figure 4 - Pond locations circled blue, site outlined red

- 6.3.2 No significant aquatic vegetation was recorded in either pond. As GCN lay their eggs on macrophytic vegetation, the lack of this would suggest the ponds would not be ideal for this species to breed. The habitat adjacent to Ponds 1 and 2 is comprised of dense scrub and deciduous woodland. This would provide potential high quality foraging, refuge and hibernation habitat for amphibians.

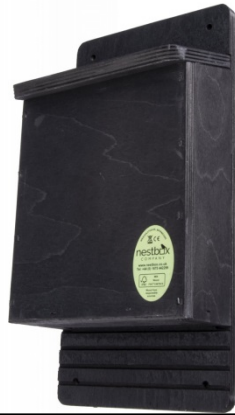
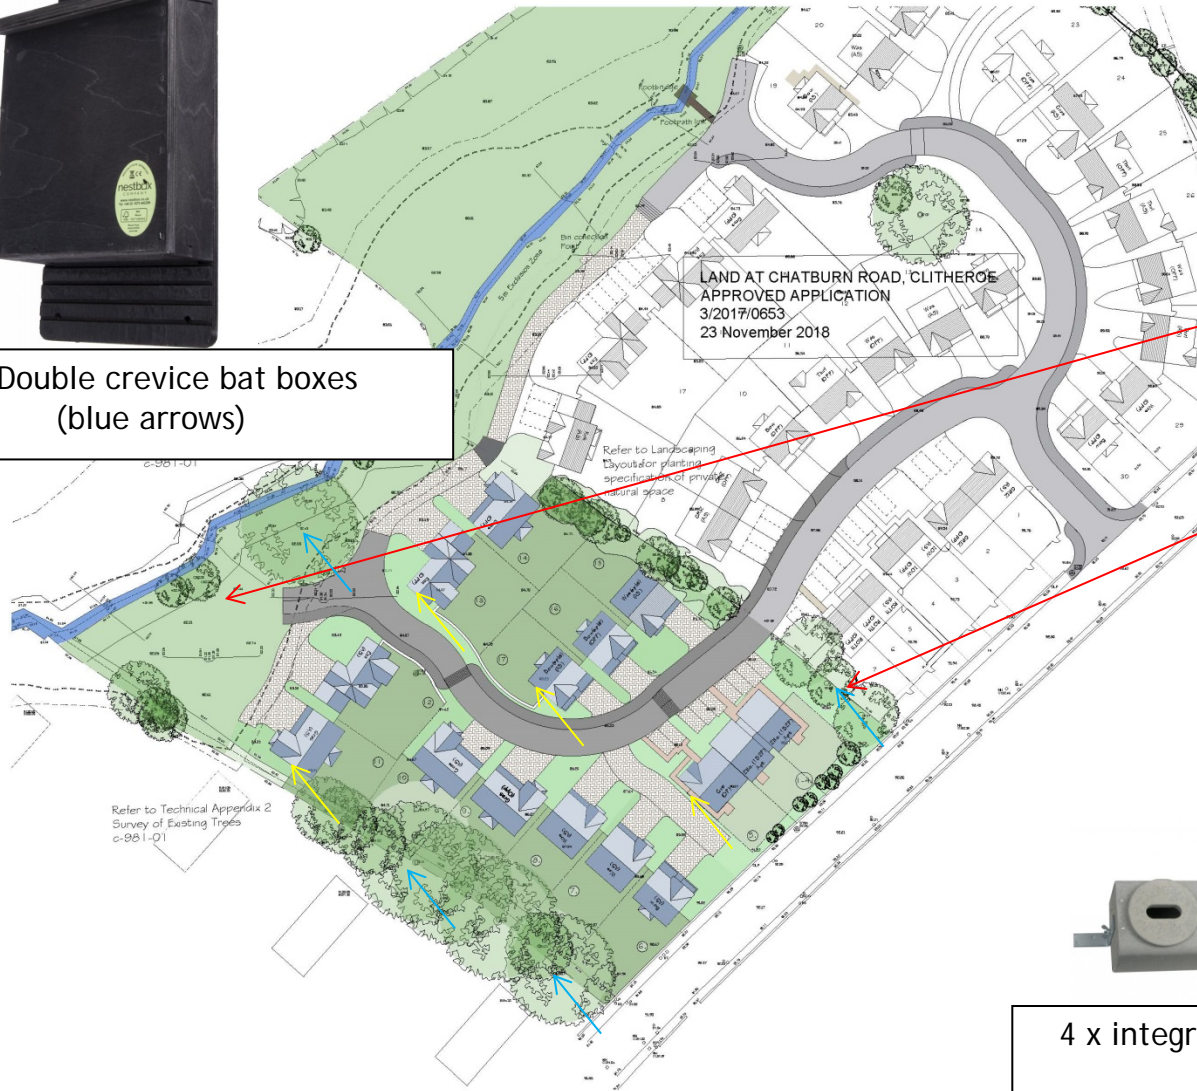
Figure 7 Proposed site Plan.

4 x Double crevice bat boxes
(blue arrows)

Open space to form a buffer between dwellings and stream
