# BARN AT MANOR HOUSE, HOWGILL LANE, RIMINGTON, LANCASHIRE

## Archaeological Building Recording

Client:  
Brent and Gillian Taylor

Planning Application Reference:  
3/2018/0036

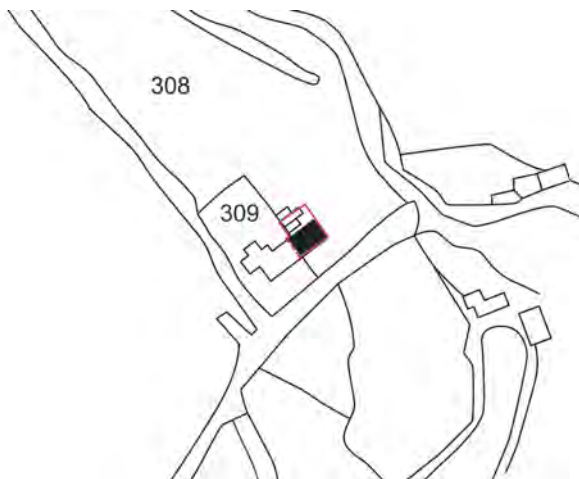
Plate 1: Extract from the tithe map for the Township of Rimington, 1846 (LRO PR 3432/3/7 1846a)

**3.1.2 Tithe Map, 1846:** the footprint of Manor House is shown in some detail on the tithe map (LRO PR 3432/3/7 1846) (Plate 1). The north-east end of the block is filled in and although small buildings appear to be marked to the north-west of that the large block to this side has yet to be built (cf. Plate 3). The land containing the main part of the building is labelled 309, which the accompanying schedule describes as a 'homestead' owned by 'Wilson & Remington' and occupied by Joseph Jackson (LRO PR 3432/3/7 1846a). The east end of the building, which includes the site, is part of plot 308, which is named 'Factory Croft', which is probably a reference to a building to the north that operated as cotton mill, and has the same owners and occupiers in the accompanying schedule (LRO PR 3432/3/7 1846b).

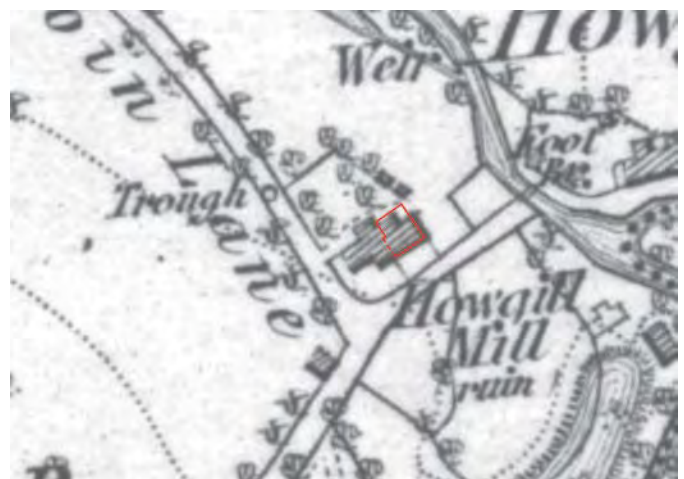
Plate 2: Extract from the Ordnance Survey map of 1853

**3.1.3 Ordnance Survey, 1853:** this map, surveyed in 1849, lacks detail (Plate 2) and is difficult to reconcile with both the earlier tithe map (cf. Plate 1) or later editions of the Ordnance Survey (cf. Plate 3). The tithe map and later Ordnance Survey maps more closely match each other, so it remains unclear which elements of the current buildings at Manor House are represented here; the depiction of Manor House is excessively simplified or possibly even out of scale (matching the size of the west end of the block of buildings to the earlier tithe map causes the barns to the east end of the block to be absent (which must be incorrect), whereas matching other nearby features to those on the later Ordnance Survey maps causes the west end of the building to be substantially oversized).

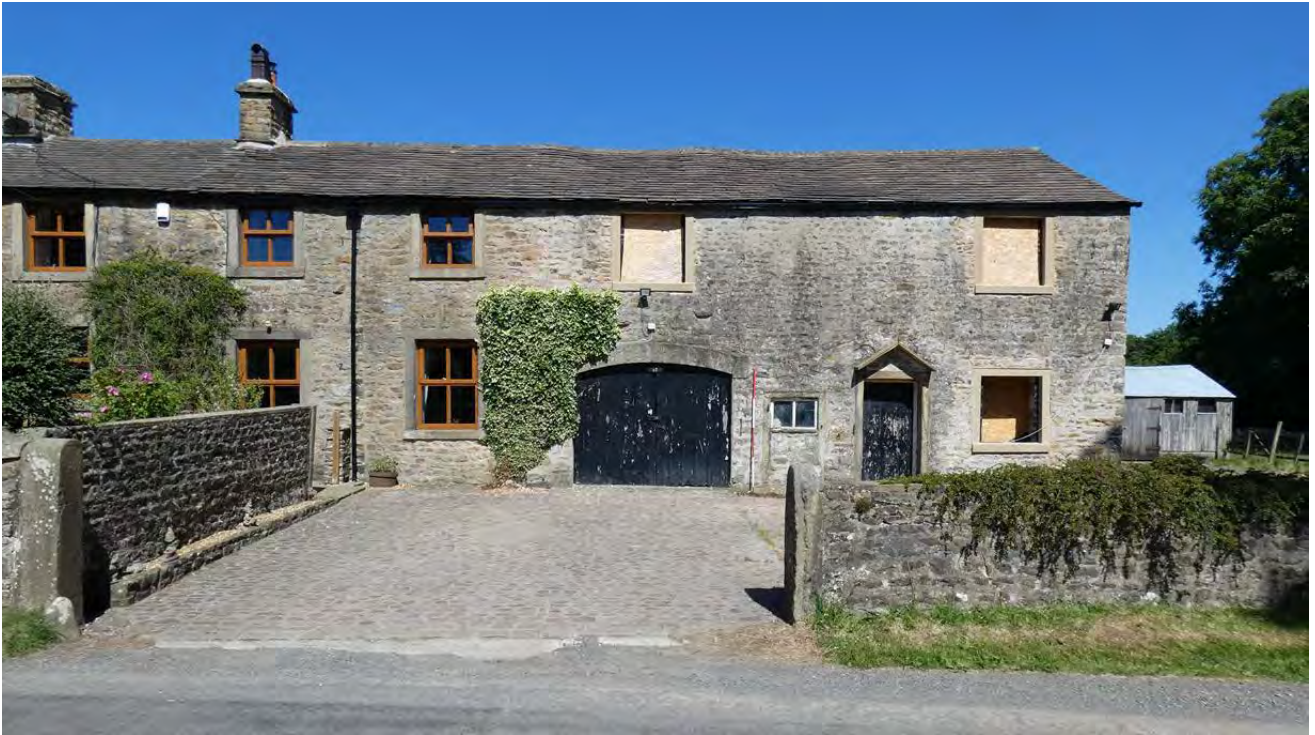
**Plate 5: South-east external elevation**

4.2.1 **South-east elevation:** the south-west end of the building comprising the current survey is overgrown with ivy (Plate 5). South-west of that is the client's home, which is separated internally from the storage areas to the north-east of the block and as such was not recorded. The elevation steps out a little to the south-east at this point to the south-west side of the large arched doorway, but this small 'plinth' does not continue beyond the arched doorway and is not apparent above the patch of vegetation. The doorway at this end has a stone voussoir arch and houses a timber plank and batten door (Plate 6). No quoins are evident in the jambs. To the north-east of that is a low-level door, with a sandstone surround, which has been partially infilled with stone and a two-light casement window at the top with a timber frame and stone sill (Plate 7). North-east of that is a second pedestrian door with a stone surround and gabled canopy above made out of two stone slabs. The plank and batten door has a timber frame. To the north-east is a large inserted window, with a modern concrete surround, and some concrete repointing is apparent. The surround has a sandstone effect, but there is no frame inside, and it is currently boarded over. Some larger cornerstones are apparent at the north-east end of the elevation. The first floor level of the elevation is fairly plain with two modern window surrounds inserted, one above the voussoir arch to the south-west and one above the window at the north-east end (Plate 6 and Plate 7; Figure 2), matching the large window aperture at the north-east end at ground floor level. The roof is slate, continuous across part of the residential part of the property to the south-west, with concrete ridge tiles.

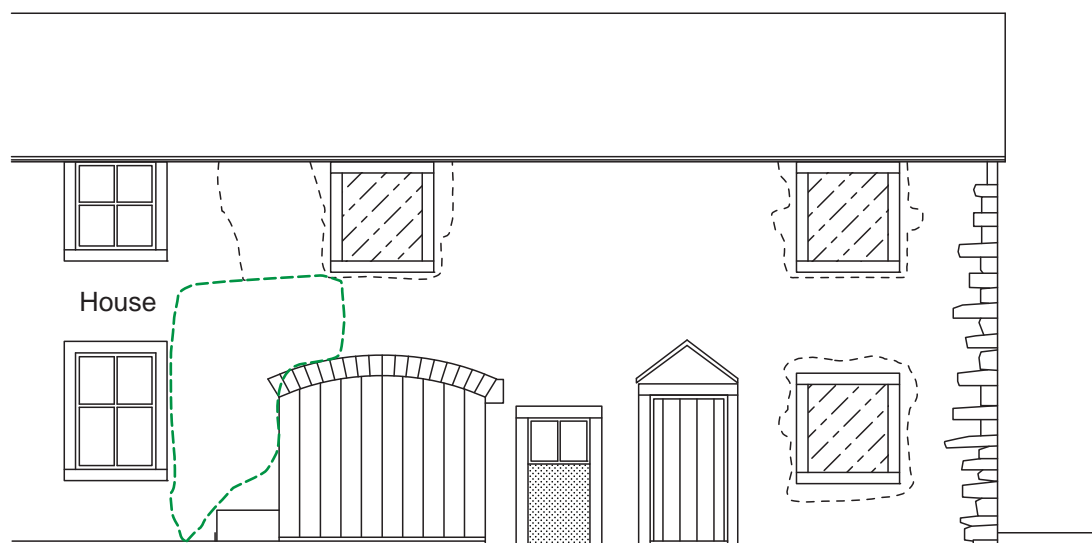
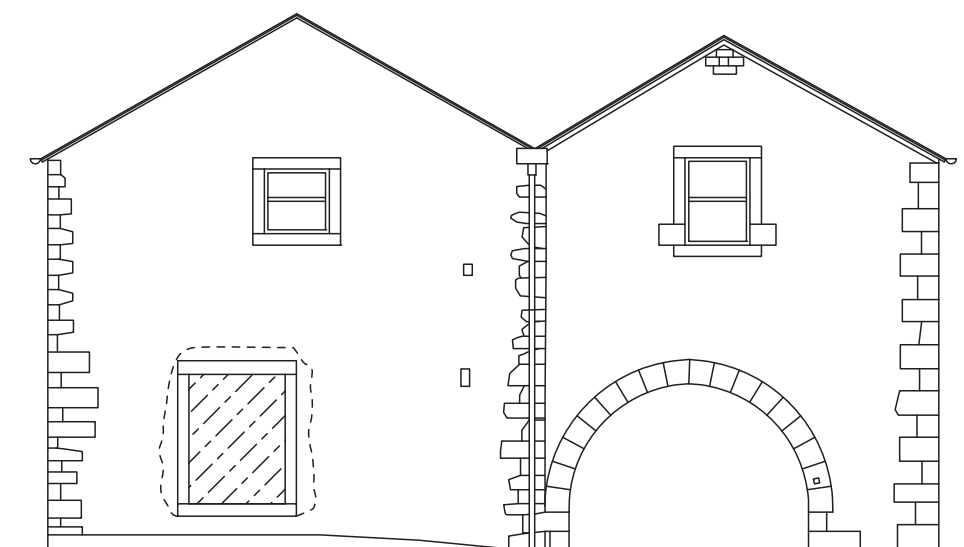
SOUTH-EAST EXTERNAL ELEVATION

4.2.2 **North-east elevation:** the north-east elevation is formed by two gable ends and there is a substantial amount of light coloured concrete repointing around the butt joint (Plate 8). The south-east gable forms the gable end of the main south-west/north-east block, which is butted by the gable end of the office and storage space to the north-west. Large cornerstones are apparent at both ends of the south-west gable end (partially hidden by the drain water goods, slightly north-west of centre) and larger, squarer, dressed quoins are apparent at the north-west end of the elevation (Plate 11; Figure 2). There is a large opening inserted at ground floor level to the south-west end with a sandstone-effect concrete surround and some concrete repointing apparent, though the opening does not have a frame in place yet and it is boarded over at present (Plate 9). Above that, at first floor level, there is a two-light hinged timber casement window with a timber frame and stone surround approximately centred below the ridge of the gable (Plate 9) and there is some concrete repointing below the eaves to the north-west. Some red brick is apparent to either side of the window, presumably infilling earlier vents in this end of the barn, and close to the north-west end of this section there are two vent slots to the south-east side of the area of light-coloured repointing. There is a large voussoir stone arch at ground floor level in the gable to the north-west (Plate 10 and Plate 12). It does not have a door attached and there are what look to be wall stubs just inside either end of the archway comprising brick and stone (Plate 13 and Plate 14). Above that is a two-light hinged casement window with a timber frame and stone surround made from several pieces, and there is an owl hole above that below the ridge and some concrete repointing below the eaves (Plate 10).

- the large inserted window surround at ground floor level at the north-east end of the south-east elevation (to G2) replaced a smaller six-light hinged casement window of a similar size and height to the one at the top of the infilled doorway to the south-west on the same elevation (Figure 2; cf. Simple Ecology Limited 2017, plate 1);

- the large opening inserted at ground floor level to the south-west end of the north-east elevation (to G2) replaced a four-light timber-framed window on this side (Figure 2, cf. Simple Ecology Limited 2017, plate 1);

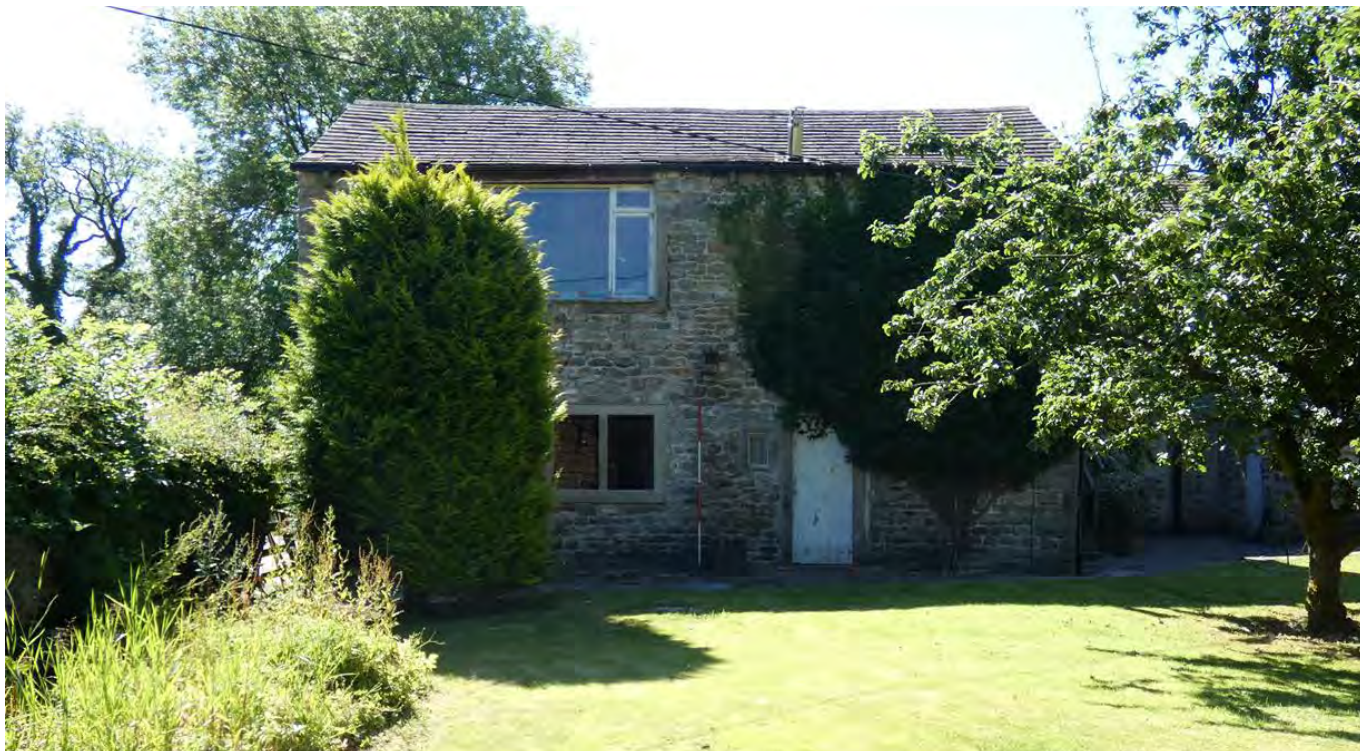
**Plate 15: North-west external elevation**

**4.2.3 North-west elevation:** this elevation, which faces the garden to the rear, is exposed stone (Plate 15), as are the others, and there are dressed quoins at either end (Figure 3). At the north-east end there is a large window inserted at ground floor level with a sandstone-effect concrete surround (Plate 16). It is divided into four sections but does not have any casements inserted yet and there is some concrete repointing visible in the stonework externally. Above that at first floor level is an equally wide window. The modern five light hinged casement window it houses has a timber frame and the surround is made from several mismatched pieces of stone with an incomplete slate sill (Figure 3). South-west of that at ground floor level is another single light window with a timber frame and frosted glass within a stone surround and to the south-west side of that is a plank and batten door with a stone surround (Plate 17). There are stone steps with a timber rail to the south-west end of the elevation (Figure 3; Plate 18).

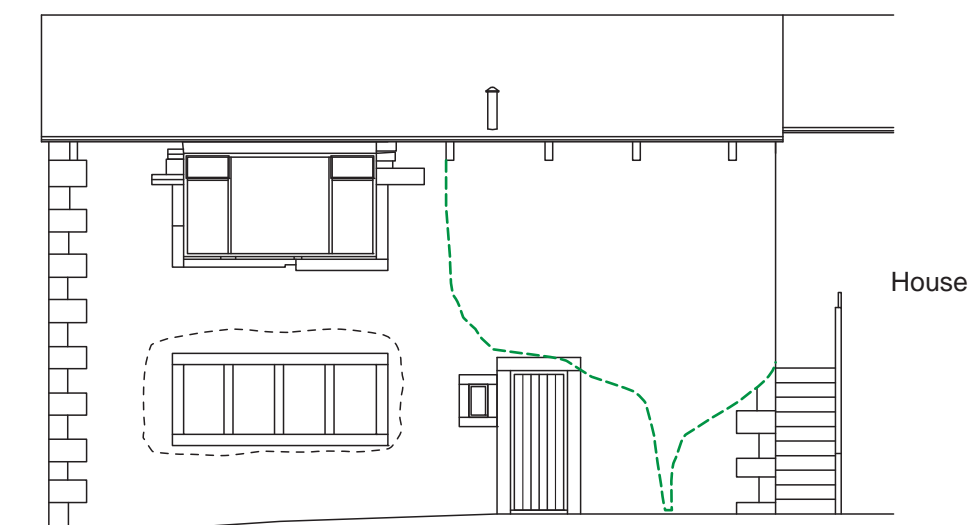
**Figure 3: North-west and south-west external elevations**

4.2.4 **South-west elevation:** the south-west elevation forms the gable end of the office and store and is exposed stone (Figure 3). It butts against the house at the south-east end (Plate 20) and there are stone steps against the elevation up to the first floor at this side (Plate 18). The roof of the office sits slightly higher than the gutter line of the house. The door at the north-west end has a stone surround and plank and batten door on long strap hinges and a timber frame and there is a single light window to the south-east of that with a fixed timber casement (Plate 19). Dressed quoins are visible at this end of the elevation, though these are hidden by vegetation above door level. The steps up to the first floor are to the south-east of the window and go above another plank and batten door with a stone surround against the house at ground floor level (Plate 21). The space below the stairs is hollow (Plate 22). At first floor level there is a four-light hinged casement timber window set within a stone surround (Plate 23) and the steps at the south-east end lead to a two-panel timber door with a timber frame within a stone surround (see Plate 18). The ridge purlin protrudes below the roofline and there is some concrete repointing below the eaves.

- it is unknown if the newly inserted window at ground floor level on the north-west external elevation (to G3) replaced an earlier opening as this side of the building was not photographed as part of the bat survey (Figure 3).

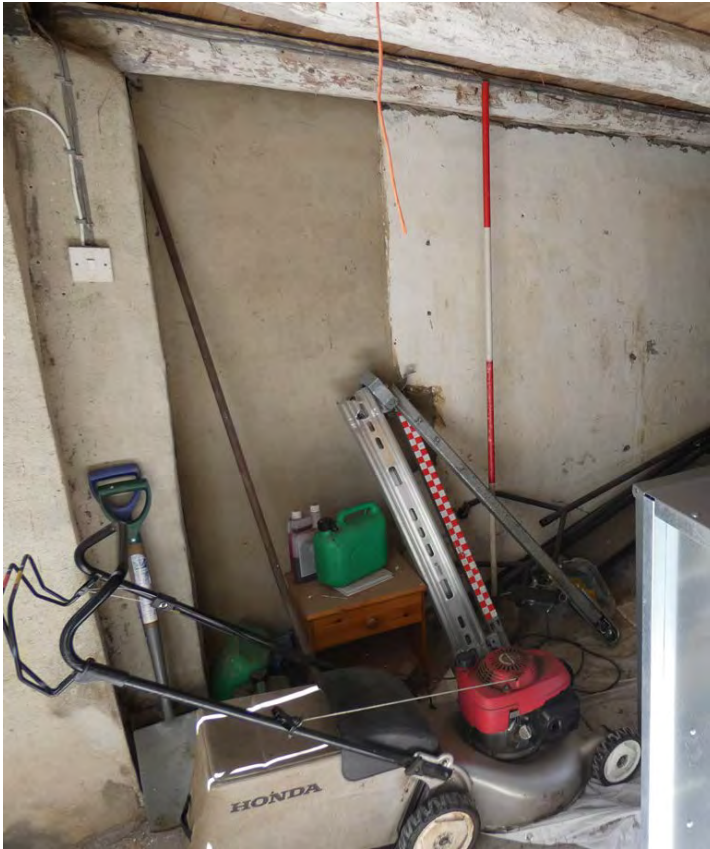
**Plate 24: South-east end of the south-west elevation**

4.3.1 **Ground floor Room 1 (G1):** despite being effectively part of one large room, comprising both G1 and G2, this room is divided from G2 by a low partition wall and can only be accessed from a doorway in the south-east elevation. The south-west elevation is finished with smoothed concrete and painted with a blocked door at each end (Plate 24 and Plate 25). The doors have been concreted over, leaving a slight recess, and are unpainted. The north-west elevation is plain painted concrete to the partition wall. The partition, which is about mid-height, is made from modern brick, which are exposed along the top course, and is painted. The south-east elevation is dominated by the large, wide stone voussoir arch above the broad plank and batten door. The floor is concrete, but mostly covered with stored items. The ceiling above comprises various roughly-hewn timber joists and above that some narrow, modern timber floorboards. There is also an iron girder below the ceiling to the inside of the arched doorway to the south-east side of the room.

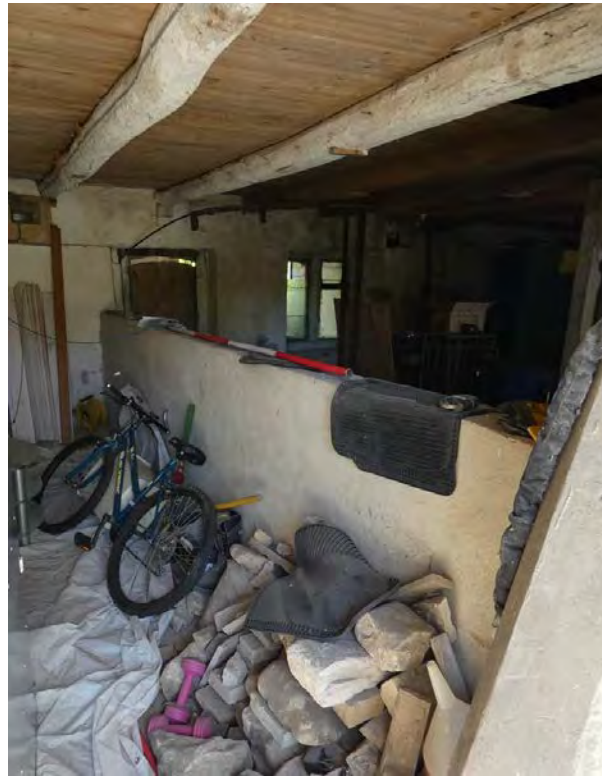
**Plate 27: Low partition wall between G1 and G2**

**4.3.2 Ground floor Room 2 (G2):** this room and G1 are effectively form one larger room which is divided by a low partition wall. The walls in G1 and G2 appear to be smooth-finished concrete and painted and are continuous across the partition which is a later insertion (Plate 28). There is a door in the north-west elevation immediately to the north-east side of the dividing wall separating G1 from G2. It is the interior side of the doorway with quoins in the jambs and a stone doorhead from G3, and it is recessed slightly, but little of the detail of these is visible from this side as it is obscured by concrete render and painted (Plate 28 and Plate 29; see also *Section 4.3.3*). The plank and batten door, which looks to be a replacement rather than original to the surround, is in a timber frame. The concrete floor slopes down to the base of the door at this point, the ramp being as wide as the doorway (Figure 4). North-west of that is a stone mullion window with a splayed surround. The windows are frosted panes of glass, with one light to the south-west side and two to the north-east, within timber frames (Plate 29). Two small jutting pieces of stone were noted to this side of the room: one above the old doorway, below one of the joists (Plate 29), and one slightly lower, near the top of the window on its north-east side (visible to the left in Plate 30). The north-east end of the elevation and the north-west end of the north-east elevation are plain (Plate 30). To the south-east side of the north-east elevation is a large recently inserted modern doorway, with brick in the surrounds and concrete blocks forming the threshold (Plate 31). Externally the doorway has a sandstone-effect concrete surround, like all the newly inserted window and door openings, but it is boarded over on this side. The doorway lines up with the former dung channel at this end, which has a gridded pattern in the concrete at its base (Plate 31). There is a recently inserted window at this end of the south-east elevation which has the same style surround as the doorway to the north-east and also has modern concrete blocks in the jambs (Plate 32). The doorway to the south-west of that is in line with the gridded dung channel (Plate 32 and Plate 33). The door is a plank and batten door with long strap hinges in a timber frame and with a stone lintel, and the window to the south-west of that is a two-light fixed casement with a timber frame, the lintel and surrounds of which are obscured internally (Plate 33). The south-west end of the room is partitioned from G1 by a low brick wall, which is painted (Plate 34). There are traces in the concrete to the north-west side of the room where the stalls presumably once were (Figure 4). The ceiling is a mix of rougher older joists and more modern machine-cut replacements most notably to the north-east end (Plate 28, cf. Plate 33) and the narrow floorboards above are also likely to be fairly modern. Access to the floor above is currently via a hole in the ceiling accessed by a set of steep timber stairs to the south-east side of the room.

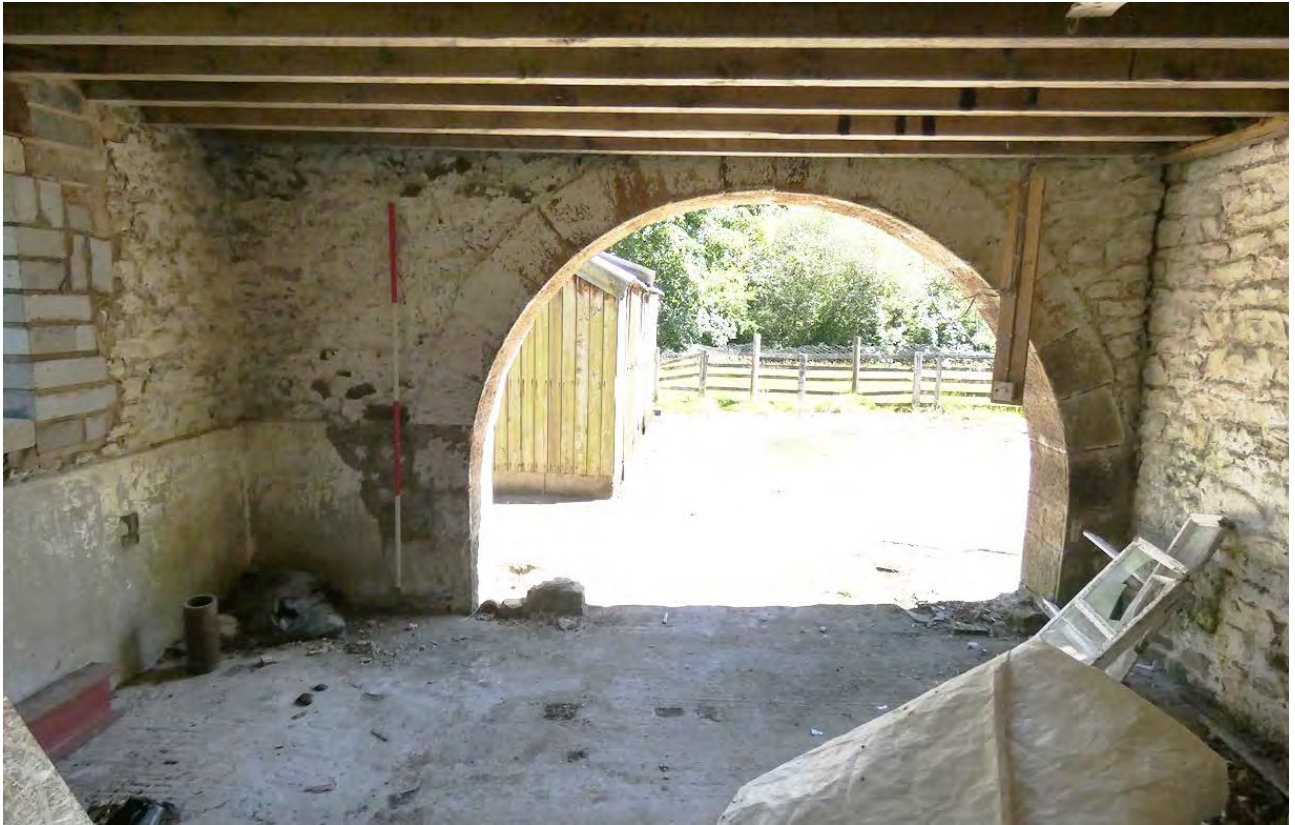
**Plate 35: North-east elevation of G3**

**4.3.3 Ground floor Room 3 (G3):** the ceiling comprises modern timber floorboards and machine-cut joists and the walls are a mix of red brick and concrete and stone and white lime mortar and concrete skim. There is a partial skim of concrete on the lower part of the north-east elevation to the north-west side of the large stone archway and there are quoins to the base and there are two possible wall stubs internal to the arch which are a mix of stone and brick (Plate 35). Above the concrete skim and to the south-east side of the arch the wall comprises exposed stone and white lime mortar and the north-east elevation butts the south-east elevation, which would previously have been an external wall. It is all stone and white lime mortar and plaster (Plate 36 and Plate 37). Close to the centre is a stone mullion window housing timber framed windows with frosted panes and to the south-west of that is an early doorway with stop-chamfered stone jambs and a false four-centred arched head with a two-part joggled lintel, which is also chamfered to match the jambs (Plate 37 and Plate 38). The doorway looks to be original to the barn, although the plank and batten door is probably a replacement albeit reusing the long strap hinges. The south-west elevation is mostly exposed stone with a concrete skim to the north-west side and the north-west end is obscured by a red brick-built rectangular partition (Plate 39). There is a boarded window to the south-east side of the elevation with a timber frame (Plate 40) and a concrete skim to the north-west of this which continues around the partition and along the north-west elevation (Plate 39). To the north-east of the brick partition there is a wide window with a modern sandstone-effect concrete surround and no window casements as of yet (Plate 41). There are concrete blocks in the jambs, which project slightly on the south-west side, and there is a girder above. The floor is concrete with some small holes in it but it is unclear what these related to previously: whatever they related to has been removed.

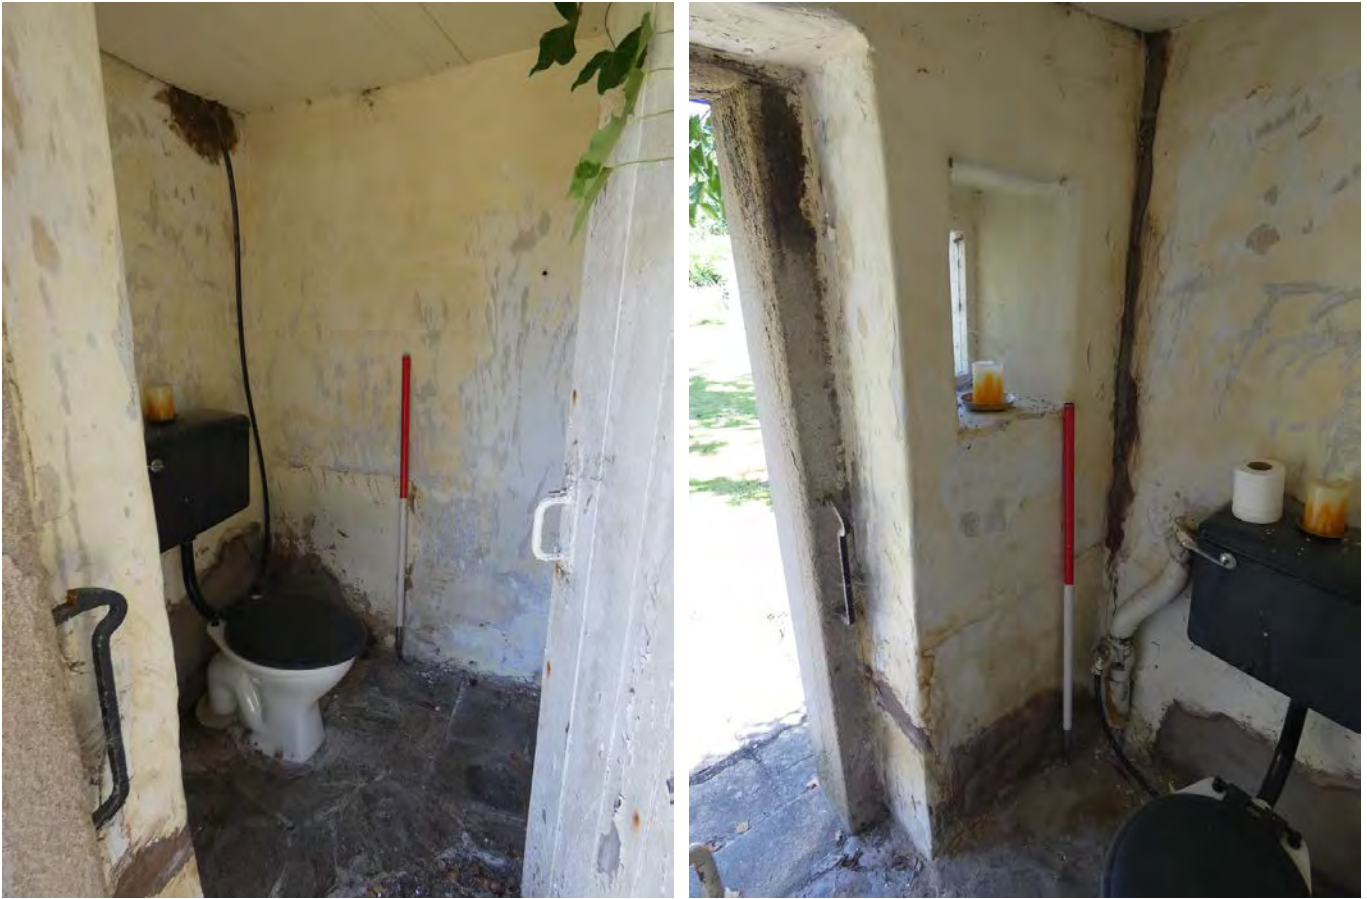
**Plate 42 (left): General view of the east end of G3a**

4.3.4 **Ground floor Room 3a:** this room is partitioned from the rest of G3 by a modern brick wall, which is a later insertion. This has provided space for a toilet. The room has a stone floor and the walls are plastered and painted and the paint is peeling. The walls and ceiling are plain. The door in the north-west elevation is a plank and batten door on strap hinges and recessed slightly and the single-light window to the north-east of that is a fixed timber casement with frosted glass and the jambs are splayed slightly inside.

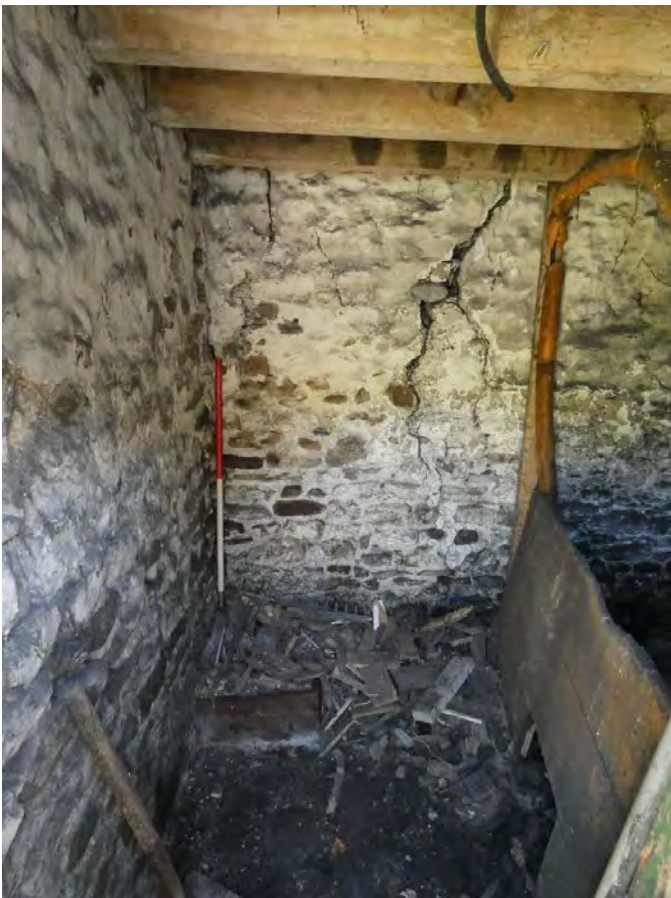
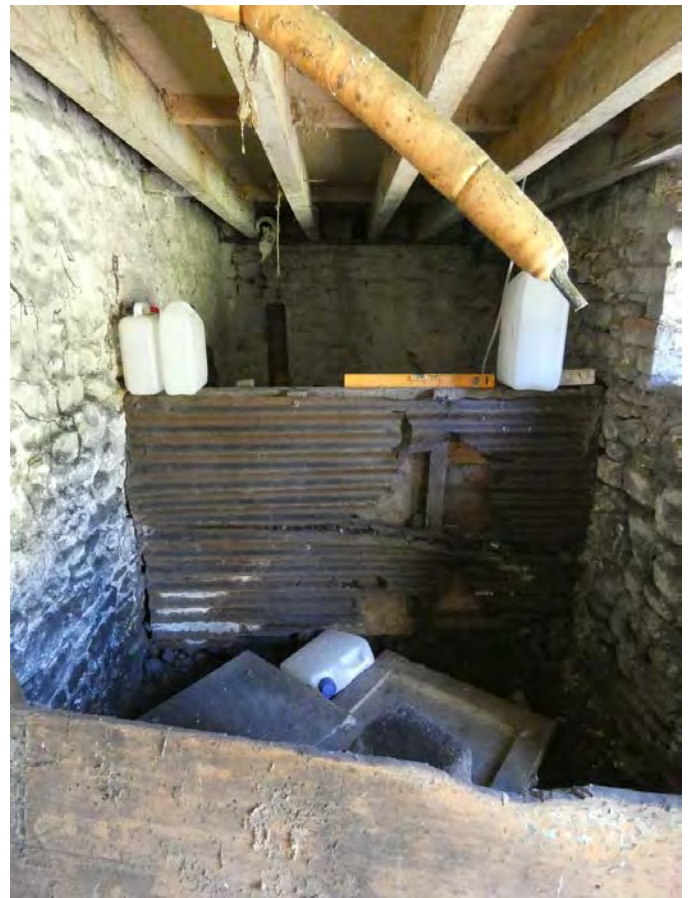
**Plate 45 (left): North-west end of the north-east elevation of G4**

**4.3.5 Ground floor Room 4 (G4):** the walls in this room all have a white lime plaster applied over the stonework (**Plate 45**). The ceiling is modern fibreboard above machine-cut joists. It was presumably originally a calf pen, then a coal store, and has most recently been used for storage. There is a low-level brick partition in the north corner (**Plate 45**) and the timber and corrugated metal sheeting dividing the room now most clearly relate to when it was a coal store (**Plate 46**). The north-west elevation is plain. The north-east elevation, dividing this end of the building from G3 to the north-east, is possibly a later insertion to the building, and there is a boarded window or hatch at the south-east end forming a small alcove (**Plate 47**). The south-east elevation would have been an external wall prior to the addition of the building to this side (**Figure 4**) and there is a narrow partially blocked vent slot to the north-east side (**Plate 48**). The vent slot is blocked to the other side (to G1) and was not apparent from that side. The south-west elevation butts the south-east elevation and the door at this end has a stone surround and plank and batten door with a stone lintel (**Plate 21**). The door to the north-west end has stone jambs and lintel and a plank and batten door and timber frame (**Plate 19**). The fixed casement single-light timber-frame window in between has a stone surround externally and a stone lintel (**Plate 19**), but brick has been used more extensively in the jambs and sill on the inside (**Plate 49**).

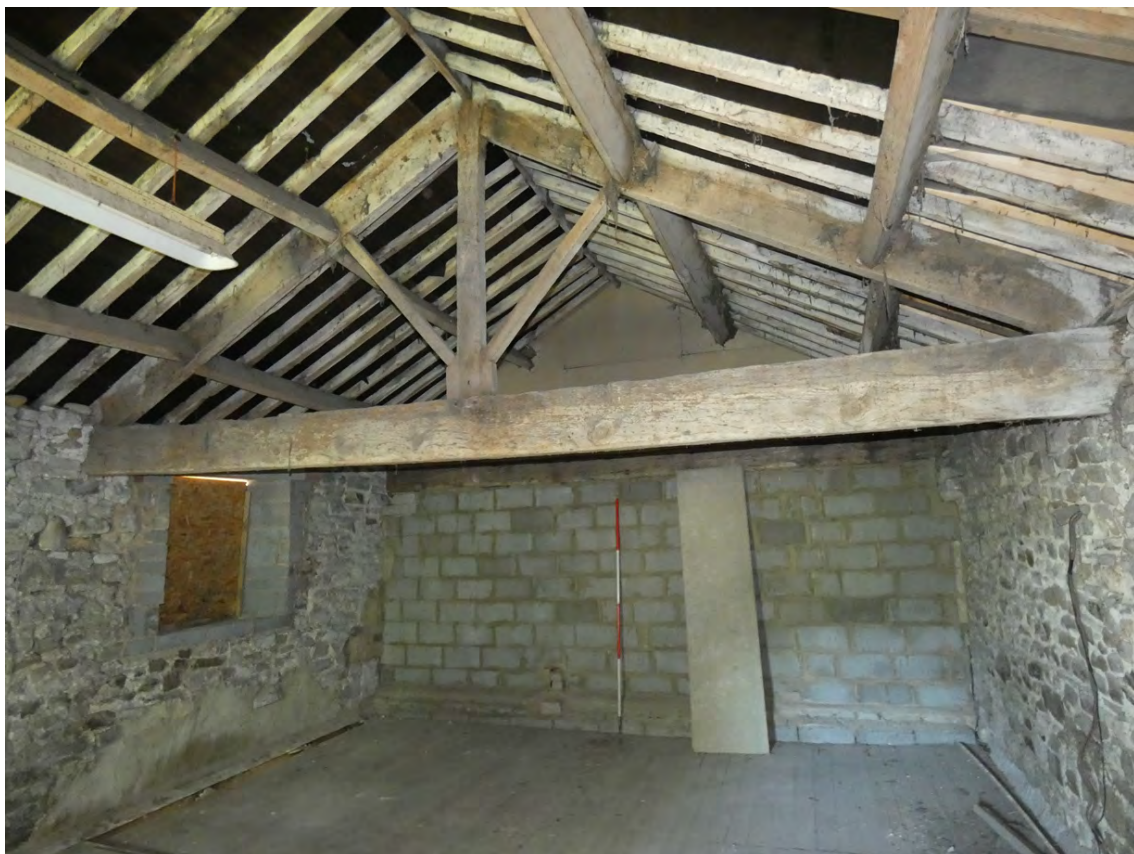
**Plate 50: North-east face of the south-west truss in F1**

**4.3.6 First floor Room 1 (F1):** there are two north-west/south-east aligned truss across the room and the tie beam of a third truss is visible in the south-east elevation. The open trusses are both suspended king post trusses with braces either side on sloping joggles, supporting a central ridge plank and two purlins per pitch (Plate 50 and Plate 51; Figure 6). The purlins are all machine-cut but the chamfered tie beams are probably older, and there are also some modern timbers inserted on the north-west side above the wall. The north-east truss is marked '742' to the south-east side on the north-east face (Plate 52), probably part of a Baltic timber mark, and there is an 'x' near the centre (Plate 53). The truss to the north-east side of the room also have a carpenter's mark 'II' on the tie-beam and king post on the south-west face (Plate 54), and the open truss to the south-east is marked 'I' on the south-west side of the tie-beam and king post (Plate 55). The slates of the roof are backed with sheet material above the modern machine-cut rafters. The walls are mostly exposed stone and white lime mortar with some later concrete block and red brick insertions with some concrete repointing. There are three low-level vent slots in the north-east elevation, including one below the window, each with a stone lintel, all of which have been blocked. The central window on this elevation is a two-light hinged timber casement with a stone lintel and sill (Plate 56). There is another broad stone above that, which was possibly once also a lintel, and there are additional vent slots either side at the height of the top of the window. The one to the north-west is open to the outside. The south-east elevation is plain stone with two modern windows inserted, each with a concrete lintel and concrete blockwork and some red brick in the splayed jambs (Plate 57 and Plate 58). The surrounds to the outside are sandstone-effect concrete but there are currently no window casements and both openings are boarded inside. The tie-beam of a third truss is visible in the south-west elevation (Plate 59), above which the elevation is boarded and below which it is infilled with concrete blocks and some brick near the centre. The north-west elevation is plain (Plate 60). The narrow floorboards are fairly modern and there is a hatch on the south-east side to the south-west of a large opening to the floor below.

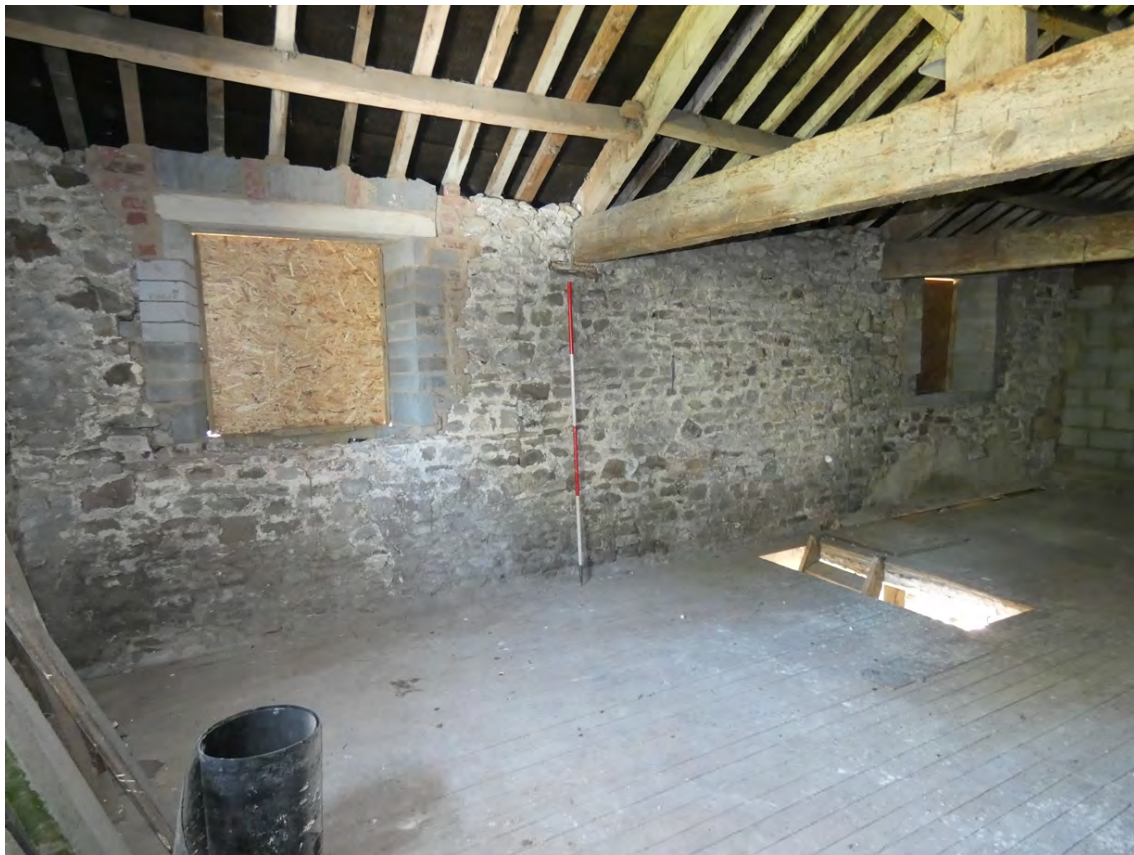
**Plate 57: North-east end of the south-east elevation of F1**

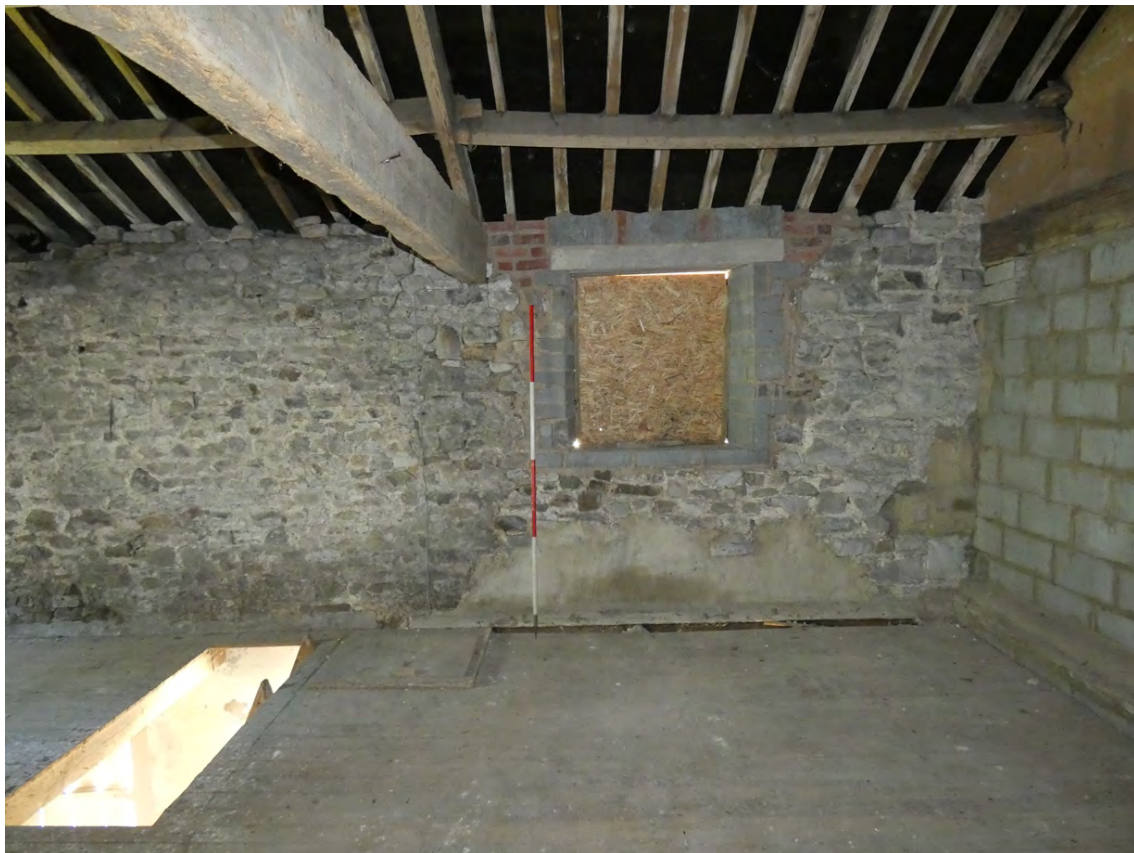
**Plate 58: South-west end of the south-east elevation of F1**

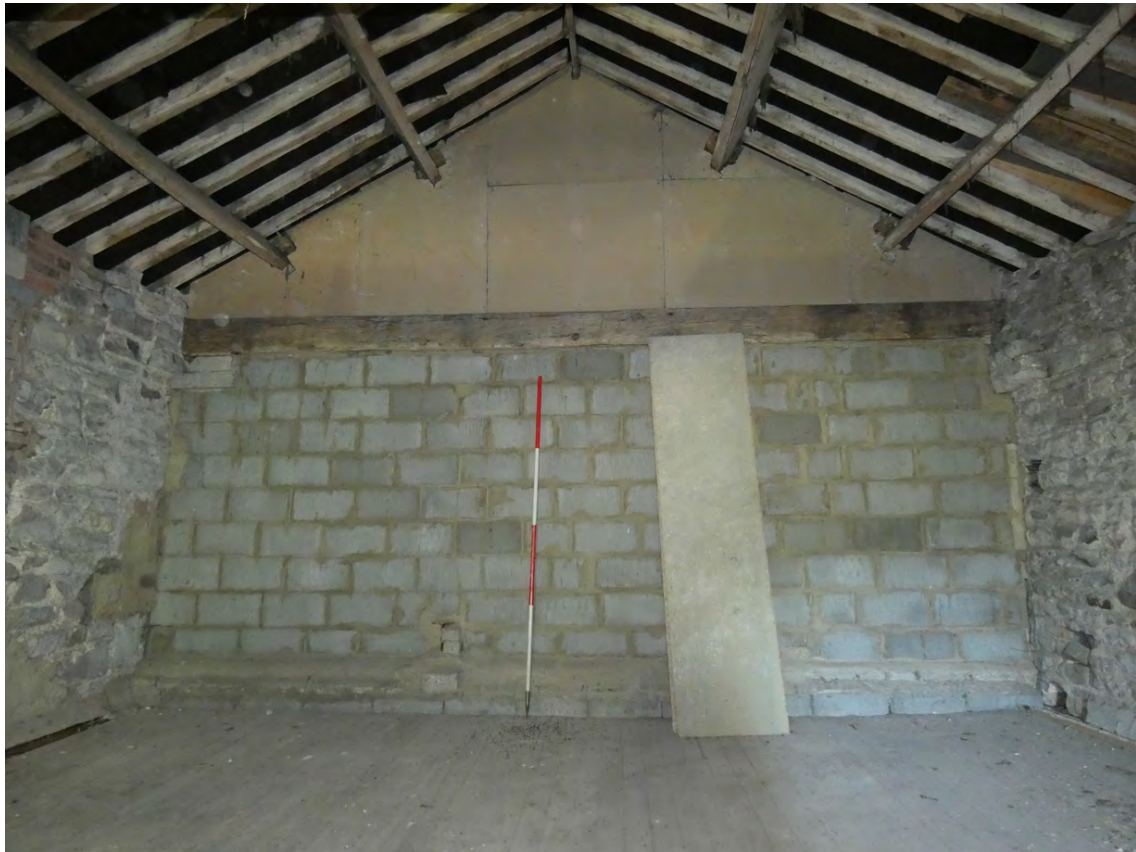
**Plate 59: South-west elevation of F1**

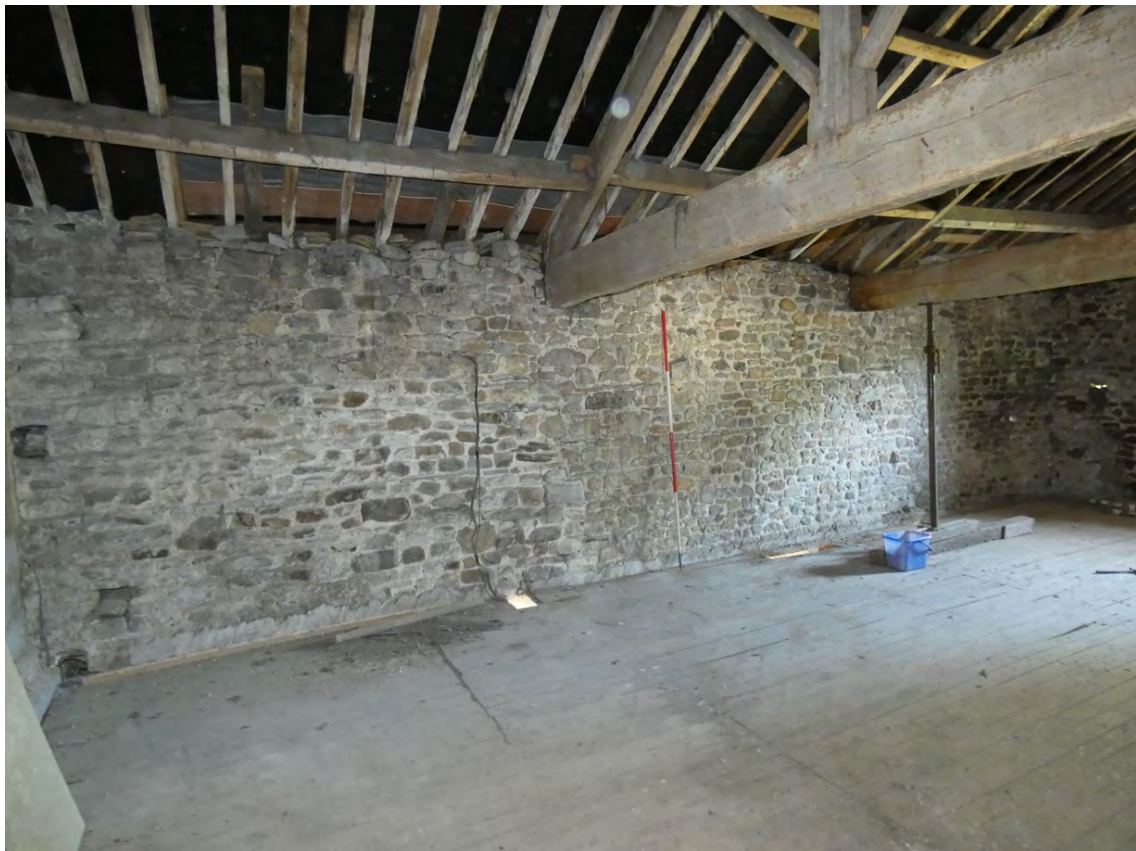
**Plate 60: North-west elevation of F1**

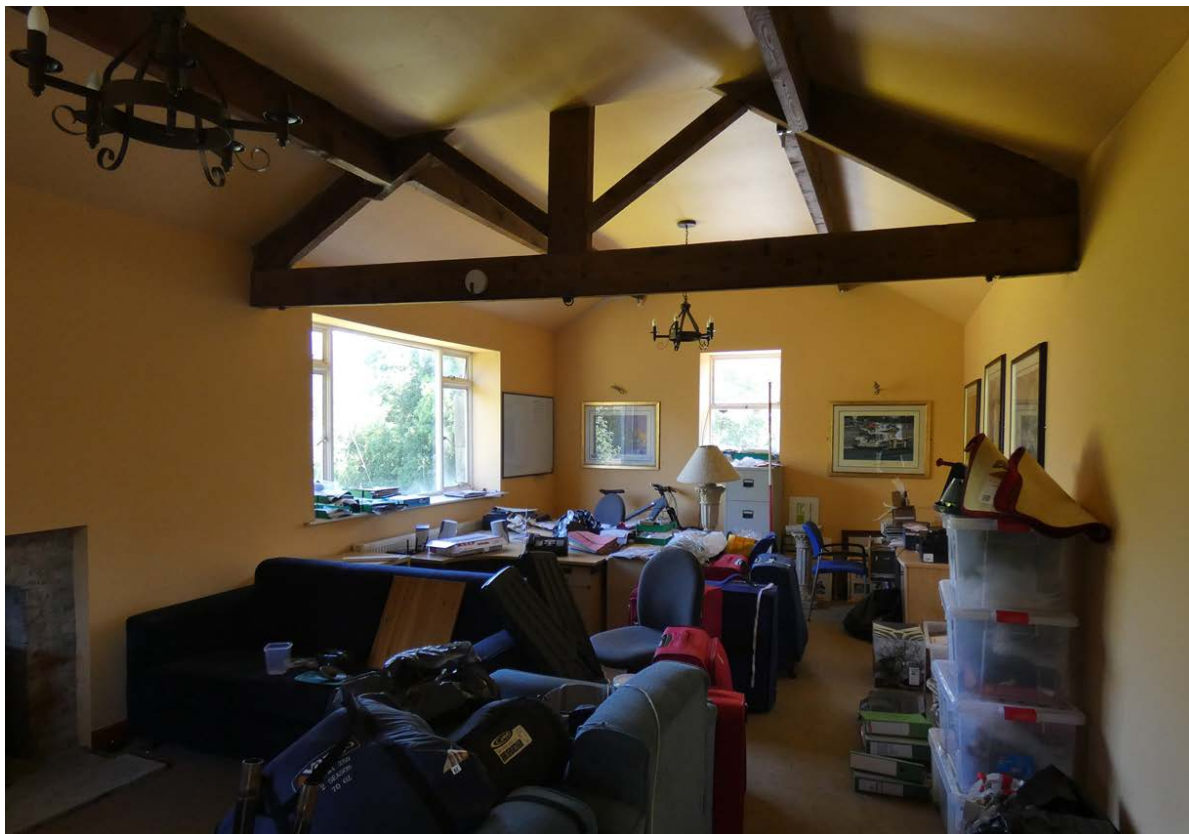
**Plate 61: General view of the north-east end of F2**

**4.3.7 First floor Room 2 (F2):** this room has been converted for use as an office and storage space. The walls are finished with smooth plaster and painted (Plate 61 and Plate 62). The floor is carpeted and there is modern skirting throughout. The windows are all modern hinged opening timber casements with timber sills and frames. There is a central suspended king post truss, with angled braces on sloping joggles and one purlin per pitch, the top section of which is obscured (Figure 6). The walls are plain and there is a fireplace to the south-west side of the north-west elevation with a brick surround, stone hearth and a wood burner (Plate 63).

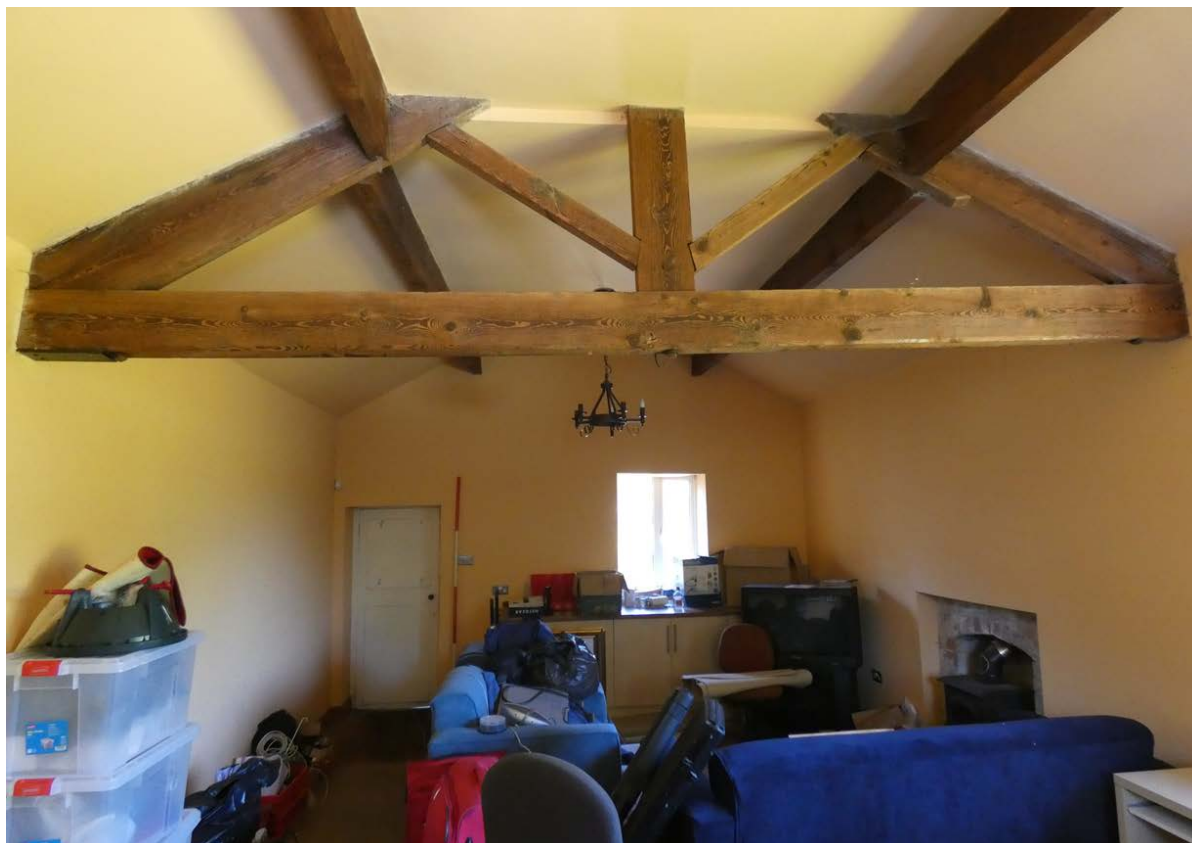
**Plate 62: General view of the south-west end of F2**
