**Siddows Hall, Henthorn Road, Clitheroe,  
Lancashire, BB7 3BY  
Bats: Building Inspection & Activity Surveys**

**Simply Ecology Limited**

**Ref: SE/ PDO001&2 /01**

**June 2020**

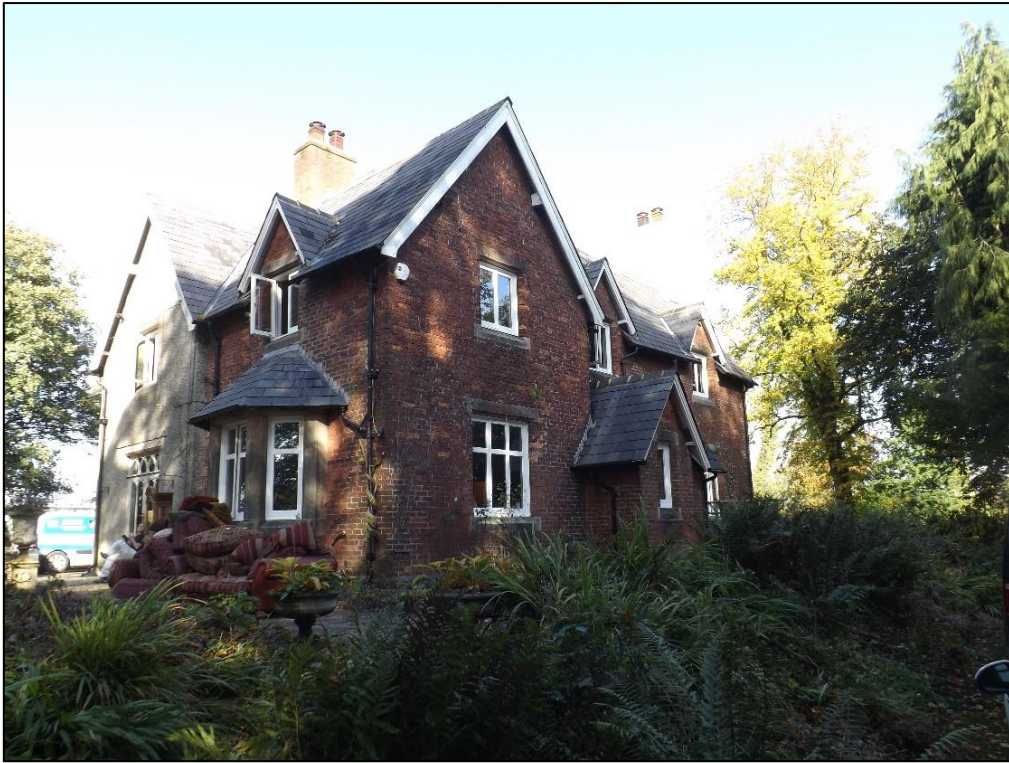
*Plate 1: Overview of the dwelling*

- 3.2.1 The survey began by checking the overall condition of the building structure. The building had a complex hip and valley slate roof with multiple features (see Plate 1). The walls consisted of a mixture of exposed brick and rendering, which was largely in good condition.

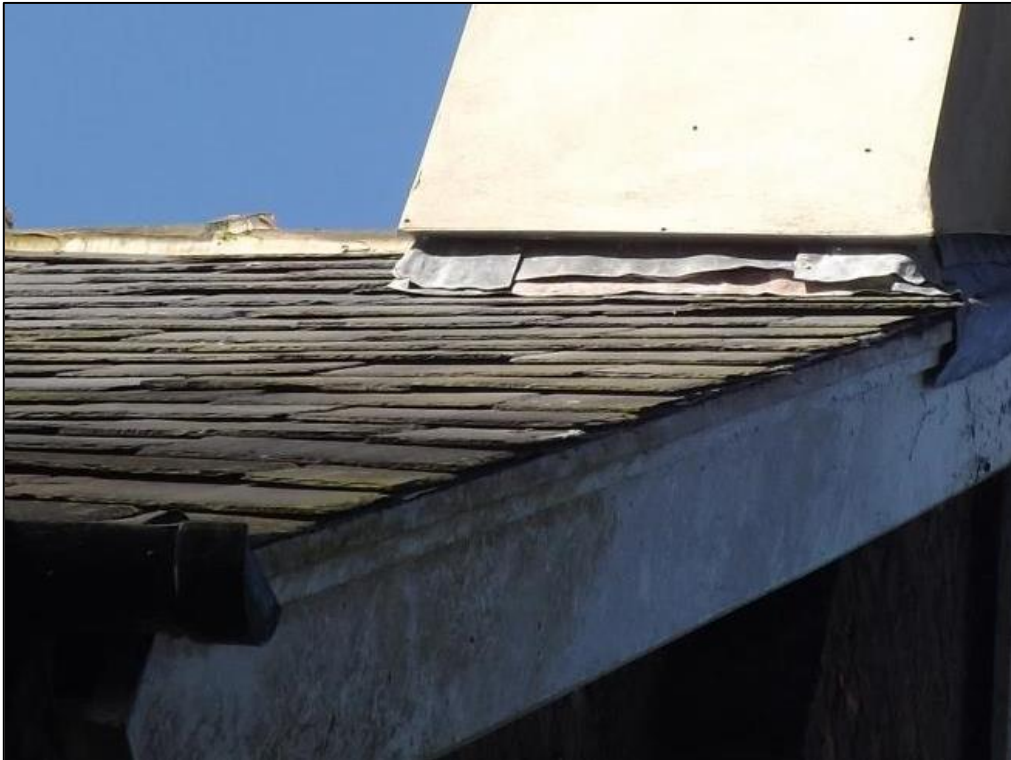
- 3.2.2 The roof inspection revealed multiple gaps beneath slate roof tiles all across the building, which were considered suitable for bats to gain entry into the loft space. Potential access points were also identified beneath the lead flashing surrounding the rendered white chimney breast, which bat droppings were visibly adhered to (see Plate 2). Gaps were evident along the gable end roof verges and particularly beneath the end ridge tiles. Numerous bat droppings were observed upon the fascia boards directly beneath these features, which suggested these were well-used entry point for bats (see Plate 3).

*Plate 2: Multiple gaps were visible beneath the roof tiles of the building and around the lead flashing surrounding the chimney. Bat droppings were also visibly adhered to the chimney breast.*

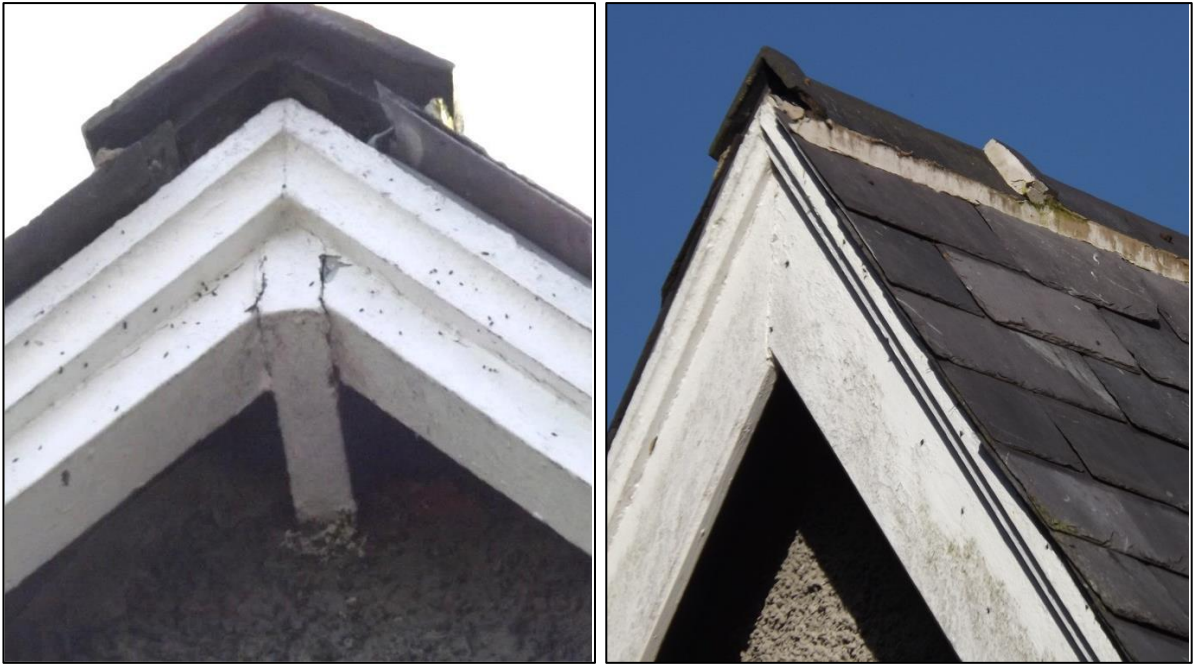
*Plate 3: Numerous bat droppings were observed on fascia boards beneath the gable end ridge tiles.*

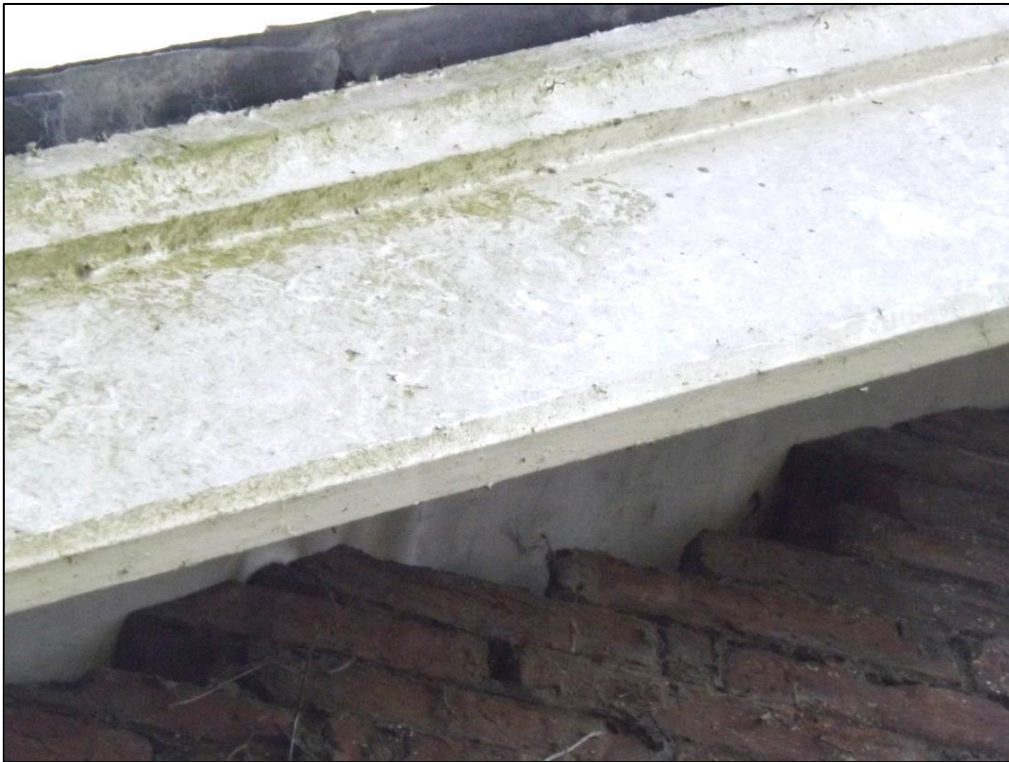
- 3.2.3 The brick walls of the building were generally well sealed; although gaps were present on the wall plate at the gable ends of the building (see Plate 4). Further cracks and crevices were also visible around the exposed roof purlins (see Plate 5). These were considered suitable for bats to gain entry into the roof space of the building.

*Plate 4: The brickwork along the wall plate was not tightly fitted and contained a number of gaps suitable for bats to utilise.*

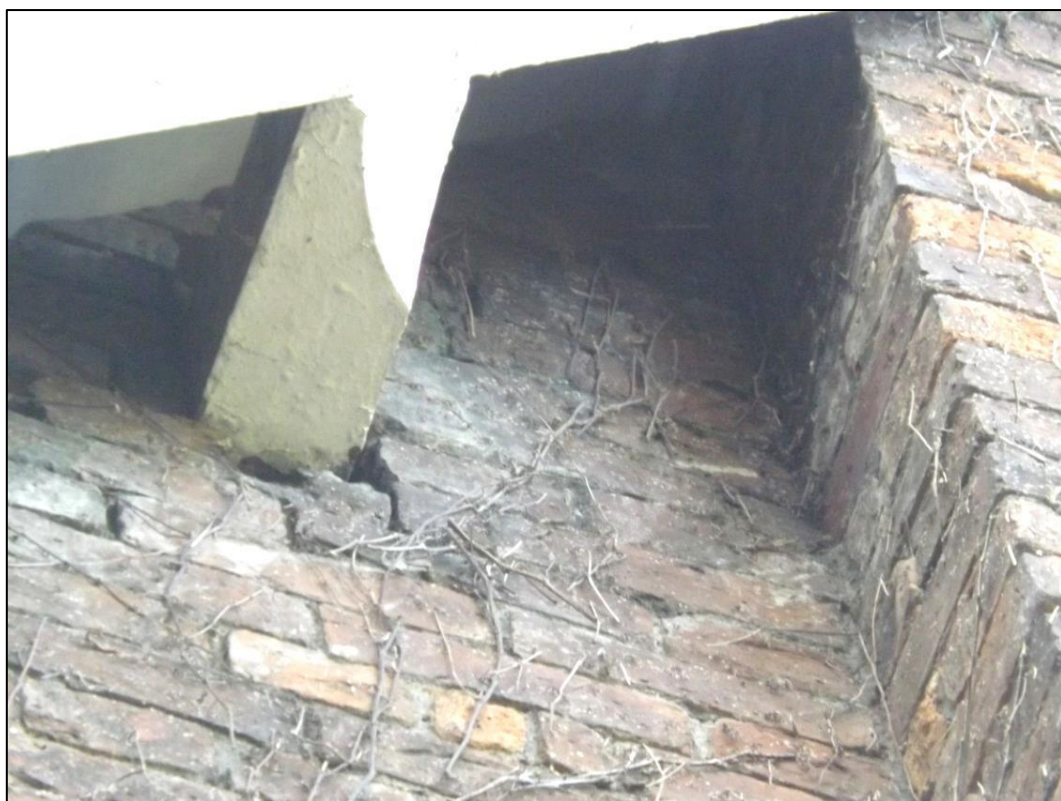
*Plate 5: Gaps were also present in the brickwork around roof purlins.*

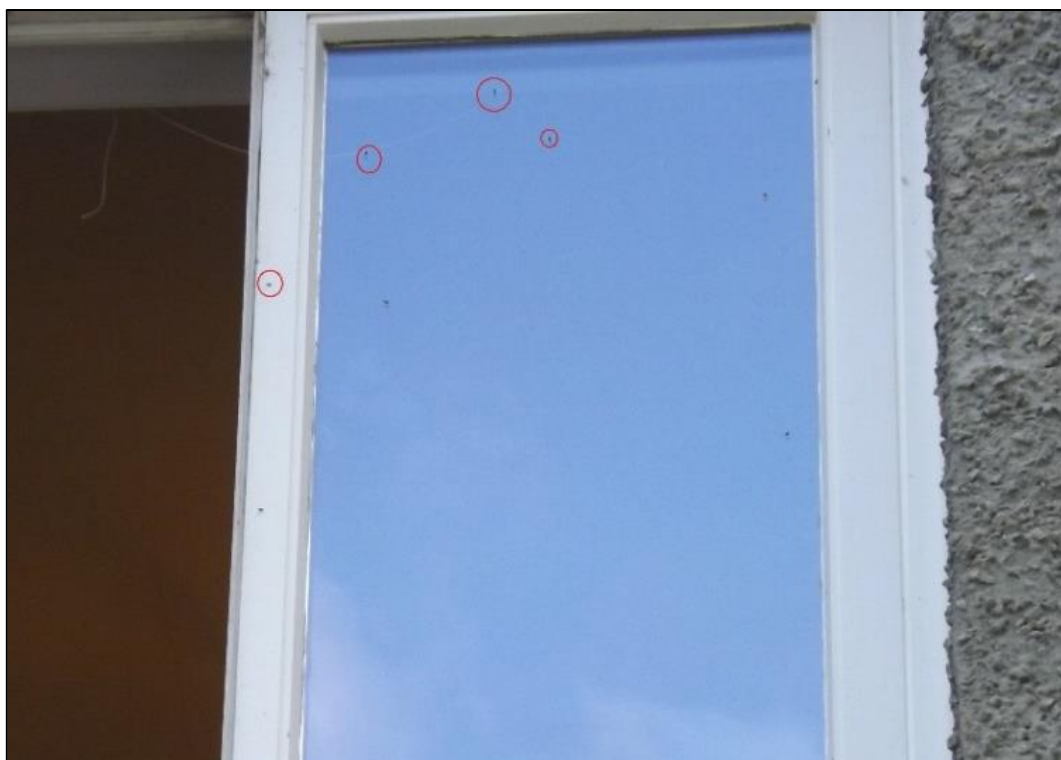
- 3.2.4 Thorough inspection of the external features also identified bat droppings on the second storey window panes along the eastern aspect of the building (see Plate 6). This suggested recent use of a bat roost around the gable end of the dormer window.

*Plate 6: Bat droppings present upon windowpanes on the building.*

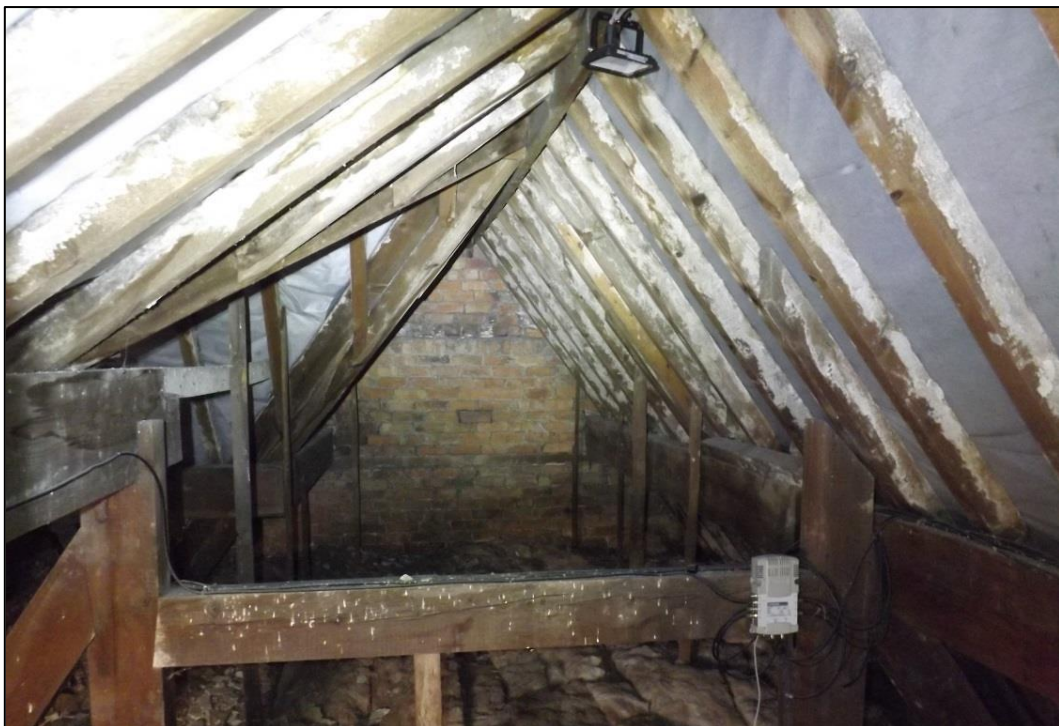
- 3.3.1 A thorough and systematic search began in the interior loft of the building with the aim of looking for evidence of historic or current bat activity, including scratch marks on the beams, staining and bat droppings. Flat surfaces were also inspected for droppings and discarded prey items. The loft was fully accessible and unaffected by the ongoing renovation works within the building (see Plate 7).

*Plate 7: The loft was fully accessible and unaffected by the ongoing renovation works.*

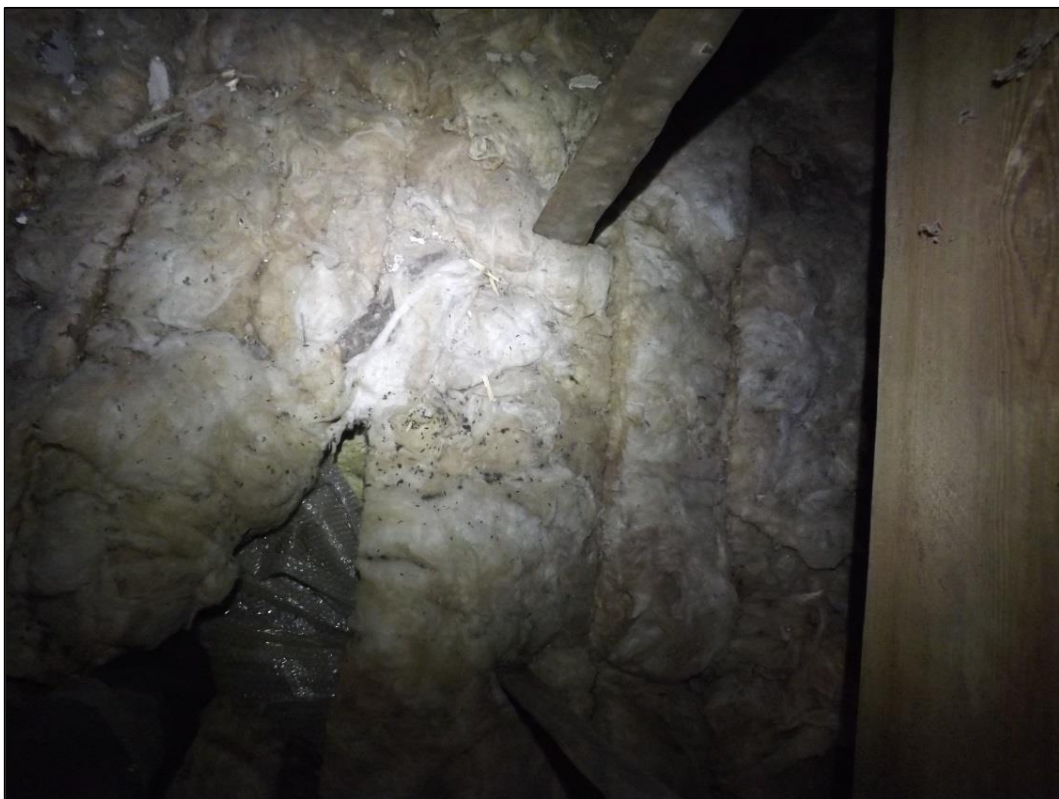
- 3.3.2 Numerous bat droppings were observed throughout the loft. These were found in clusters upon the insulation, flooring and within the beams (see Plate 8, Plate 9 and Plate 10). On closer examination it appeared that the droppings were not fresh, suggesting historical usage of the loft void by bats. A handful of fresh droppings were found on the inside of the south facing chimney breast.

*Plate 8: Clusters of bat droppings were present in areas throughout the loft.*

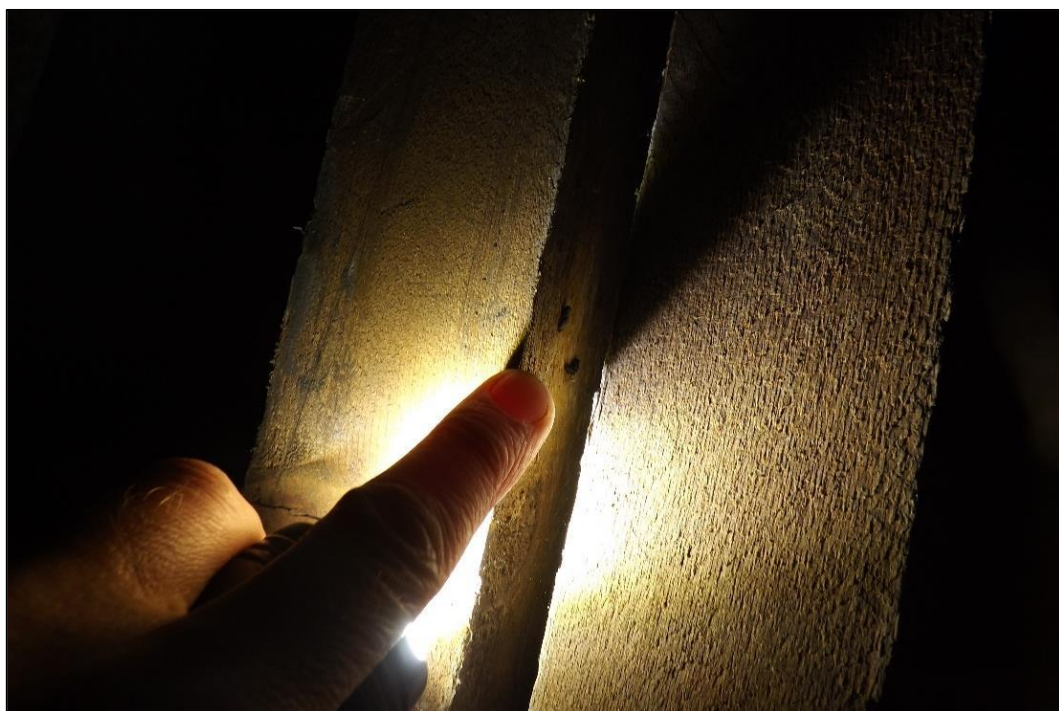
*Plate 10: Bat droppings were also found between loft beams at a crevice roost location.*

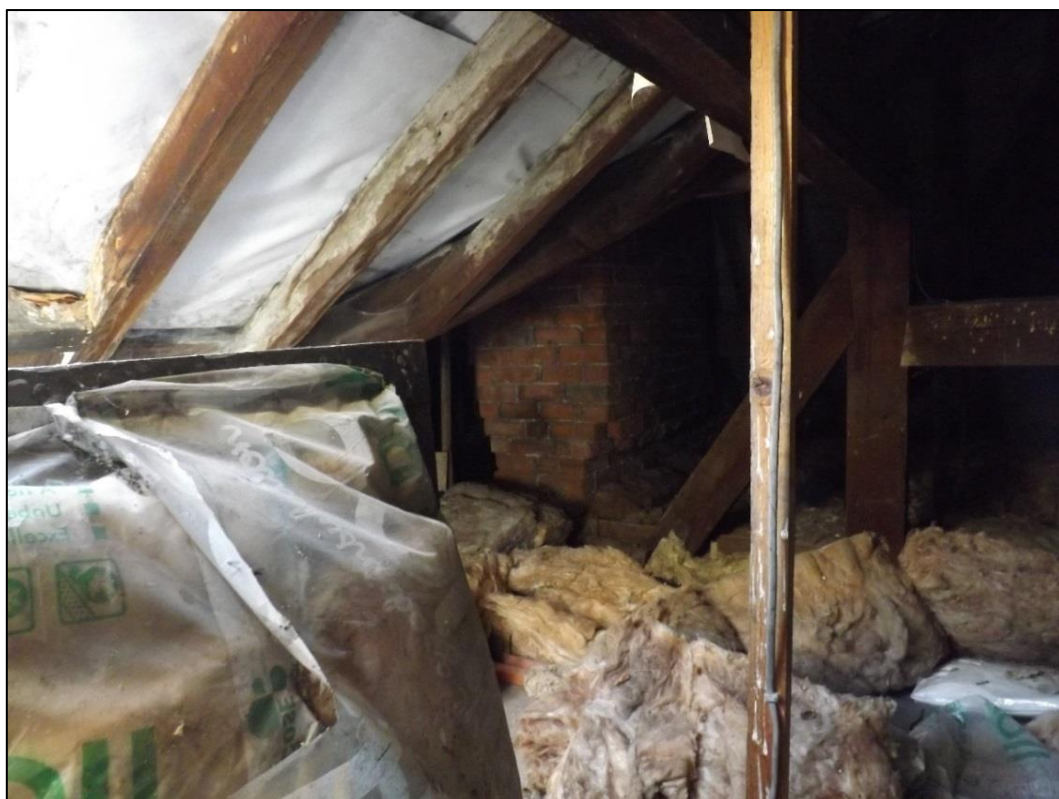
- 3.3.4 The roofing membrane had a date stamp of 2018 on it, which confirmed that re-roofing had taken place in the loft within the past year. The visual appearance of the droppings suggested that they were not from 2019, and that a bat roost areas was now probably confined to the void above the roofing membrane and underneath the roofing tiles. Only a handful of fresh droppings indicated any ongoing bat presence in the main loft void. It was considered that the bat encountered by the contractors was possibly an infrequent event since the re-roofing. Nevertheless the membrane did have some gaps evident and adjacent to the chimney breast which could potentially allow bats to access the main loft void (see Plate 11).

Plate 11: Some gaps were present in areas of the roofing membrane.

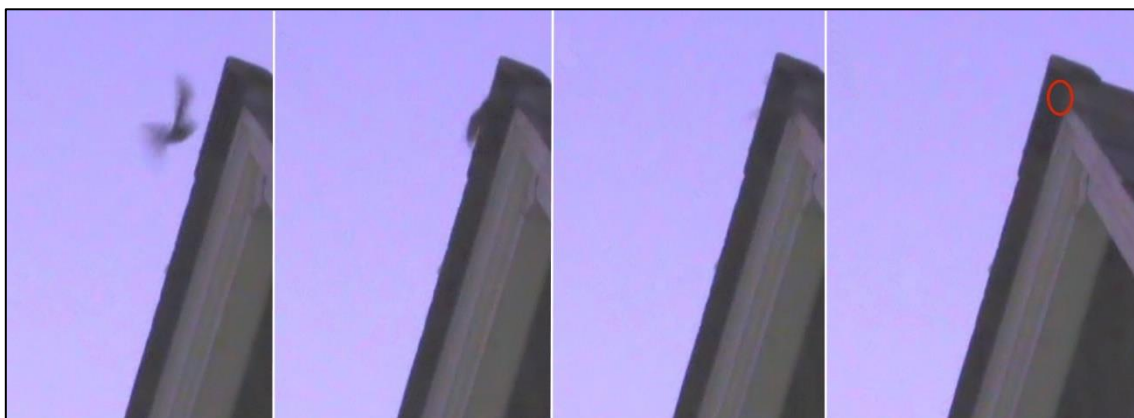
- 3.5.7 Between 04:00 and 04:11 a total of 41x soprano pipistrelle were seen to enter this roost in the northwest facing dormer gable. Up to 10x bats were seen to be swarming near the roost entrance at any one time. All bat activity had ceased by 04:24.

*Plate 12: Soprano pipistrelle approaching and entering roost in northwest dormer gable.*

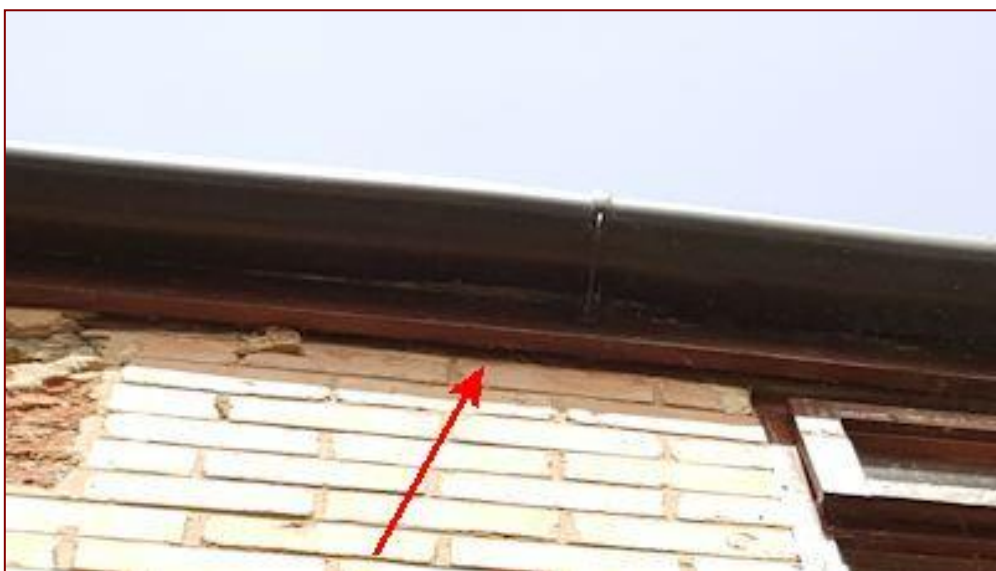
Plate 13: During construction, gaps can be incorporated under fascia that are suitable for crevice dwelling species.

- 6.6.1 In order to compensate for any loss of the small bat roosts in the building, it is advised that roost provision is built in to the building redevelopment. This can be incorporated into the design of the new building in the form of gaps in the eaves or underneath the ridge tiles of the roof.
- 6.6.2 It will be straightforward to incorporate crevice roosts behind the fascia boards of the new extension (see Plate 13). These should be a gap 15mm-20mm from the wall and their creation will be overseen by the Appointed Ecologist. It is anticipated that these roost locations will ensure long term provision for year-round roosting bats. The gaps under new fascia will compensate for the loss of the 2x individual pipistrelle roosts.

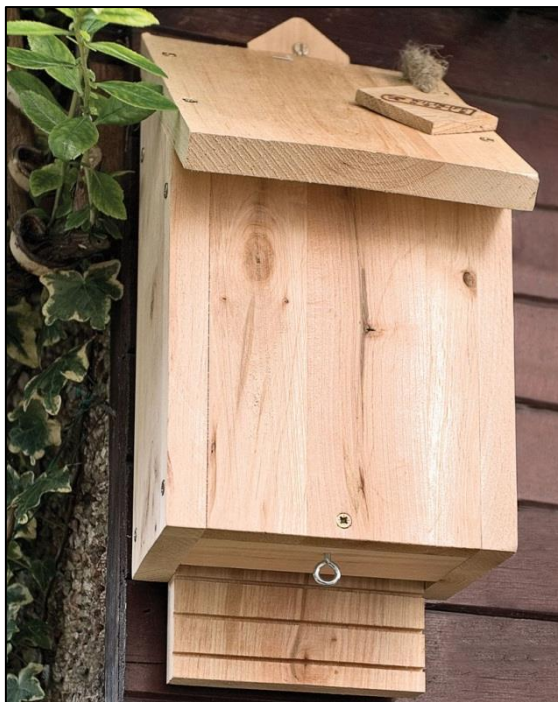
Plate 14: The 1x wall mounted bat roosts will be installed prior to any redevelopment works.

- 6.6.3 It is essential that temporary bat roost accommodation is provided on site prior to redevelopment of the building (see Plate 14). This would be in the form of 1x traditional wooden bat boxes, to be fitted at least 4m above ground on to trees on site. This should face south-west, south or south-east. If any bats are found during the commencement of slate stripping, then they would be put into the bat box.
