26 Church Street  
Ribchester, Lancashire:  
Heritage Assessment

August 2019

## **26 CHURCH STREET, RIBCHESTER, LANCASHIRE, PR3 3XP:**

### **HERITAGE ASSESSMENT**

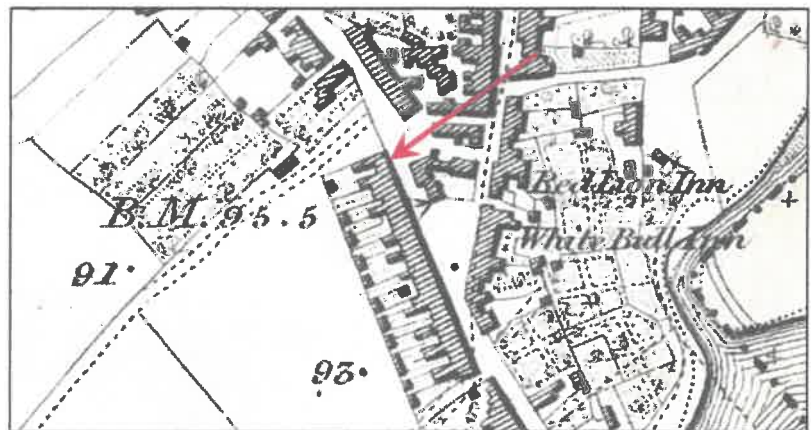
Figure 1: Ordnance Survey map, 1847<sup>4</sup>

- 4.2 The continuous terrace of houses on the west side of Church Street, at the north end of which 26 stands, forms a heterogeneous row of weavers' cottages of different dates, but contains two date-stones of the 1790s, and the whole row is thought to have been constructed in a short spate of building about that time.
- 4.3 The Ordnance Survey map of 1847 (figure 1) shows the house at the north end of the row with a rear wing, a feature shared by most of the other houses in the terrace. A detached outbuilding, likely to have been a privy, is located at the west side of the plot, and appears to have been shared with the neighbouring dwelling.

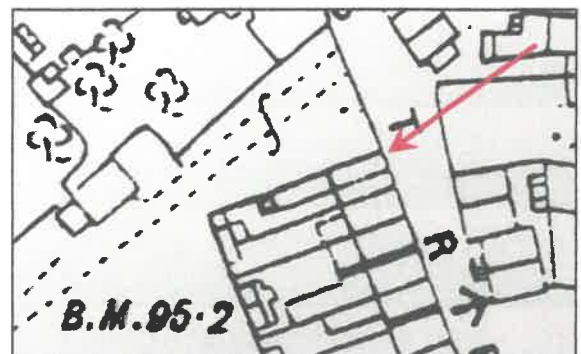
Figure 2: Ordnance Survey 1893<sup>5</sup>

- 4.4 The available copy of the first edition 1:2500 map is poor (figure 2), but it does show an essentially similar arrangement, as does the (clearer) 1932 edition, albeit the detached outbuilding had been demolished by then (figure 3).

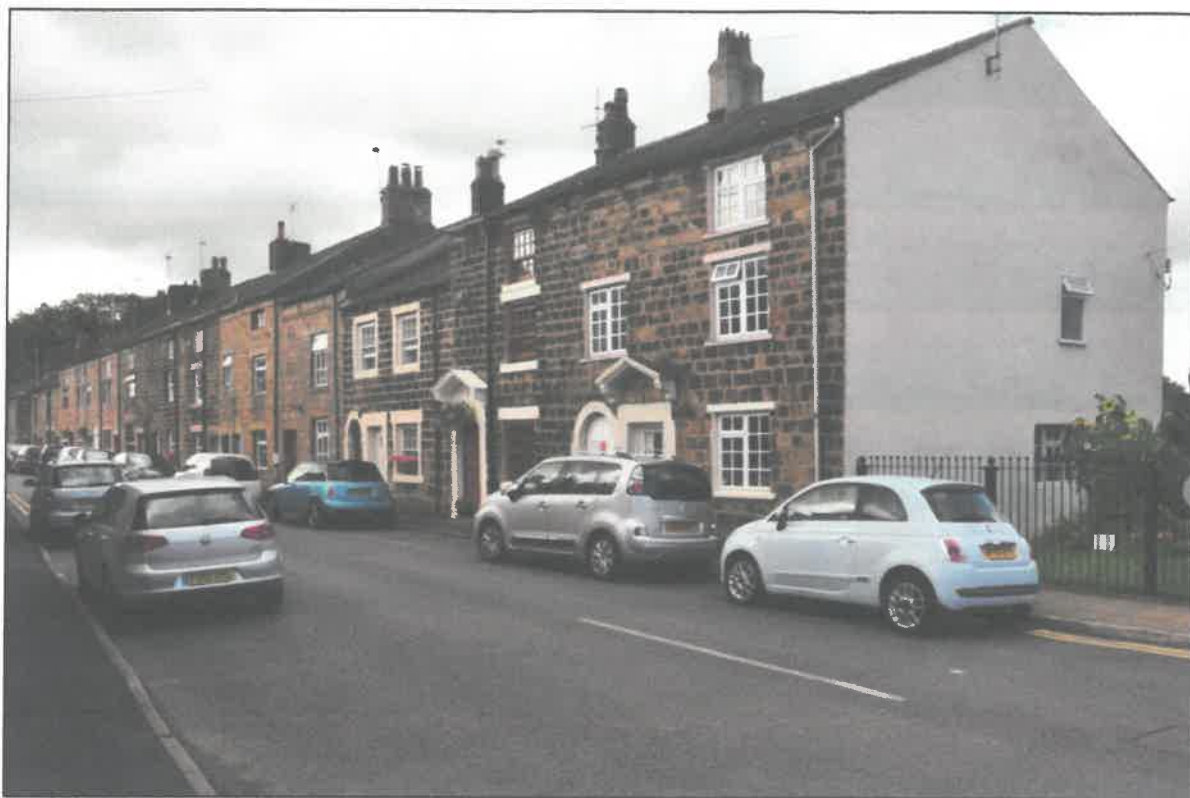
Photo 1: Setting: No.26 (at right), at north end of row along Church Street

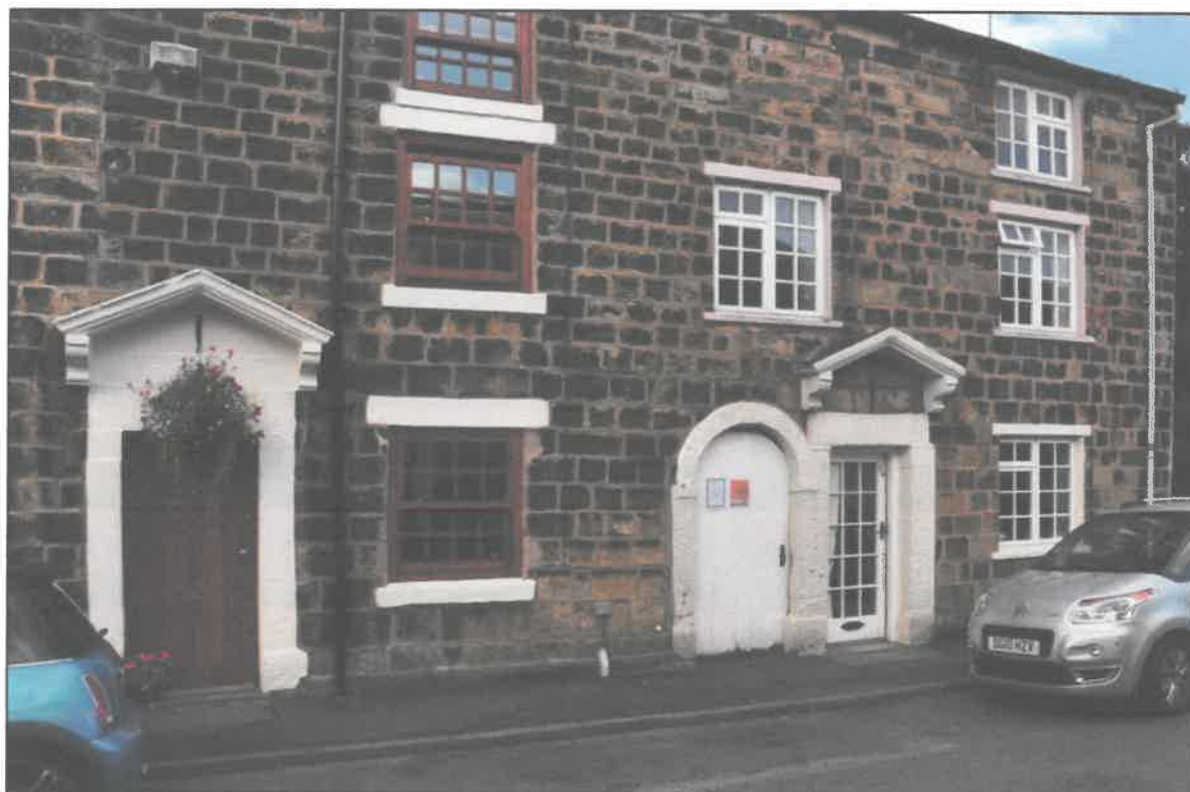
Photo 2: Front elevation of nos.25 and 26 (at right)

- 5.1 Nos. 25 and 26 Church Street form a pair of three-storey houses, which appear to have been added to the north end of no. 24, and share many architectural details with that two-storey antecedent. The front is faced with squared sandstone laid in deep courses, and although the top storey of no. 26 has been rebuilt in the 20th century (with its inner leaf of concrete block), the rebuilt work has re-incorporated the plain eaves band and shaped corbels which support the guttering.

- 5.2 The main doorways to both houses have heavy, upright sandstone jambs, over which are triangular stone hoods or canopies, borne on shaped corbels: these appear to be early 19th century additions. A third doorway, immediately next to the entrance to no. 26, has a semi-circular arch with keystone and leads to a shared through-passage ("tunnel").

- 5.3 All the front window openings to no. 26 have been enlarged slightly at top and bottom, and have modern sills and lintels, contrasting with the original ones to no. 25, which retain their deep stone dressings. The window frames have modern, small pane casements. Although the listed building entry describes one of the first floor windows as having been inserted, this seems highly unlikely.

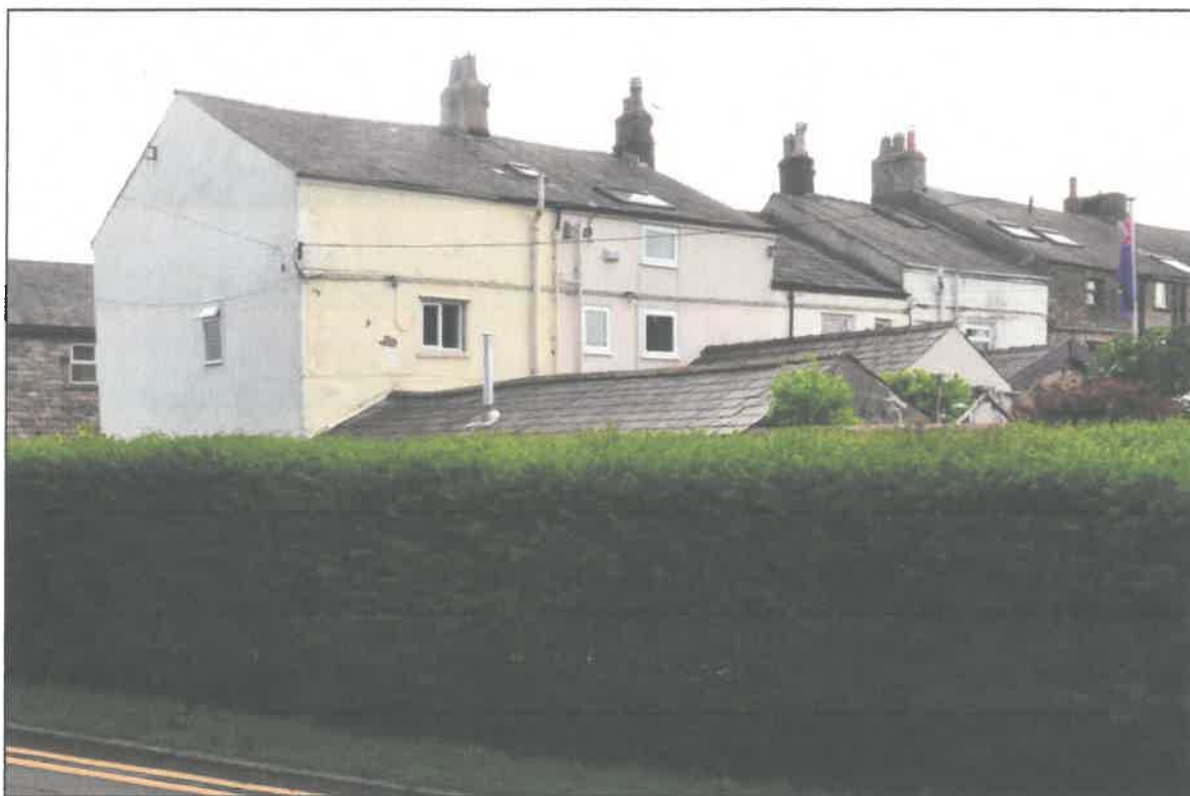
Photo 3: Rear view (no.26 at left), with roof of wing visible

- 5.4 The north gable and rear of the house have painted cement render, concealing the stonework, and the two windows in the former are likely to be 20th century insertions. The rear has a ground floor window to the side of the wing; this

might have been a doorway historically. There is a first floor window with modern dressings, and the position of a blocked second floor window over it, evident externally as a pair of vertical joints.

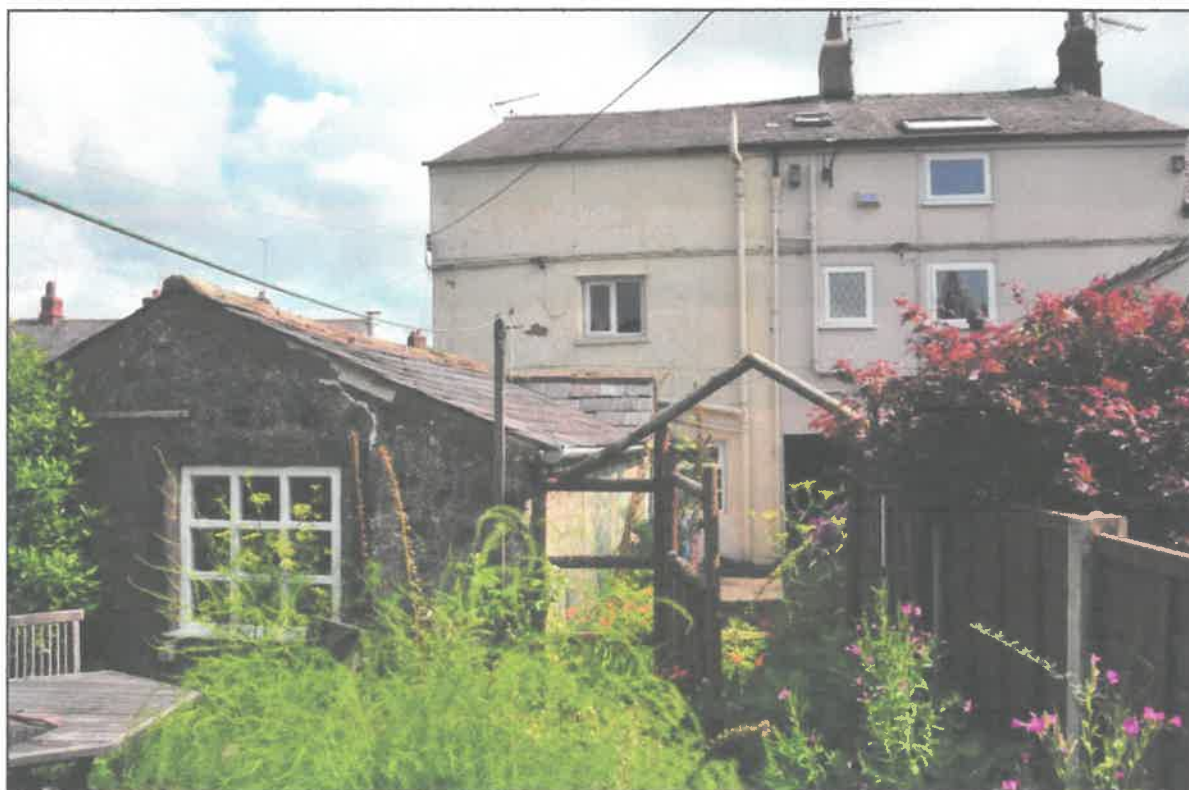
Photo 4: Rear view (no.26 at left), with rear wing in foreground

- 5.16 The wing is built from random rubble, which contrasts with the front of the house, although only the wing's north side has exposed stonework, the two other sides being rendered to varying degrees.

- 5.17 The roof is of blue slate, of uncertain date, but probably secondary; the ridge is the original sandstone. It is likely that the wing was originally covered with local stone slate.

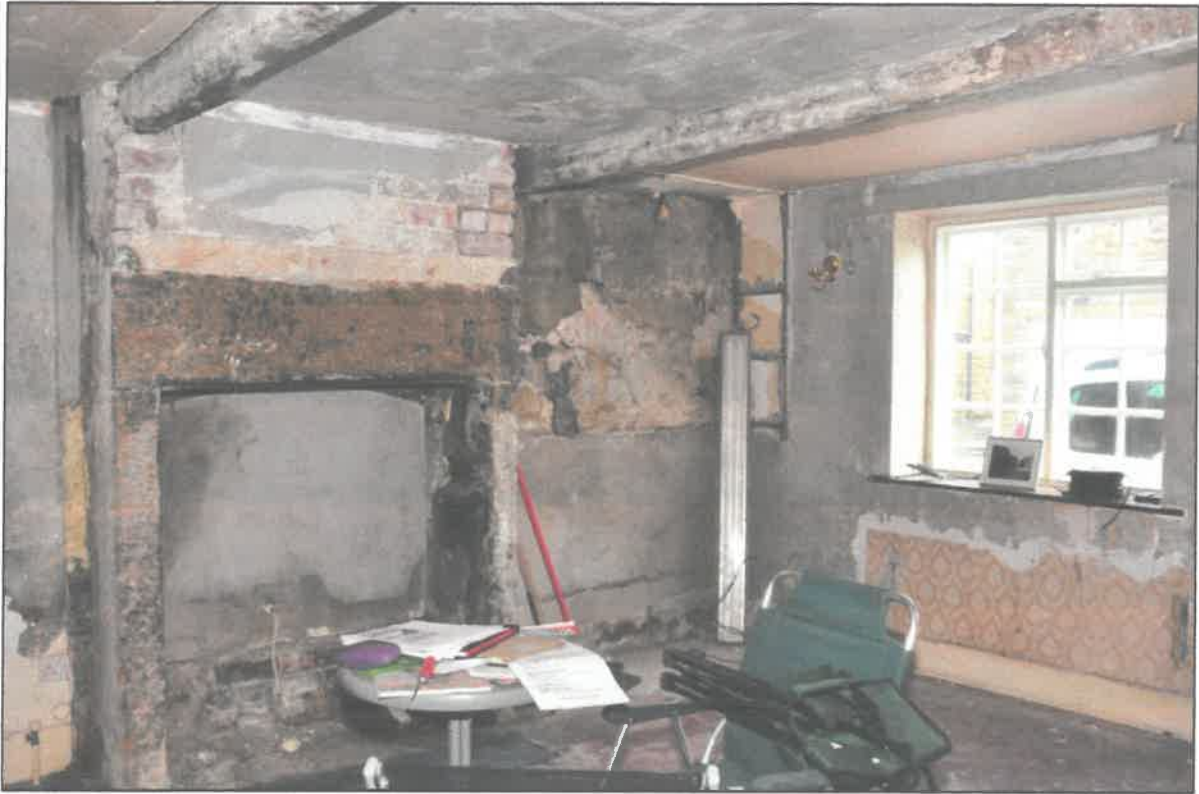
Photo 5: Front fireplace on ground floor

- 5.6 The ground floor formerly comprised a front and a rear room, once separated by a thin masonry wall, but removal of the wall in the 20th century means that these now form one large space, with only a small 20th century vestibule to the front door. The chimney breast and a plain fireplace recess (intended for an iron range) survive in the gable wall of the front room, but those in the rear room have been removed, their absence permitting the insertion of the modern north window.

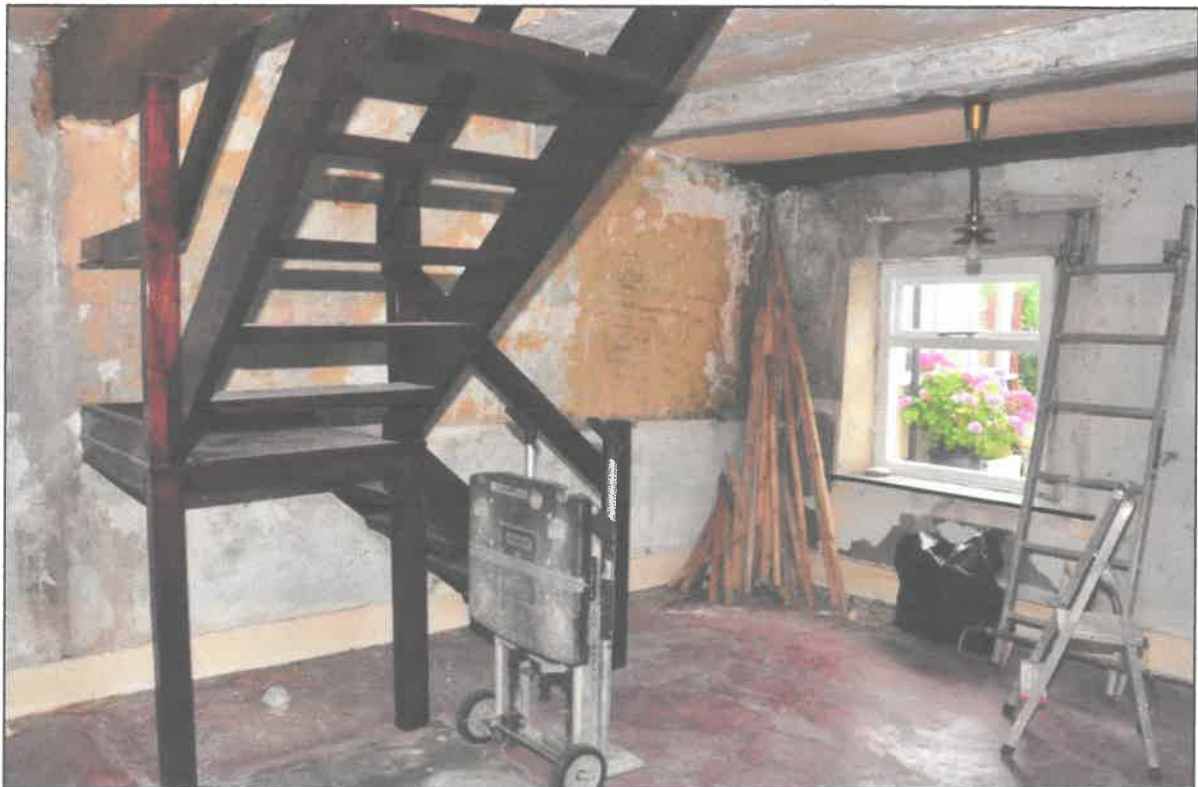
Photo 6: Present staircase, within former back room, ground floor

- 5.8 The present open-tread staircase to the first floor is mid to late 20th century. It replaced an earlier staircase (details unknown), formerly situated against the south wall, whose removal has left a scar in the plaster and infill within the concrete floor. To judge from these, and the position of the former wall in relation to the parallel ceiling beam to the rear, the stair was entered from the north, and underwent a quarter-turn before continuing up towards the rear of the house.

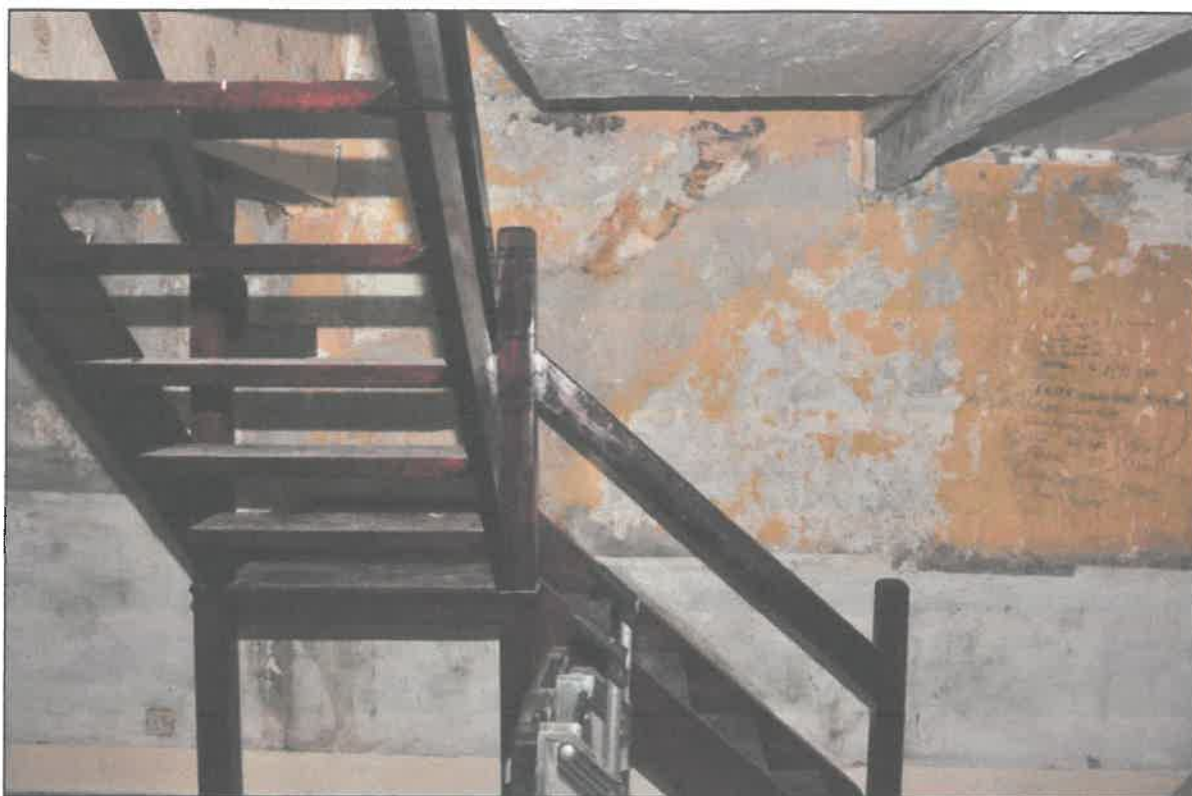
Photo 7: Present staircase, within scar of predecessor in plaster behind

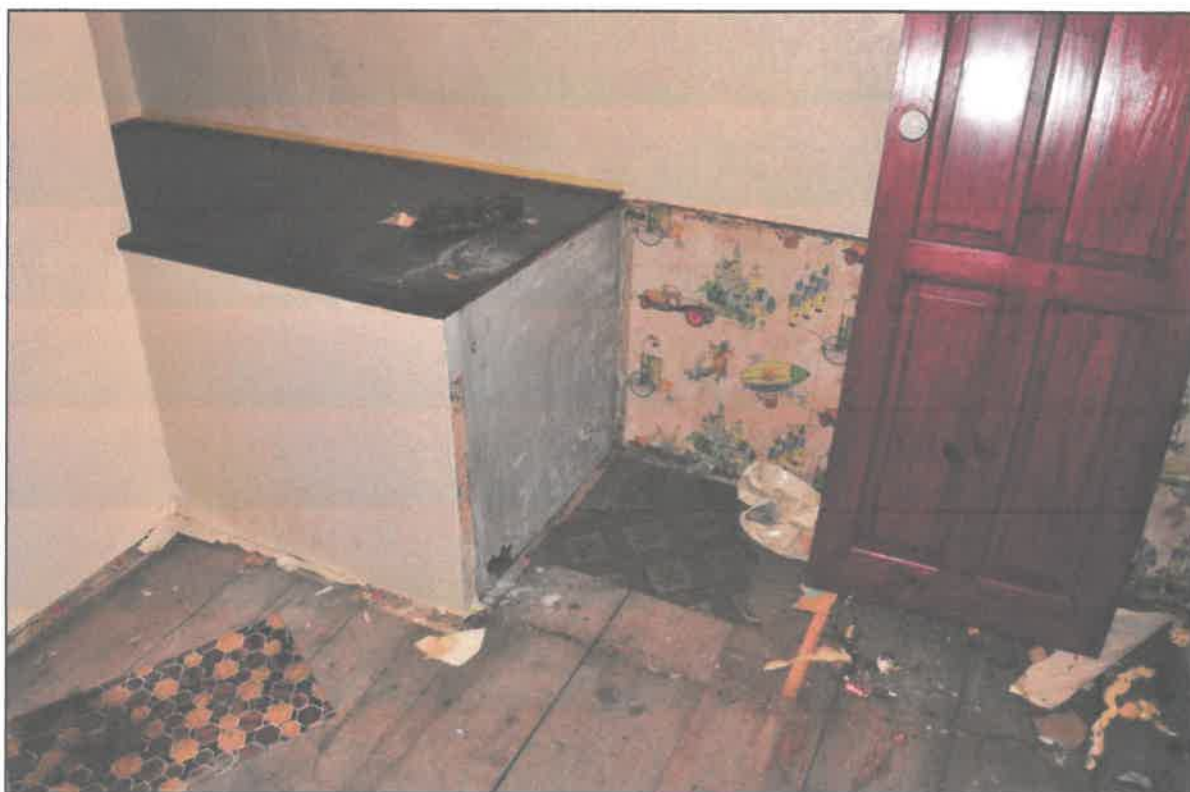
Photo 8: Site of former staircase aperture, within first floor

- 5.9 The earlier staircase from the ground floor would have entered the rear of the first floor through the aperture now covered by the raised boxing for the modern staircase.
- 5.10 On the first floor, the cross-wall dividing front and back has been partly removed, and a number of modern partitions have been installed to create the present arrangement of three bedrooms and bathroom, though there may have been some historic partitions in addition to the masonry wall. There would formerly

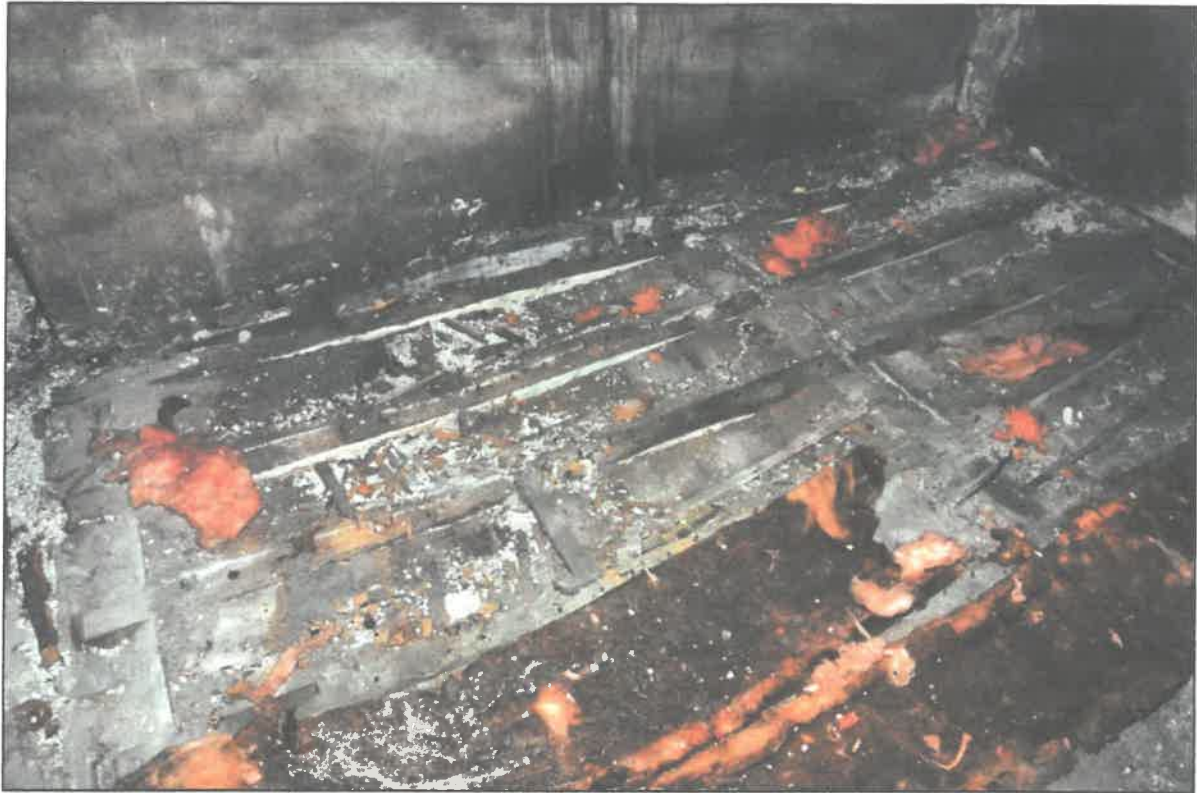
Photo 9: Upper view of joists on second floor

- 5.11 The second floor was a habitable room originally (as it remains in the adjoining house), but has fallen out of use, and is presently only accessible through a small trapdoor. An investigation for a larger opening which would have accommodated a staircase has not proved fruitful, but the infilling of an opening for a stair, once removed, may only have involved the insertion of a single joist across the aperture, and the making good of the ceiling.

- 5.12 Apart from any opening for a staircase, the second floor was fully boarded with wide pine boards, indistinguishable from those on the first floor, but only remaining in fragmentary condition around the perimeter of the room, where they are in very poor condition. The extent of boarding throughout the second floor is indicated by square nails standing proud in the joists.

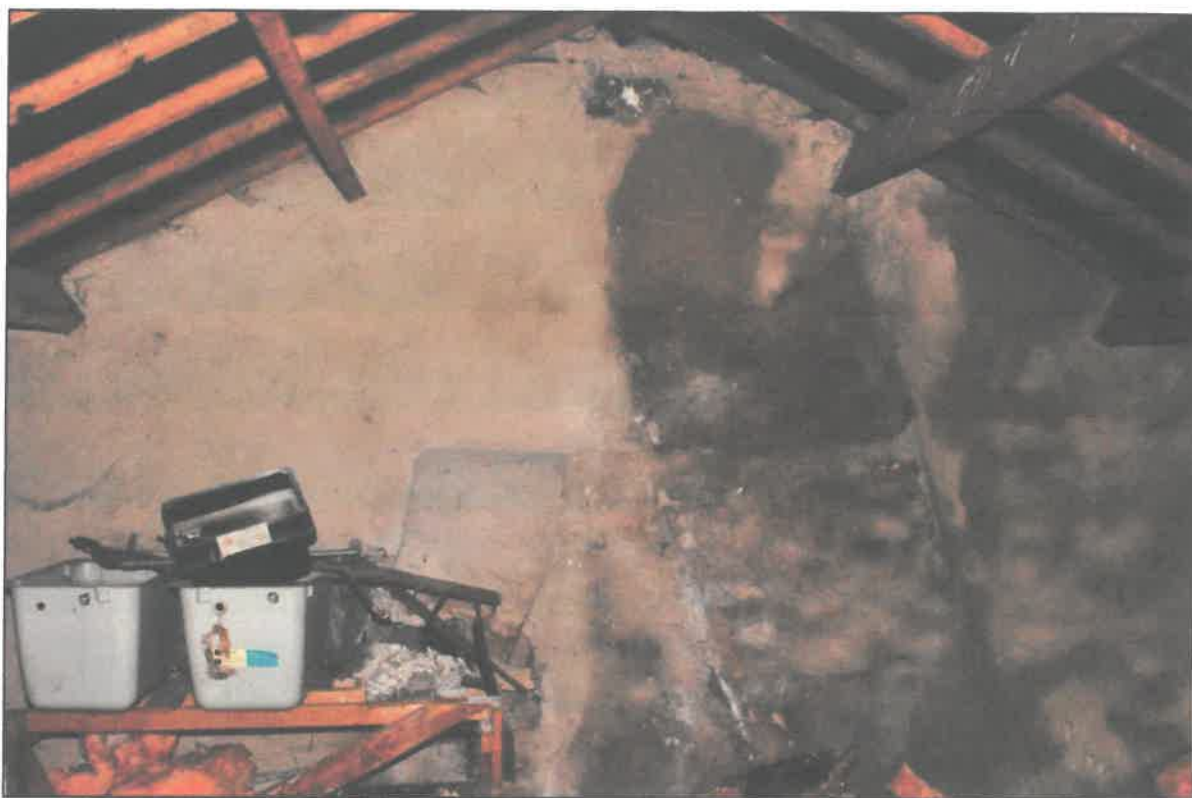
Photo 11: North gable, second floor, with pair of flues (stack over removed)

- 5.5 The roof of the three-storey house is blue slate with tile ridge, coverings which are likely to be contemporary with the modern rebuilding of the front wall at second floor level, and to have replaced original stone slate and stone ridge. A chimney stack at the north gable has been removed, probably at the same date: the pair of flues it served can be seen inside the house.

- 5.13 The outer walls of the second floor contain a window to the east, within the rebuilt fabric, and one to the west, now infilled with concrete blocks. The west and south sides are finished with lime plaster, while the east and north walls have modern plaster; the pair of flues once connected to the gable ridge stack show within the latter. The roof timbers are all modern replacements.

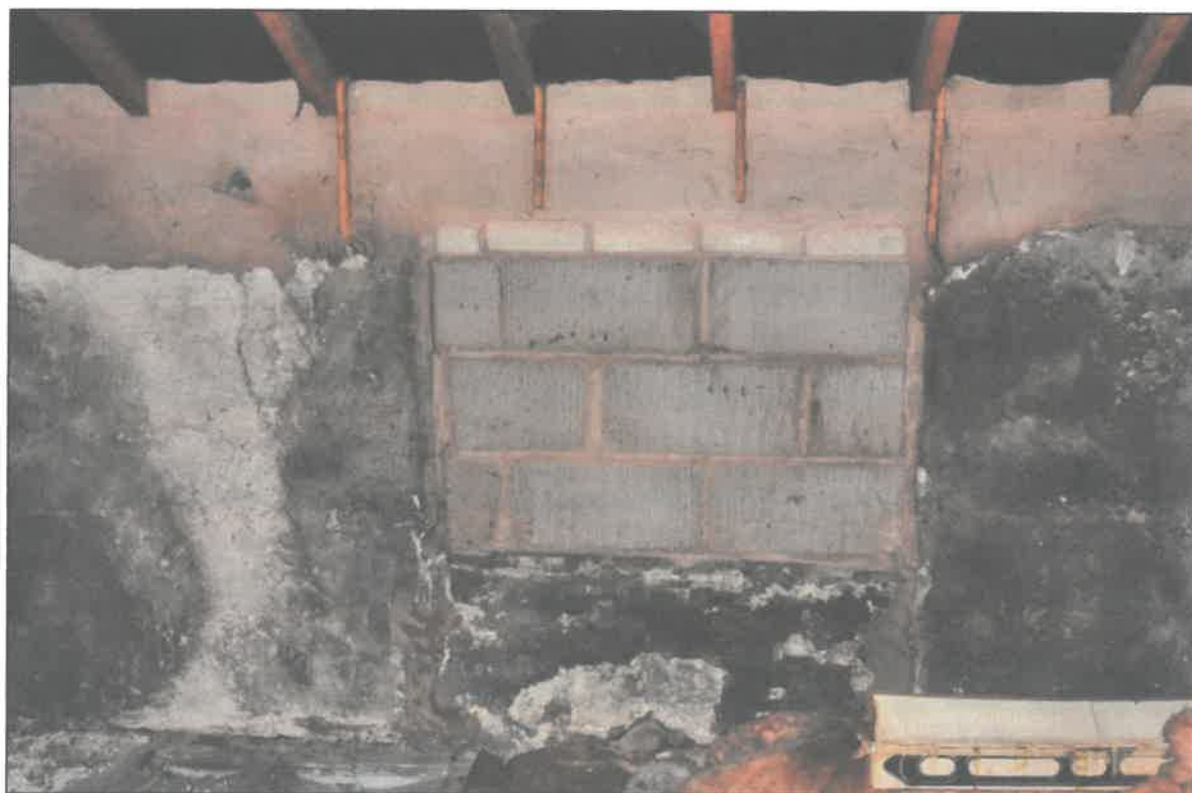
Photo 12: Blocked window, west side of second floor

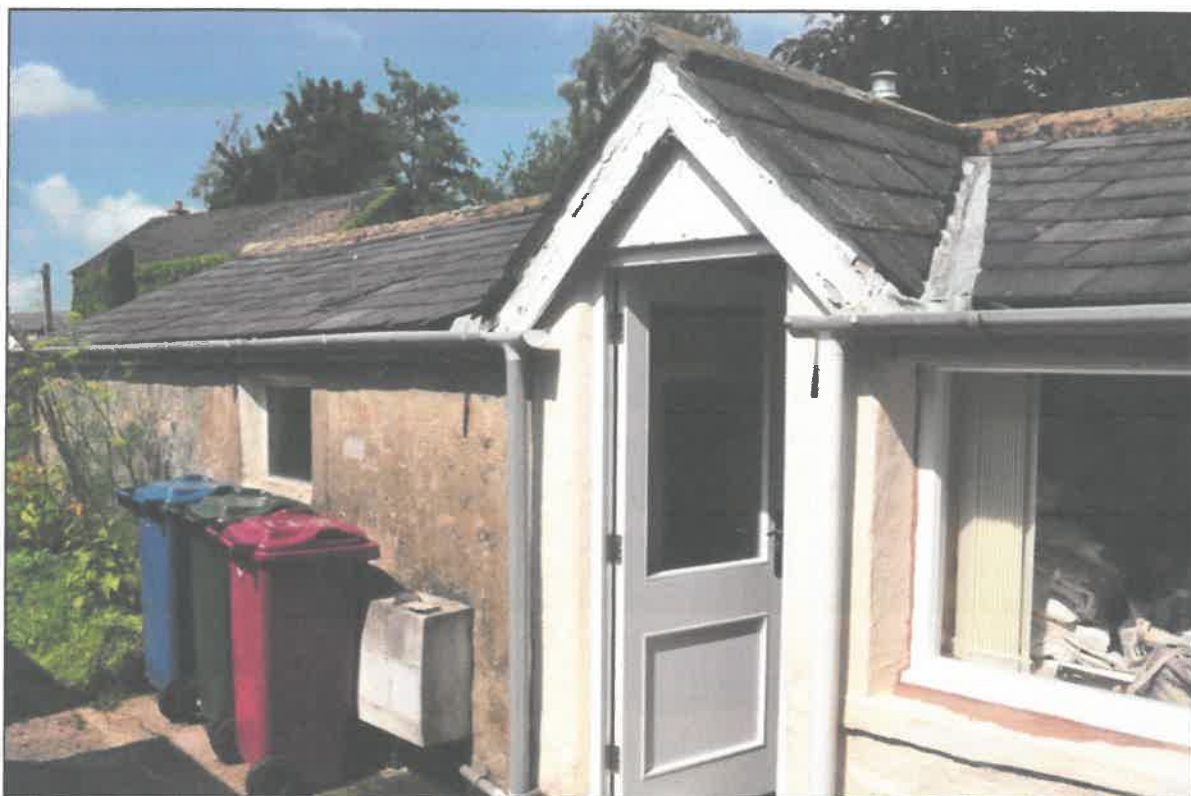
Photo 13: Rear wing (former loom-shop): south side, with altered doorway

- 5.18 The present arrangement of openings in the south side of the wing appears to have been altered to some degree, and the doorway has been heightened, through the addition of a small gablet in the roof. The large window to the present kitchen may have been enlarged, but the smaller window to the back room may be unchanged except for the rendering of its surround. There is also a window in the wing's west gable.

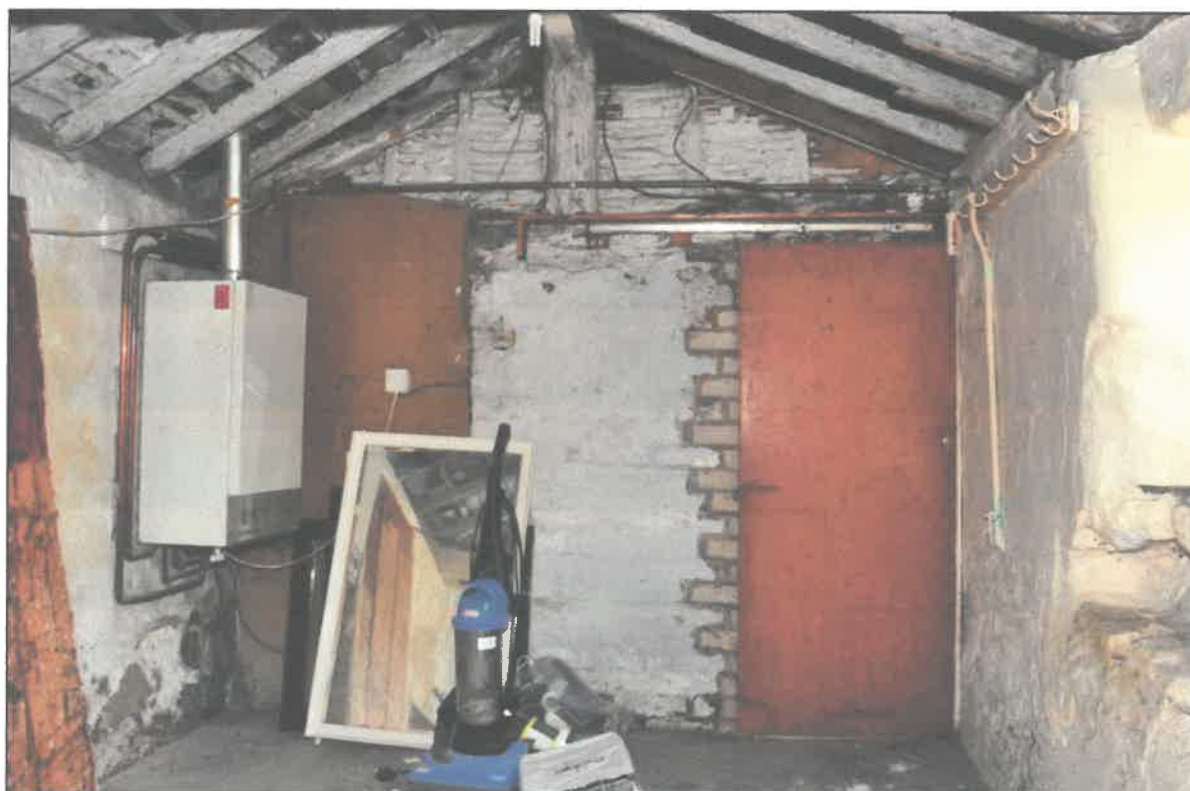
Photo 14: Rear wing : truss and cross-wall, looking east (part of former loom-shop)

- 5.19 The wing is of three unequal bays, with two rather crude king-post oak trusses, the east one closed with lath and plaster. The masonry wall below this truss is very probably secondary, as may be the lath and plaster, and it is likely that the wing contained one large room originally. The west truss has a later softwood truss alongside, and rafters are also softwood, probably late 19th or 20th century replacements, contemporary with the blue slate covering. The ridge is the original, whole-tree member.

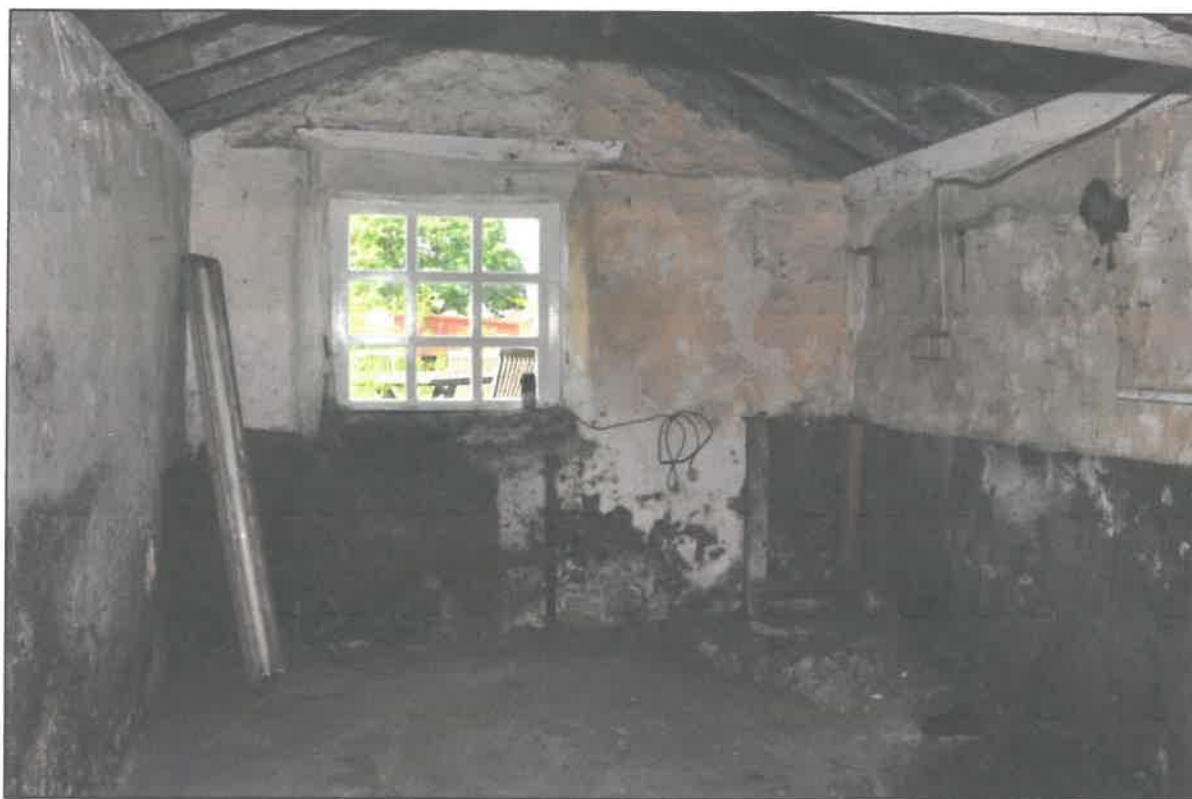
Photo 15: Rear wing: west room (part of former loom-shop)

- 5.20 The present kitchen has an asphalt floor, the west room a concrete floor (recently a back kitchen or utility room). Investigations by the owner indicate that this concrete, and an underlying layer of hardcore, are approximately 300mm deep, and that the wall coating extends to a similar low level. The floor level has therefore been raised, perhaps in an attempt to relieve damp, although that inconvenience was probably an original intended aspect of the wing, when built as a cotton loom-shop, and lower floor levels would have provided greater head-room than at present.

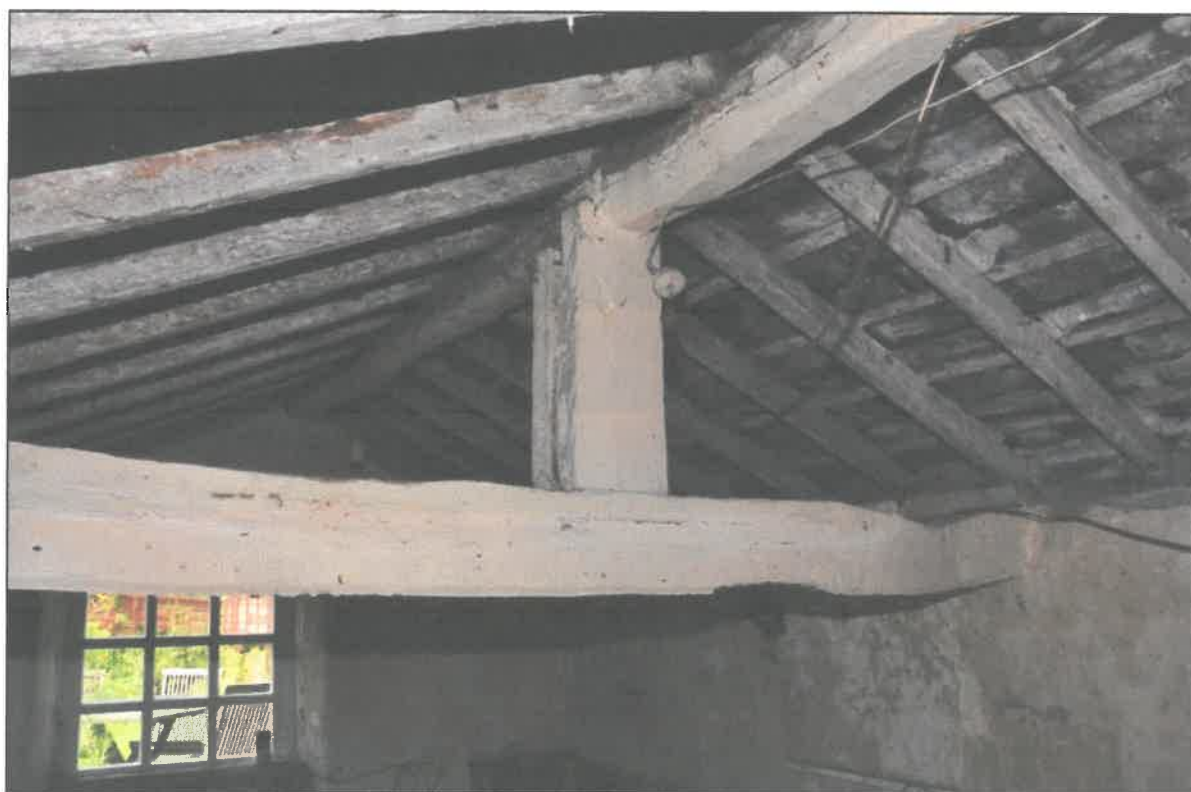
Photo 16: Rear wing: west truss, and other roof members
