Preliminary Bat Roost Assessment Report

Outbuilding at Lower Buck,
Edisford Road,
Waddington,
BB7 3HU

29.06.2020

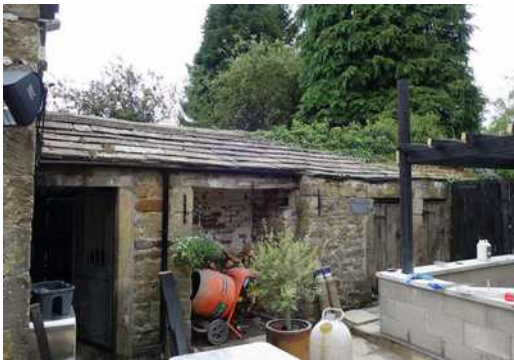
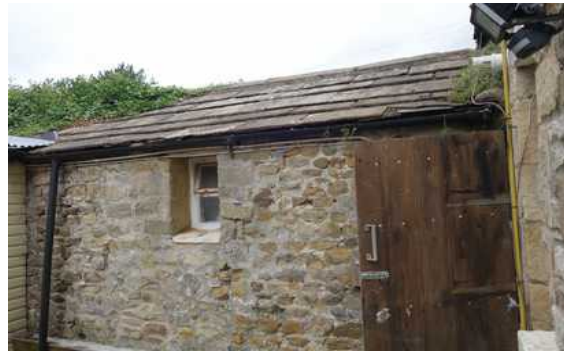
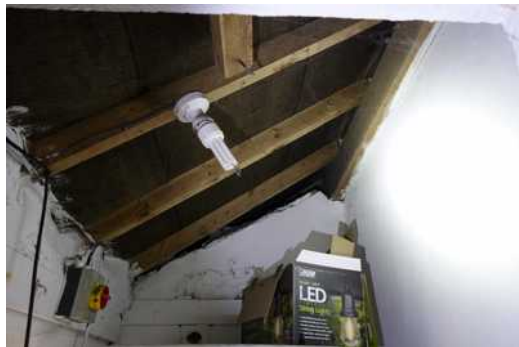
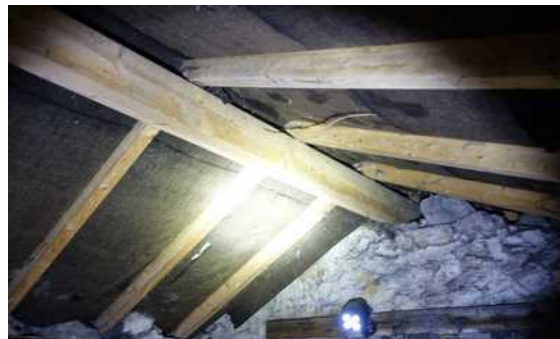
The property consists of a single storey stone built outbuilding with double pitched stone slate roof. External walls are in a good state of repair, well pointed and sealed. The property has a double pitch stone slate roof with close fitting slates. No lifted, slipped or missing tiles were observed and ridge tiles are pointed and sealed. The western third of the building's roof has a covering of ivy.

The building is currently used for storage and interior spaces have lighting present. Roof slates are lined with a bituminous roofing felt.

The building is in a good state of repair, well sealed and with no obvious potential roost features.

Overall the building offers negligible roosting potential.
