Arboricultural Impact Assessment Overview

in Relation to Resubmission for
Approved Residential Development at

**Land off Clitheroe Road, Barrow,
Lancashire, BB7 9AQ**

Title:
TREE IMPACT PLAN
 in Relation to Resubmission for Approved Residential Development (Plan 1 of 2 - Western Site)

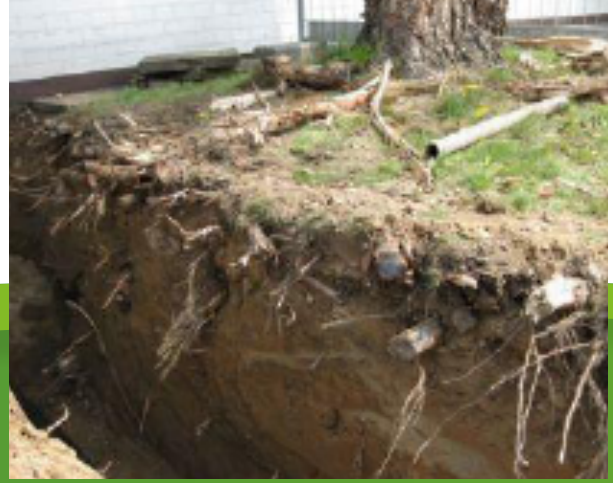
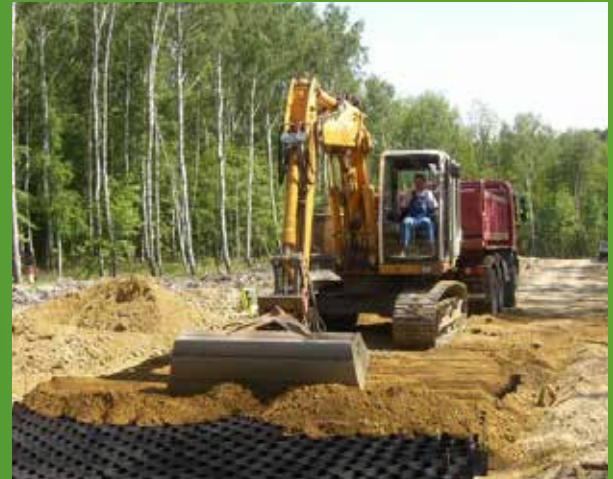
COMPACTION DAMAGE

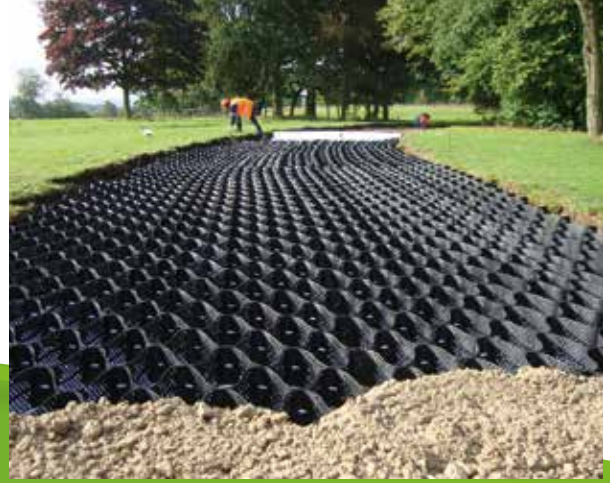
THE GEOWEB[®] SOLUTION

Used extensively in civil engineering construction for over 30 years, the GEOWEB[®] system is a three-dimensional structure that:

- provides strength to confined soils
- distributes loads laterally, not vertically
- reduces point loads
- reduces compaction of the subsoil

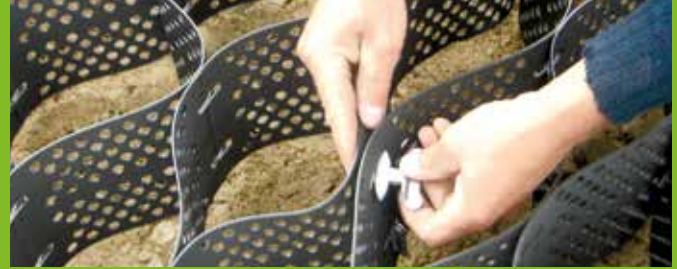
TRP SYSTEM INSTALLATION

Step 1: Remove the upper grass and soft soils by hand or by machine if acceptable.

Step 2: Install a high-strength woven geotextile allowing adequate drainage as a separation layer between soft subgrade and GEOWEB® infill material.

Step 3: Expand GEOWEB® sections over the area to be protected and use temporary stakes or weights to hold sections open to prevent movement during infilling.

Step 4: Connect adjacent sections using ATRA® Keys. Position the sections so the slots are aligned, insert the key and turn 90 degrees locking the panels together. ATRA® Keys provide a long-term connection that is safer, quicker and stronger than staples or cable ties. In environmentally protected areas (SSSI in United Kingdom), ATRA® Keys can be used without the requirement for diesel-fueled compressors.

Step 5: For permeability, infill the fully connected GEOWEB® system with a well graded, crushed, angular stone such as MOT Type 1X (also known as MOT Type3). Over fill the cells by up to 30mm to allow for compaction.

Step 6: Compact the fill material with conventional plant or non-vibratory plant when required. Fill should be maintained above the GEOWEB® system by a minimum of 10mm at all times or a permanent wearing course of blocks, porous asphalt or gravel installed.

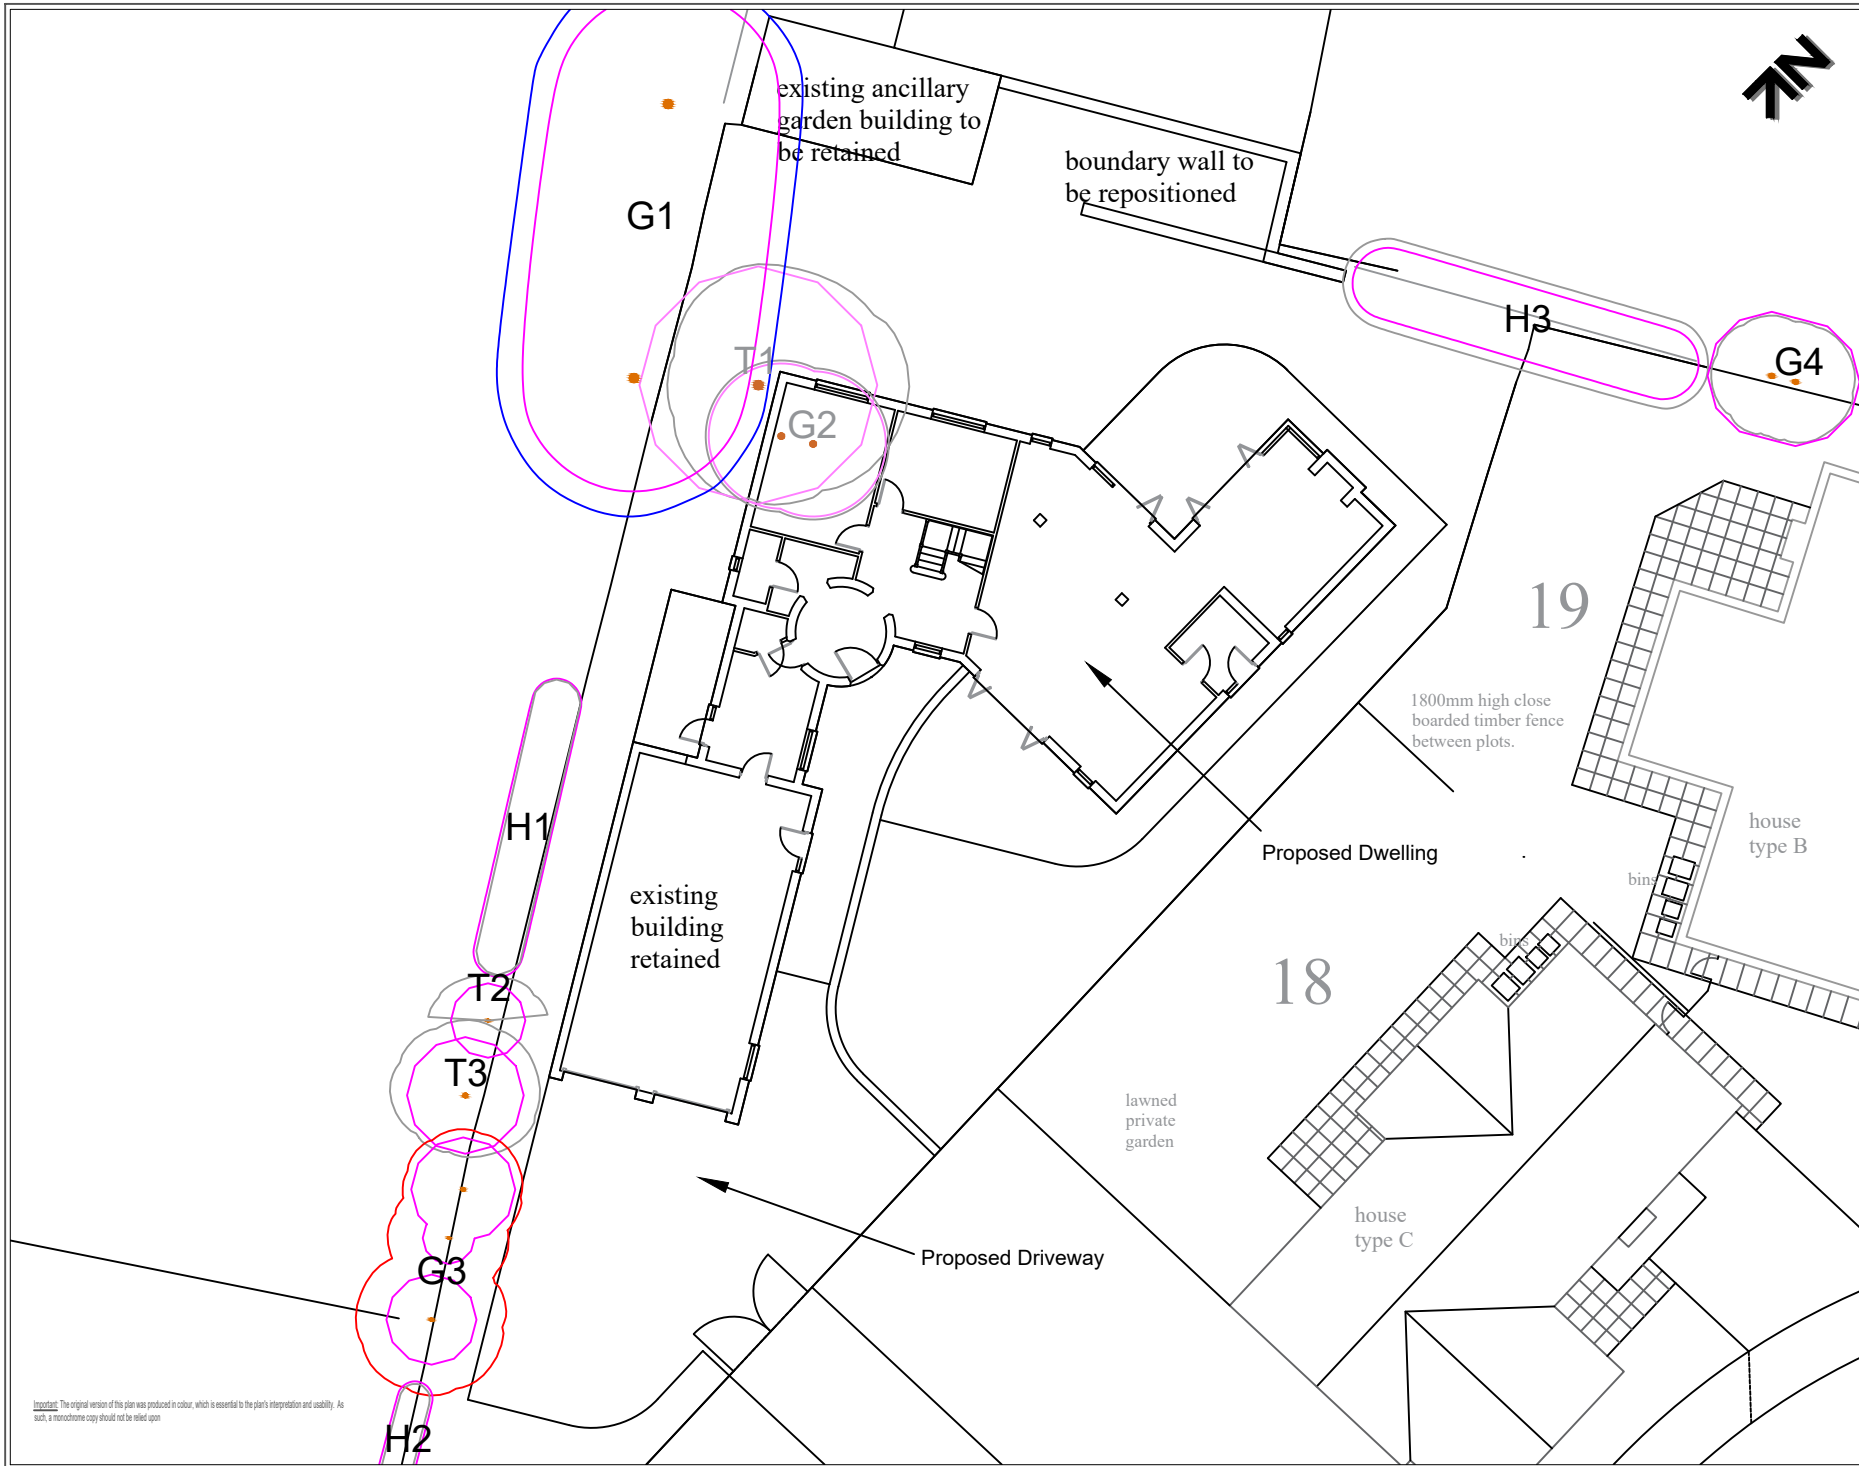
Note 1: The stem locations of individual trees T2, T6, T8 and trees in groups G1 and G4, woodlands W1 and W2 and hedges H4, were not included on the topographical site plan provided and were subsequently plotted by the arboricultural surveyor at the time of the survey using GPS siting and measurement from existing site features. As such, the locations of these trees cannot be considered wholly accurate

Note 2: Trees with their identifying numbers labelled in grey are proposed for removal in the context of the proposed development.

RPAs
 Area(s) of Ground Around Trees that Should be Protected Throughout Development Works with Protective Fencing to form a Construction Exclusion Zone - see Appended Temporary Protective Fencing Specification
