TREE SURVEY SCHEDULE FOR ARBORICULTURAL IMPACT APPRAISAL							
Site:		Land off Clitheroe Road, Barrow, Lancashire, BB7 9AQ					
Client:		Reilly Developments

Surveyor:	Jennie Keighley PhD MSc MArborA
Survey Date:	22 November 2017
Job Ref:	BTC1475

- TEMPORARY PROTECTIVE FENCING & GROUND PROTECTION SPECIFICATION -

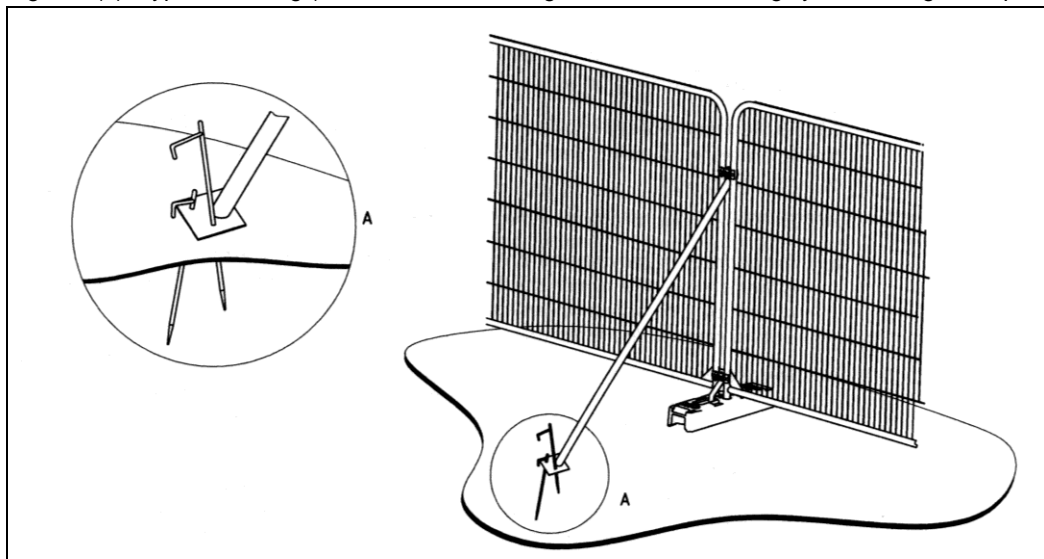
Figure 3(a): Type 2 Fencing (BS5837:2012 above-ground strut stabilising system with ground pins)

Type 2 Temporary Protective Fencing Construction (see Figure 3(a), below)

1. Temporary protective fencing panels shall be weldmesh "Heras" panels of at least 2.0 metres in height.
2. The panels shall stand on rubber or concrete feet.

3. The panels shall butt together, and be joined together using a minimum of two anti-tamper couplers, installed so that they can only be removed from inside the fence.

4. The distance between the fence couplers shall be at least 1.0 metre, and shall be uniform throughout the fence.
5. The panels shall be supported on the inner side by stabiliser struts, which shall be clamped to the scaffold framework at a 45° angle and extend back into the CEZ and shall be attached to a base plate, which shall be secured to the ground with pins (Figure 3a).

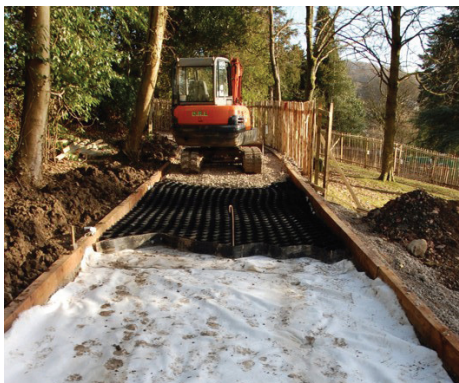
*Fallbarrow Park, Windermere:
CellWeb TRP® Installation*

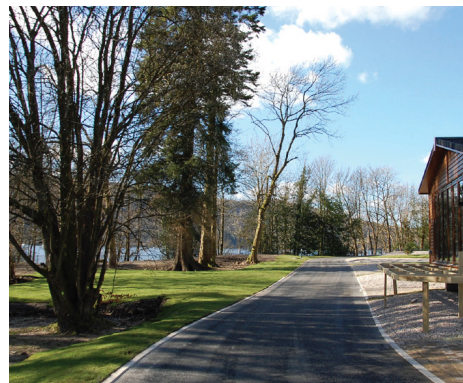
*Fallbarrow Park, Windermere:
Completed CellWeb TRP® Installation*
