# **Preliminary Bat Roost Assessment Report**

**Berner House,  
West Bradford Road,  
Waddington,  
BB7 3JD**

**21.09.2020**

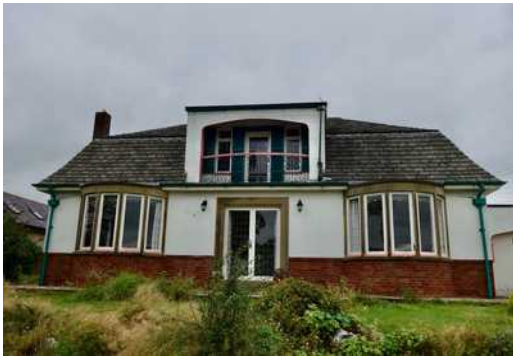
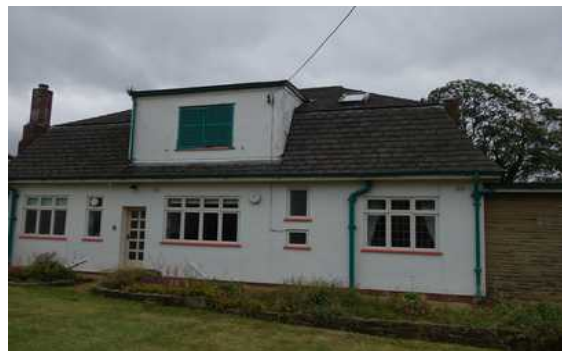
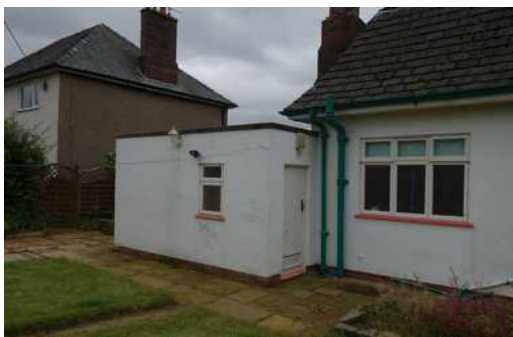
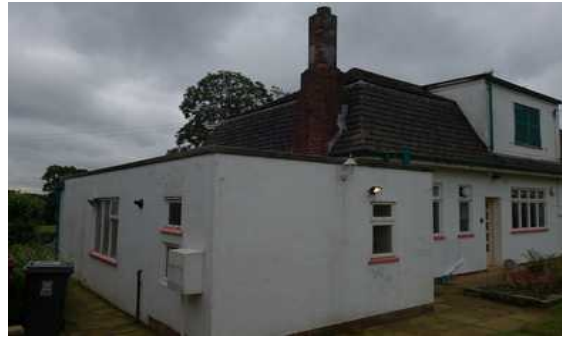
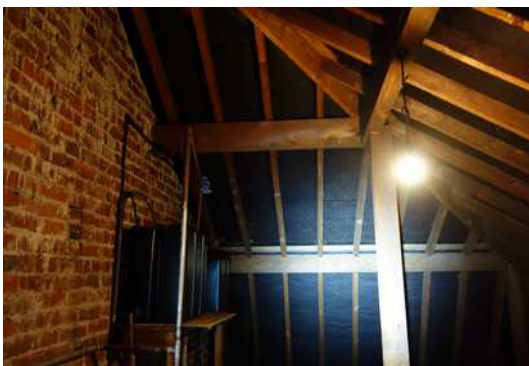
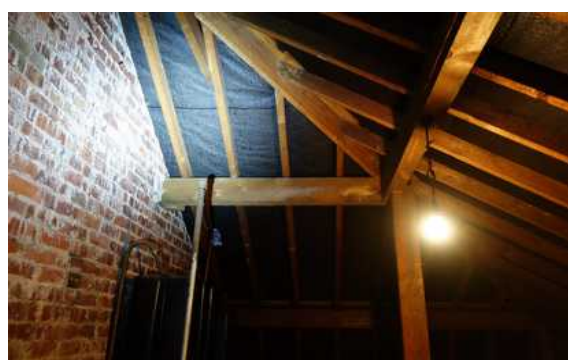
The property consists of a detached dormer bungalow with a hipped slate roof. An adjoining single storey flat roofed garage is present on the eastern gable. Roof slates are close fitting with no obvious lifted, slipped or missing slates. Ridge tiles are well pointed and sealed. Lead flashing where present is close fitting.

External walls are well pointed and rendered with no obvious cracks, gaps or crevices. Timber soffits are in good condition and close fitting. Roof slates are lined with a bituminous roofing felt that is in good condition. The lofts are boarded and have lighting present.

The building can be considered to offer negligible roosting bat potential.

The property was assessed as offering negligible roosting potential with no obvious gaps or crevices suitable for roosting bats. Gaps in pointing where present were shallow offering little cover for roosting bats.

No physical evidence of bats grease marks or urine splashing was recorded on or within the buildings despite suitable horizontal surfaces being present and undisturbed. No evidence of bats was observed on the exterior of the building.
