**Dusk emergence survey at**

**6 Southfield Drive,  
West Bradford,  
Clitheroe,  
BB7 4TU**

**Survey Date: 12/6/20**

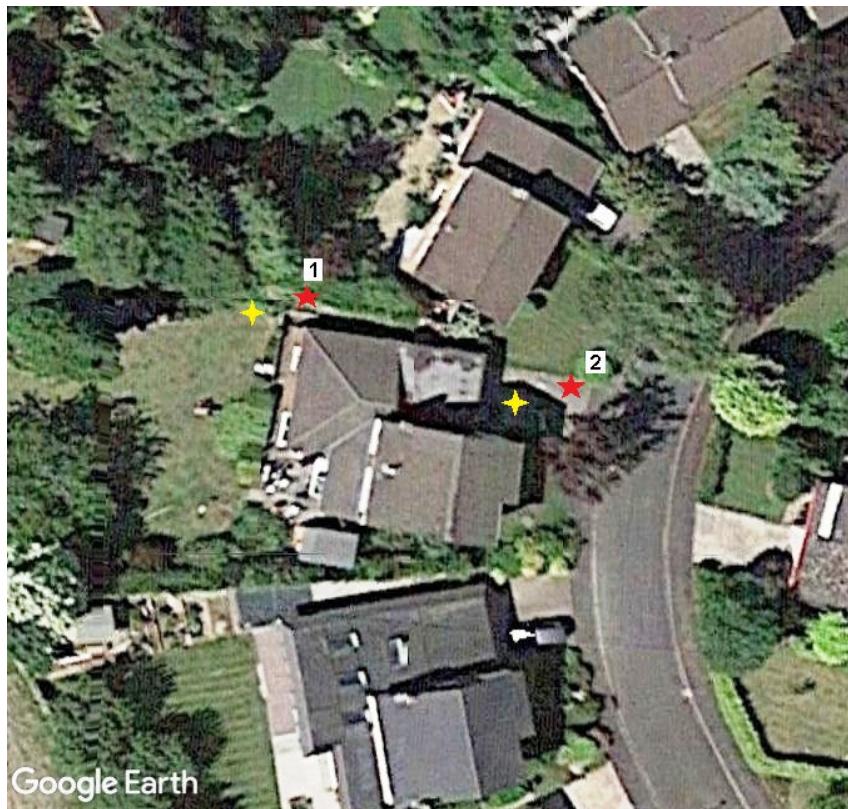
Fig. 1.

I had one assistant with me for the dusk survey. We took up fixed positions to watch for bats leaving the building; at first together at position 1 then as darkness fell separating to positions 1 and 2, as shown in Fig 1 below.

In addition I placed an Anabat SD1 at either side of the gable end. See Fig 1 below. These record bat calls for analysis on computer later. They are extra tools for helping to confirm the species present. The microphones of the detectors used are not water-proof, so recording was stopped around 22.00 when rain became heavier.

Key: Approximate locations (1 and 2) of surveyors shown by red stars.  
Approximate locations of recording devices shown by yellow crosses.

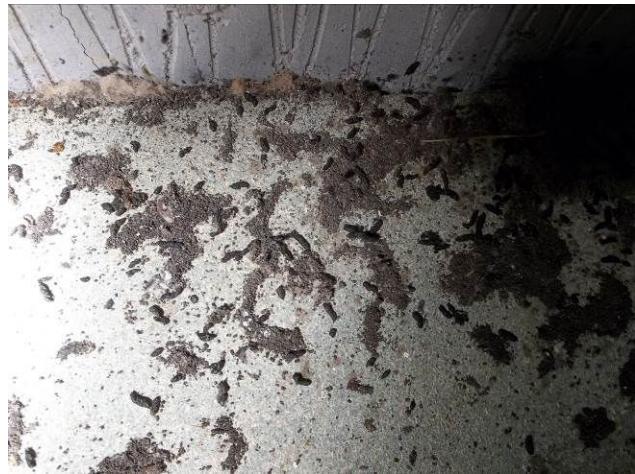
Stored items from near the gable wall had been removed and apparently-fresh droppings had been deposited on top of old:

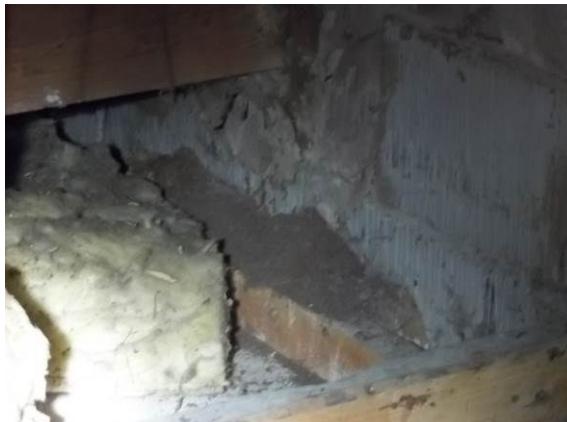
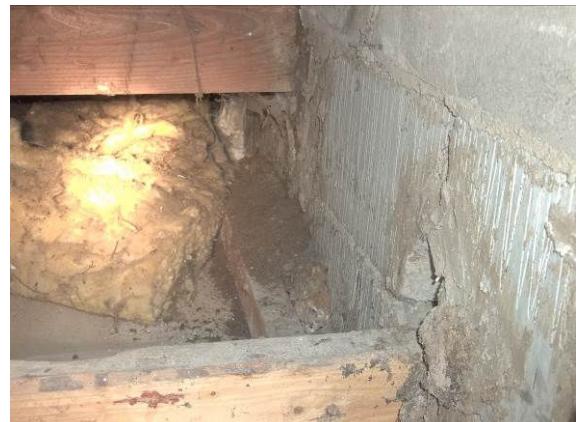
A large pile of apparently, old, disintegrated droppings towards the western end of the gable wall appeared not to have changed, though one fresh dropping was seen:

Pile of droppings as seen on 15/8/19 and 12/6/20

The emergence of two bats from the western end of the gable, ties-in with there being a pile of old droppings in that vicinity in the loft. It is possible that the cavity wall insulation was introduced in the recent past and has limited the available roosting space in that vicinity since.

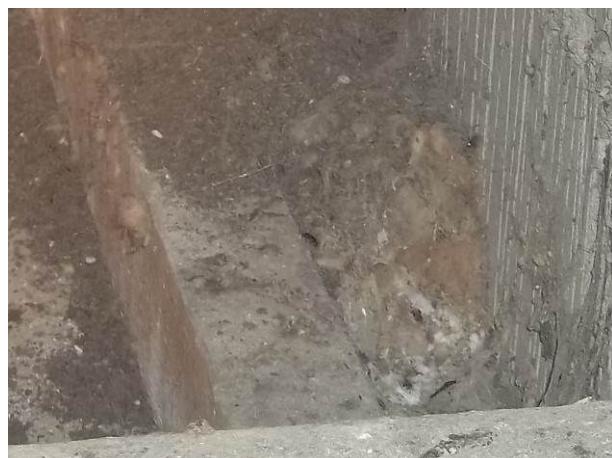
Single fresh dropping on 12/6/20

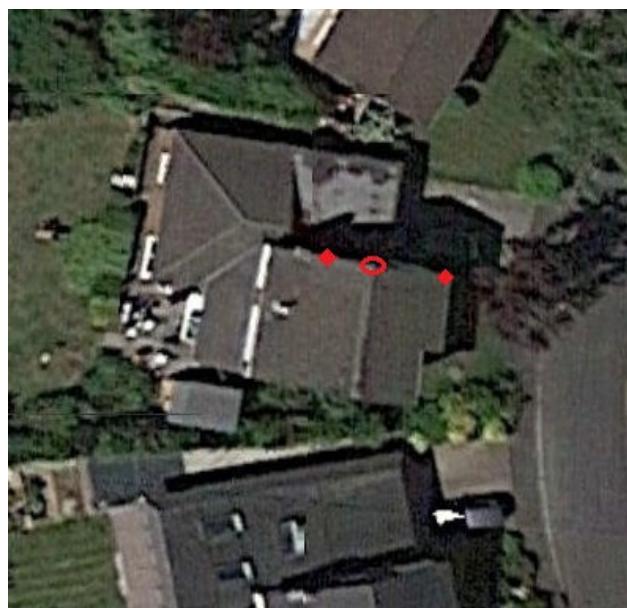
Fig. 1. Key: Approximate emergence locations of bats on 12/6/20 shown by red squares.  
Apex emergence point of 20+ bats on 30 or 31/5/20 shown by red circle

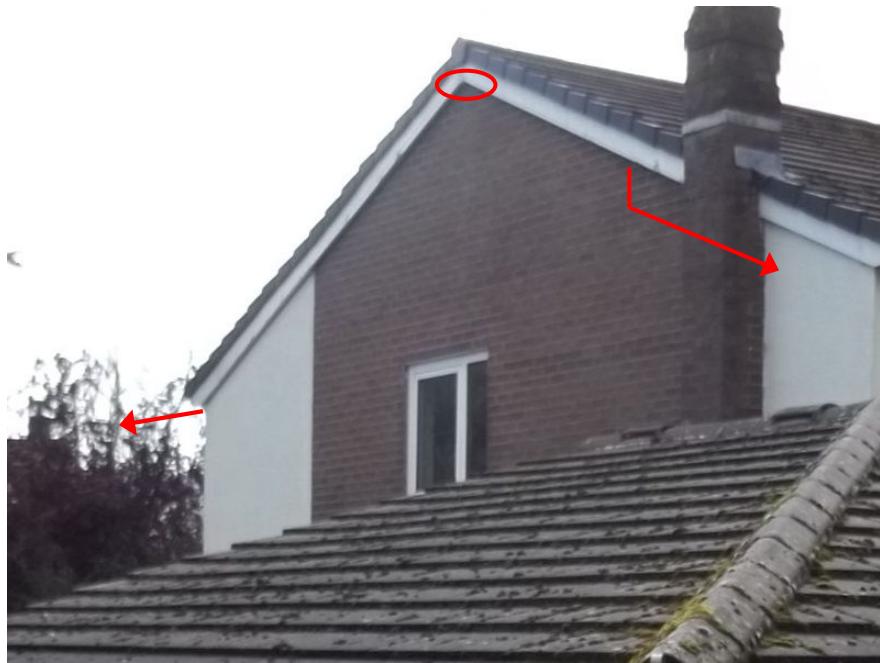
No pre-emergence sounds such as chittering were heard from within the loft, but the client reported having counted 20+ bats emerging from the gable apex over the space of around 10 minutes on **30<sup>th</sup> or 31<sup>st</sup> May**.

Plate 1. Apex emergence point, as confirmed by client, shown by red circle.  
Approximate emergence points on 12/6/20 shown by red arrows.

I understand the plan now is not to tie-in the new roof along any of its length, leaving a drop of around 0.5m between the eaves of the existing house the roof of the new extension, at the western end of the property.

However there will be still be a single-storey element alongside the new two-storey extension. To ensure cats cannot access the new extension roof, to sit below the roost and pick-off bats as they emerge, there will need to be a structure put in place to prevent them jumping from one to the other.

The bat consultant needs to be supplied with the revised drawing illustrating that the two roofs will not be tied in, and giving the measurement of the distance between the existing roof and the extension roof. It should also show a plan to prevent cat access from the single-storey roof to the new extension roof.

Provide the bat consultant with revised drawings showing the proposal as up-dated.

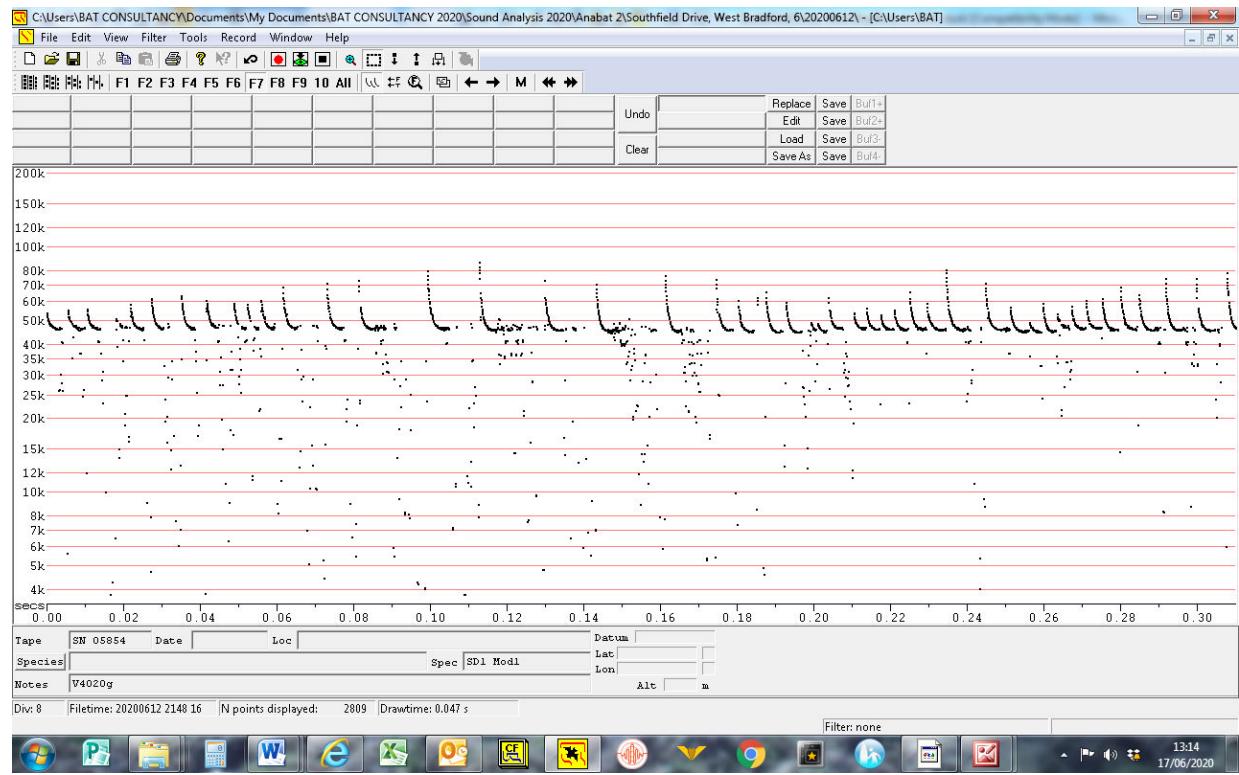
### **Appendix 1 - Example sonogram recorded at dusk survey**

Only common pipistrelles (*Pipistrellus pipistrellus*) were recorded, including one shortly after a bat emerged. It is reasonable to assume therefore that this is a roost of the common pipistrelle.
