Existing Elevations

Site Address	63 Hillcrest Road, Langho, BB6 8EN
Client Name	Mr and Mrs Worden
Date	Sept 2020
Scale	1:100 @ A3

Proposed Elevations

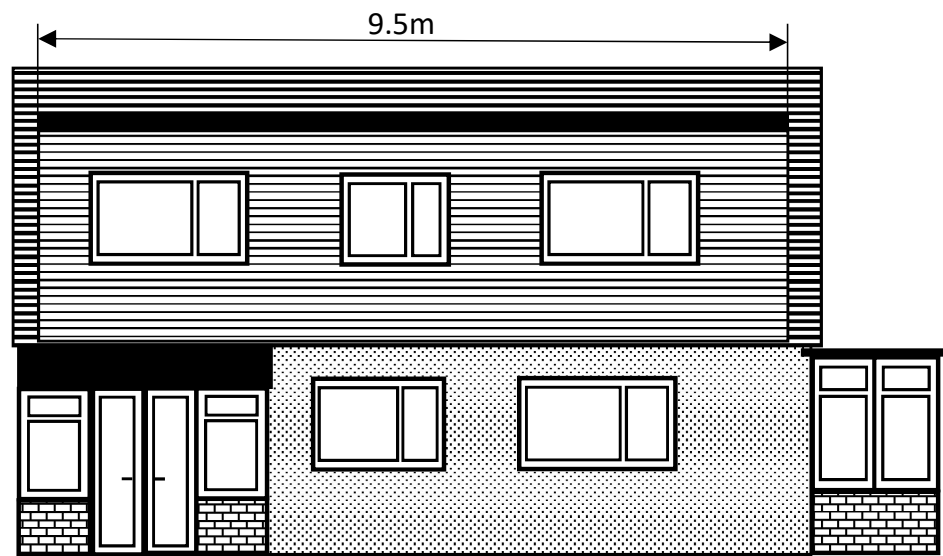
Proposed Side Elevation

- Cladding on dormers to match existing at front of house
- White UPVC windows to compliment existing
- New slate grey roof tiles
- All new drainage to run into existing drain pipes
- Rubber roof membrane to new dormers
- Existing driveway parking for 5 vehicles
- Width of dormer is to wall to gain enough headroom for the stairs to be moved. Currently stairs are in the lounge and for a better fire escape route the stairs are proposed to move to their own hallway with clearer exit route (please see \*).
