**13 York Street**

***Bat Survey Report***

## Executive Summary

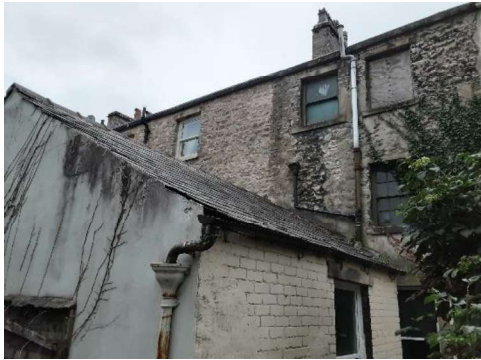
**Figure 2:** View of the north-western elevation, with a single storey extension.

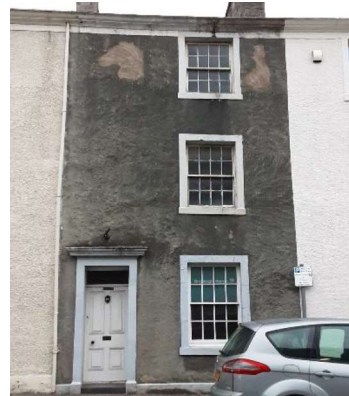
**Figure 3:** View of the south-eastern elevation.

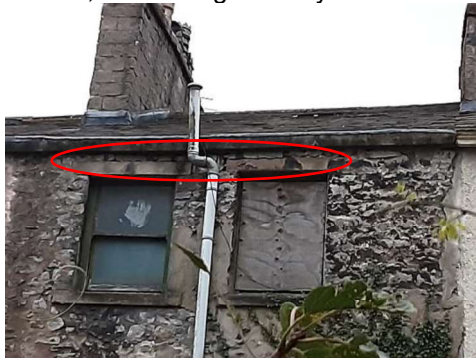
**Figure 4:** Collection of crevices within the brickwork (circled) and boarded up window on north-western elevation.

- Missing/lifted tiles;
  - The timber board covering a window on the third storey; and
  - Crevices within the brickwork on the north-western elevation as a result of missing mortar.

- 4.4 Due to the presence of the aforementioned roosting features which could be used by opportunistic individual bats, the building was assessed as providing **low** potential to support roosting bats.

- Removal of the wooden board on the third storey window and any works to the roof structures will be undertaken carefully and systematically, by hand;

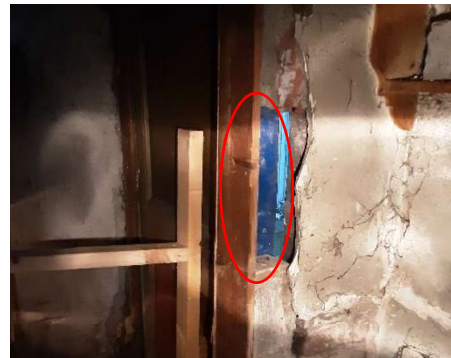
- 3.9 A single door and two windows are present on the ground floor of this elevation, a single window is present on the second storey and two windows are present on the third. A gap (approximately 10 cm x 30 cm) is present in the stonework adjacent to the door's wooden frame (Figure 5), this feature may allow access for wildlife into the internal space. The stone lintels of the windows are well sealed, with the exception of the two windows on the third storey, here narrow gaps are present between the lintels and the stonework above (Figure 4); these features may offer roosting opportunities for small numbers of crevice dwelling bats. A window on the third storey has been boarded up (Figure 4); any gaps present between the board and the wooden window frame may offer roosting opportunities for small numbers of crevice dwelling bats.

**Figure 5:** Gap adjacent to the rear doorway (circled).

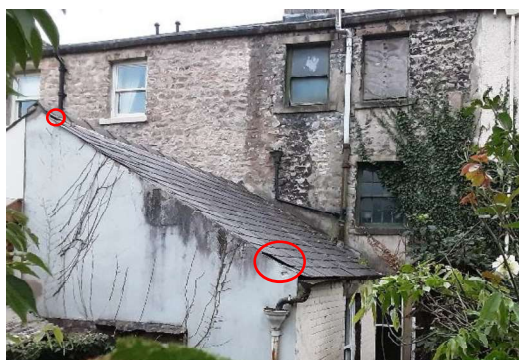
- 3.10 Both the main building and the rear extension have a pitched slate-tiled roof. Overall, both roofs appear to be in good condition, however occasional lifted tiles were noted throughout. A single missing roof slate was noted on the bottom north-western corner of the rear extension. Overall, the ridge tiles appear to be well sealed, however a small area of missing mortar was noted on the north-western corner of the rear extension. The aforementioned features are considered to provide roosting opportunities for small numbers of crevice dwelling bats as well as potential access to between the roof tiles and the roof membrane. Two chimneys are present on the roof of the property; the

**Figure 6:** Location of missing tile and area of missing mortar beneath ridge tile on rear extension (circled).

- 5.3 Bat roost features can also be designed into the new extensions, including:
- Installation of Morris bat slates on the roof pitches to replace lifted tiles and provide access points to the space between the slates and roof liner;

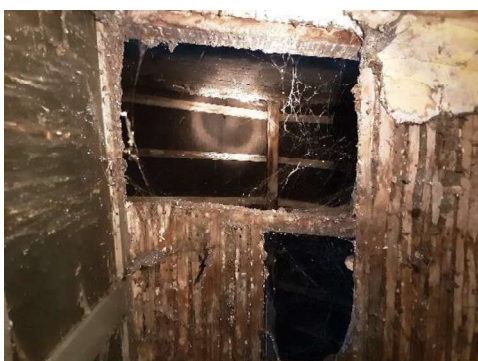
- 3.11 Internally, the house has been separated into a series of rooms which are currently vacant. Although access into the internal space is possible via a gap in the brickwork adjacent to the rear door (Figure 5) and potentially through gaps behind the wooden board on the third storey (Figure 4), the internal space is considered unsuitable for use by roosting bats due to the absence of suitable roosting features and the bright nature of the rooms. The third storey ceiling is in a poor state of repair; the ceiling is warped in places and numerous gaps are present (Figure 7), allowing access for wildlife between the internal living space and the loft space. The roof is constructed of timber beams and a roof membrane is present beneath the slate tiles (Figure 7); no gaps were noted within the roof membrane. The presence of a large skylight (Figure 8) within the roof results in a bright loft space; as such, the loft space is considered unsuitable for use by roosting bats.

**Figure 7:** Gap within ceiling of third storey, through which the lined roof is visible.

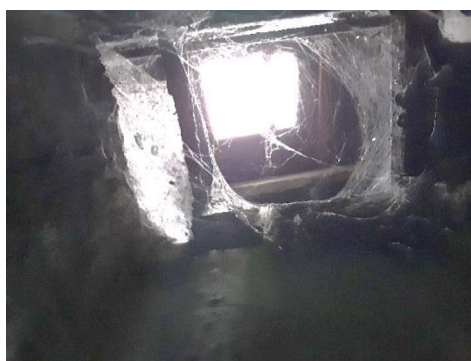
**Figure 8:** Large skylight within the roof visible through gap in ceiling.

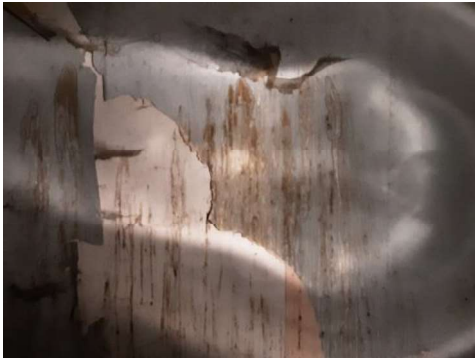
- 3.14 An abundance of old bird droppings was recorded on the wall of the third storey rear bedroom (Figure 9); also noted within this room was a collection of bird skeletons and suspected old nests which had been swept into a corner on the floor (Figure 10). It is considered likely that birds have previously used this room for nesting, likely gaining access from the window which is currently boarded up. Due to the absence of fresh evidence and the presence of a board covering the window, it is considered unlikely that this interior space has recently been used by nesting birds.
- 3.15 A small area of ivy clad is present on the north-western elevation. Due to the thin nature of the ivy clad, it is considered to provide **negligible** potential to provide nesting opportunities for nesting birds.

**Figure 9:** Collection of bird droppings within third storey rear bedroom.

- 5.4 Contractors must undertake care and due diligence during the works; prior to the commencement of the works, the internal space must first be checked for the presence of any live birds by the contractors. If any live birds are present, all works must stop and the animal allowed to leave the area of its own accord. If nesting birds are present, no works will be carried out within 5 m of an identified nest until the young have fledged and are no longer returning to the nest site. Works will only be undertaken once a scheme ecologist has declared the nest to be no longer in use

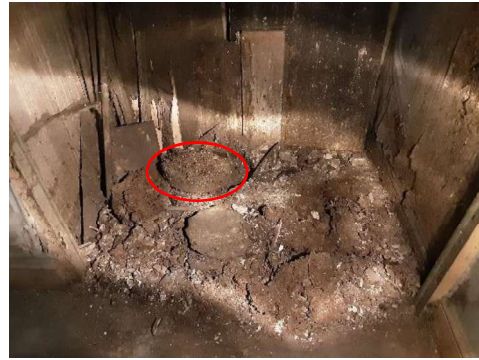
**Figure 10:** Suspected old bird nesting material within third storey rear bedroom (circled).

- 4.7 Although evidence of past nesting birds was noted within the third storey rear bedroom, the presence of existing/future nesting birds is considered highly unlikely due to presence of a wooden board blocking the likely access point. As such, the proposed internal renovation works at York Street are considered highly unlikely to cause a negative impact to nesting birds.
