**67 Hillcrest Road,
Langho, Blackburn,
Lancashire
BB6 8EN**

**Survey & Assessment in Respect of Bat Species,
and Nesting Birds.**

10^h July 2020

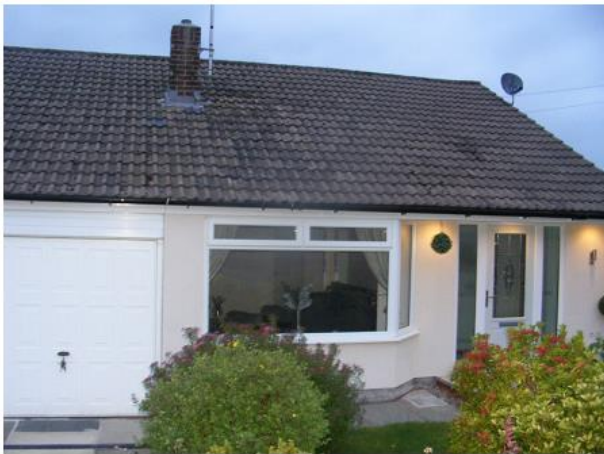
PHOTO 1
Southern Elevation

The bungalow had been built from brick, with both the northern and southern elevations covered in render. The building was currently occupied and was heated, insulated, and in a good state of overall repair, with well-sealed soffits and roof, and the render covering was also sound, and well kept. Thus overall, the bungalow was assessed to offer very little bat roosting opportunity, (refer to **figs 3 and 4**, and **photos 1 to 8**).

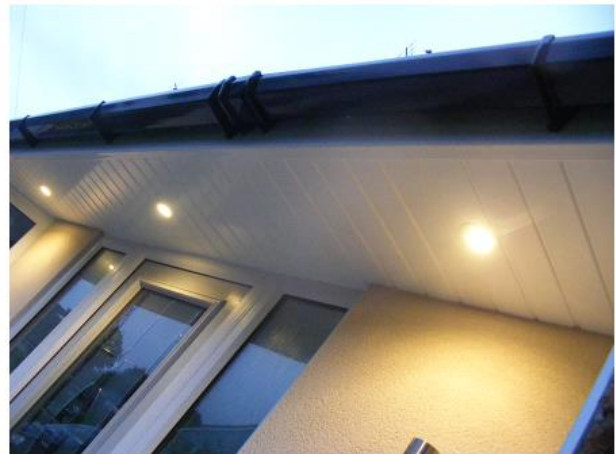
PHOTO 2
Underside of Porch Roof

There was a small entrance porch located at its south-eastern corner, with a flat roof covered in plastic tongue and groove planking, and no roof void. Also, positioned at the south-western corner of the building was an integral garage with a flat concrete roof.

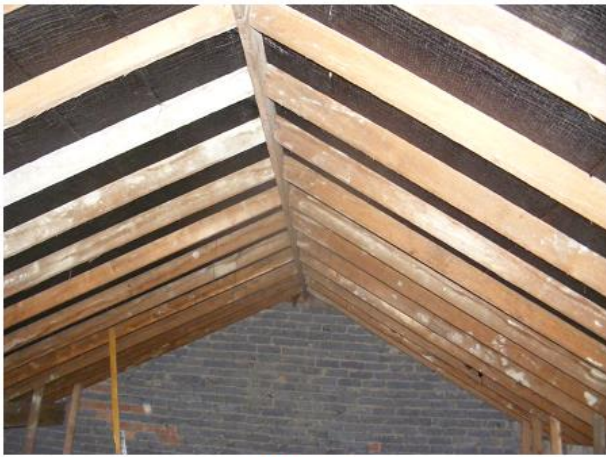
PHOTO 7
Underside of Main Roof

The targeted bungalow was the eastern half of a semi-detached block, with a pitched roof covered in underlined concrete tiles and with an insulated roof void. The western half of the block was not included in the application, and therefore was not surveyed.

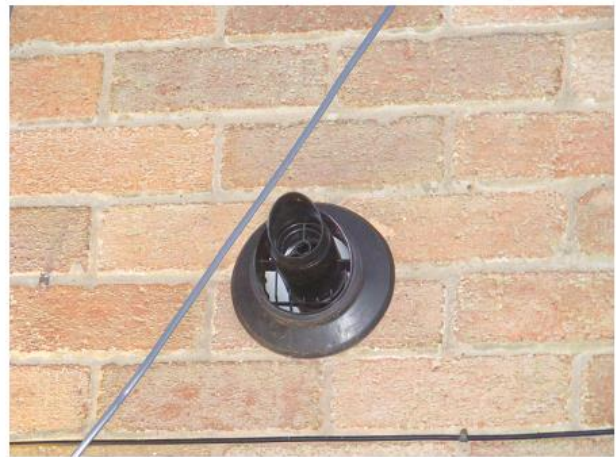
PHOTO 10
Vent in Eastern Elevation

- Positioned centrally in the eastern wall was a ventilation pipe from the bungalow's central heating system, which protruded a short distance with an open end, however it was observed that the pipe contained an internal mesh, and therefore the pipe was concluded to offer no bat roosting potential, (refer to **figs 3 and 4**, and **photo 10**).

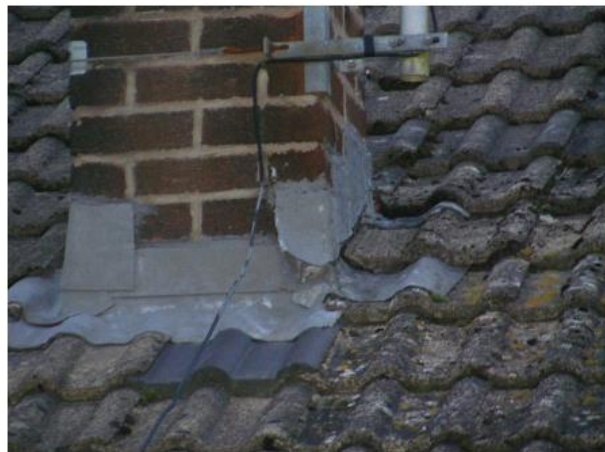
PHOTO 11
Lifted Lead Flashing around Chimney

- A small area of lead flashing had lifted from the south-eastern corner of the chimney, positioned in the southern part of the roof, but again inspection using close-focus binoculars found there to be neither bat droppings, urine or fur staining, nor prey remains, and therefore the gap was deemed to have not been used by roosting bats, (refer to **figs 3 and 4**, and **photo 11**).

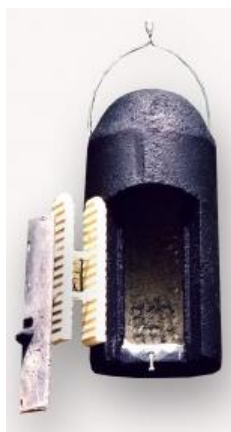
Schwegler 1FD Bat Box

This Schwegler 1FD bat box has been developed specifically for smaller bats. The interior and the type and size of the entrance hole match the requirements of smaller species. It features a special layout inside the domed roof, an increased interior height, and two grooved internal wooden front panels with precise spacing between them.

These boxes are to be erected as recommended by the Bat Conservation Trust guidelines which state that:

- Ideally, erect the boxes facing so they face in different directions, to provide a range of temperature conditions. For example, boxes facing from south-east to south-west allow the sun to fall on each box for part of the day. During very hot days a south-facing box may overheat, but the other boxes should have some shade during the day.
- Bat boxes should be located close to a linear vegetation feature such as a tree line or hedgerow or to lines of buildings. Some bat species use these features for navigation between their roosting site and feeding ground and to avoid flying in open and exposed areas.
- Ensure that tree branches or other items will not impede the bats’ approach to the box – clear away underneath the box so the bats can land easily before crawling into the box.
- Boxes should be erected at a height of approximately 4m above ground level
