**ENVIRONMENTAL SCREENING FOR:**  
**LAND AT THE SOUTH SIDE OF RIDDINGS LANE**  
**WHALLEY**  
**BB7 9SF**

**ON BEHALF OF:**  
**THE BROCKHALL PROPERTIES SYNDICATE SIPP**

**PROJECT REF: 6712**

**REPORT DATE: 1 NOVEMBER 2018**

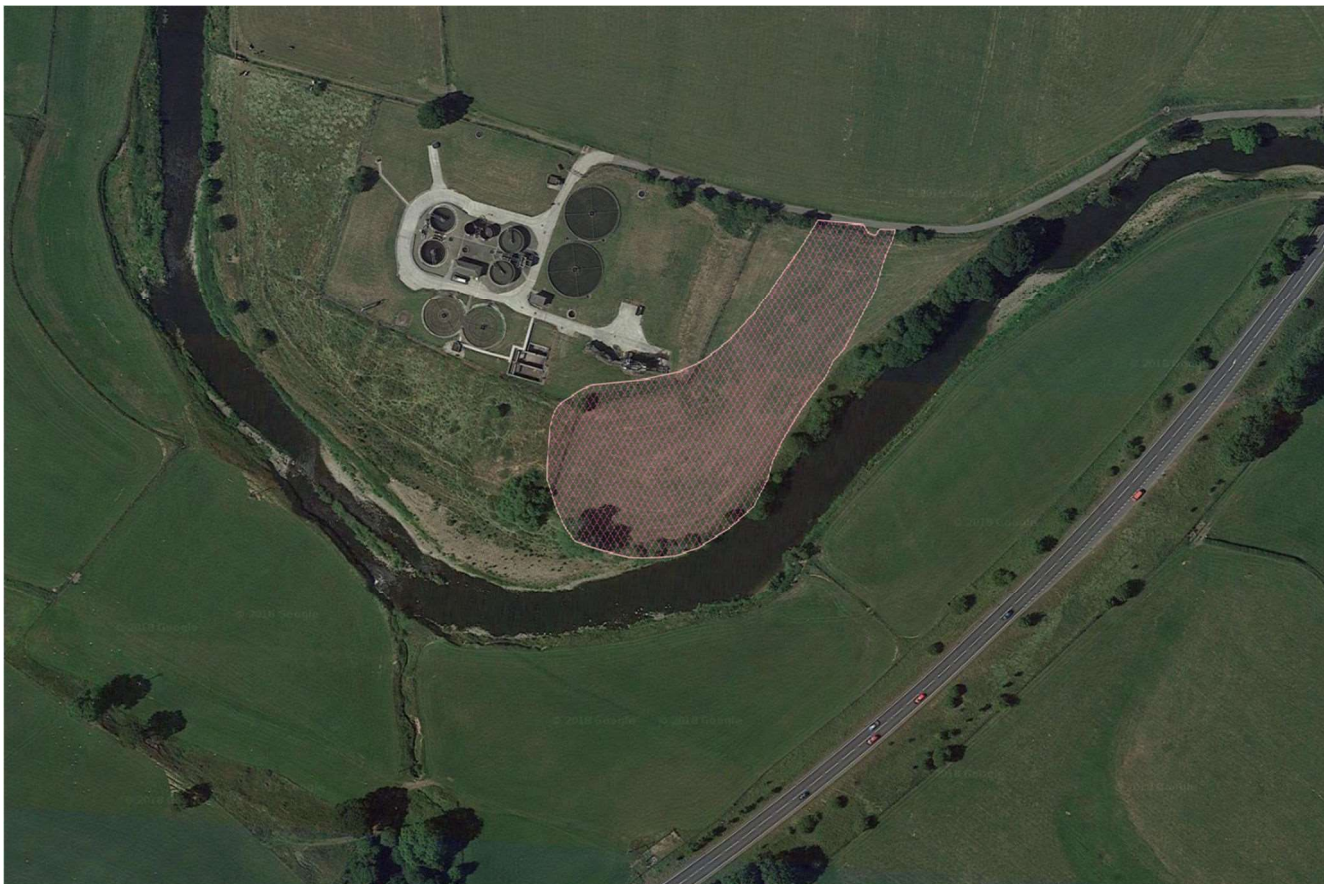
- 6.6 The aerial extent of the landfill according to the Environment Agency is as follows:-

- 6.7 This historic landfill ceased operation on 31<sup>st</sup> December 1973. It is known as the “Whalley Sewage Works” site and has the waste reference EAHLD07127. The organisation that deposited the waste is not known. It contained the following waste classifications:

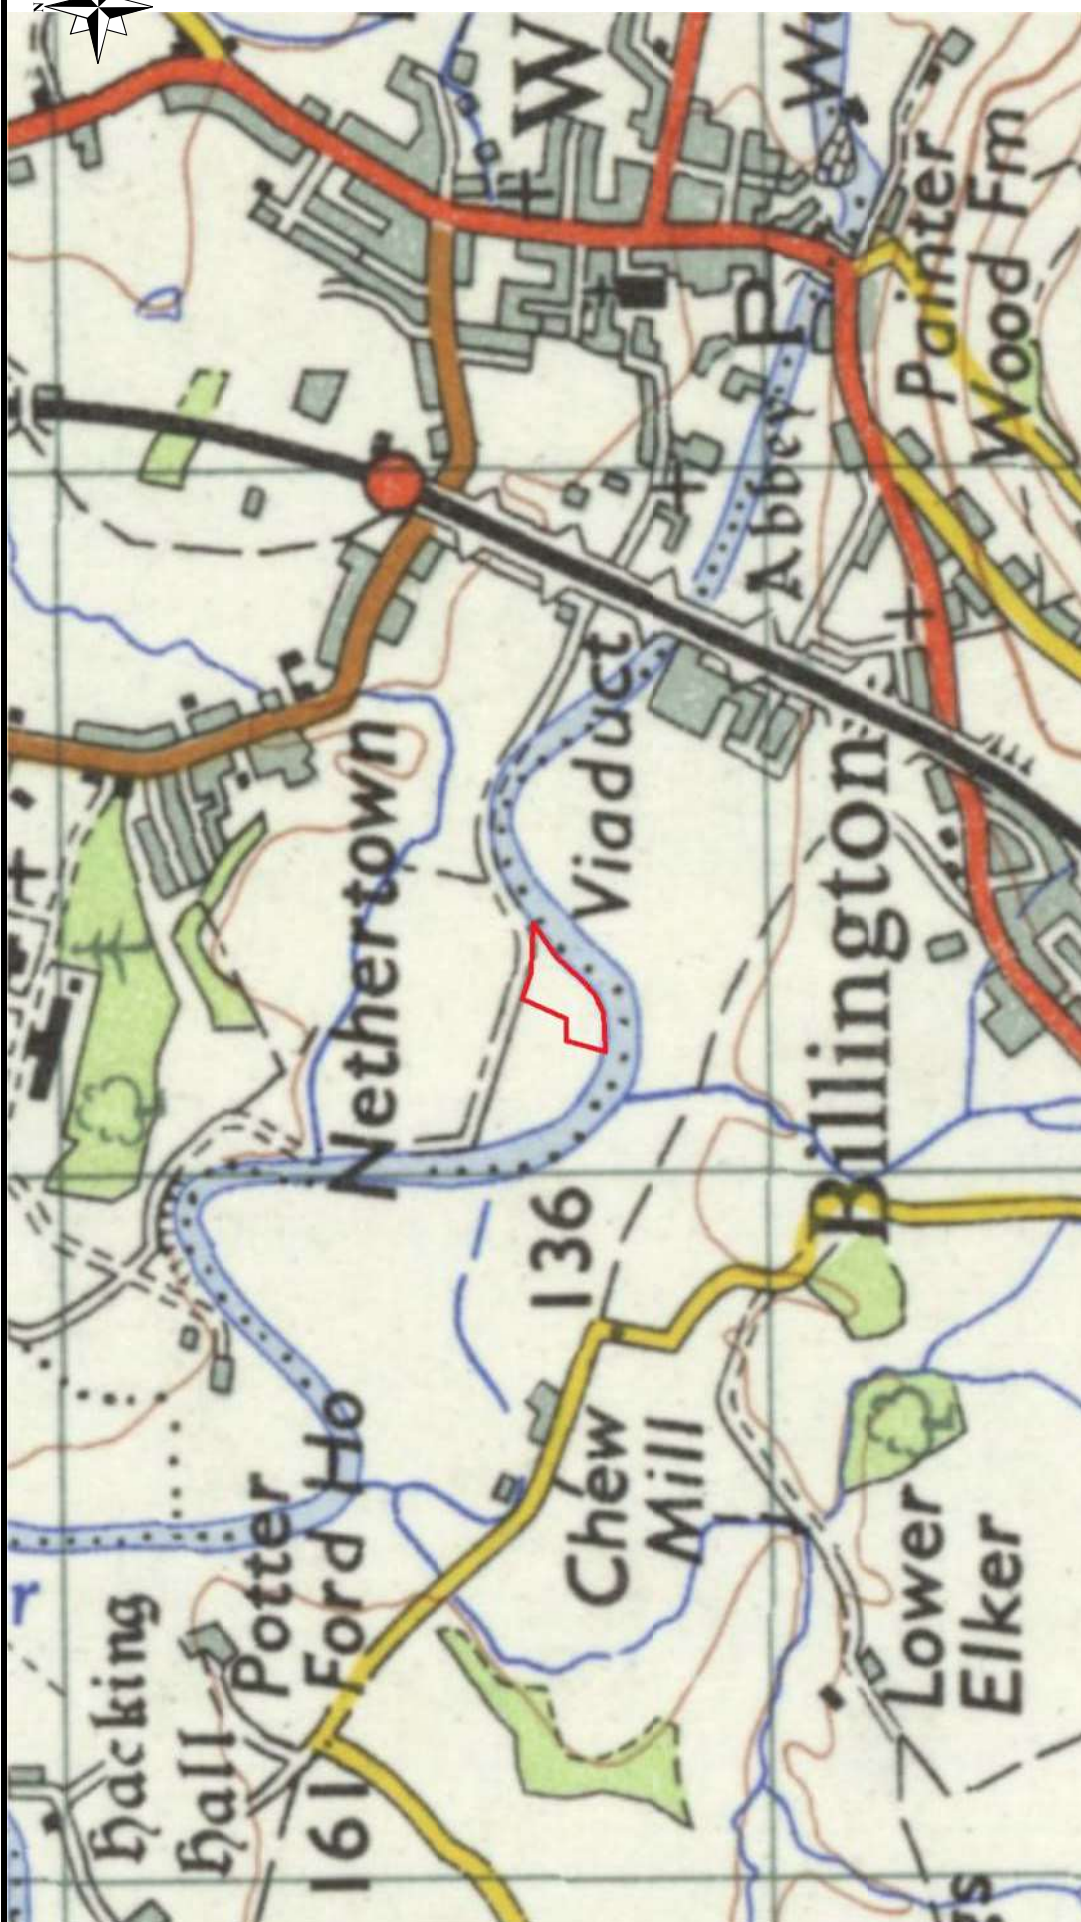
| Project: <b>Land at the south side of Riddings Lane,<br/>Whalley BB7 9SF</b> | | Drawing: <b>9</b> | |

- 2.13 There are no material changes from the preceding extract of the Ordnance Survey.

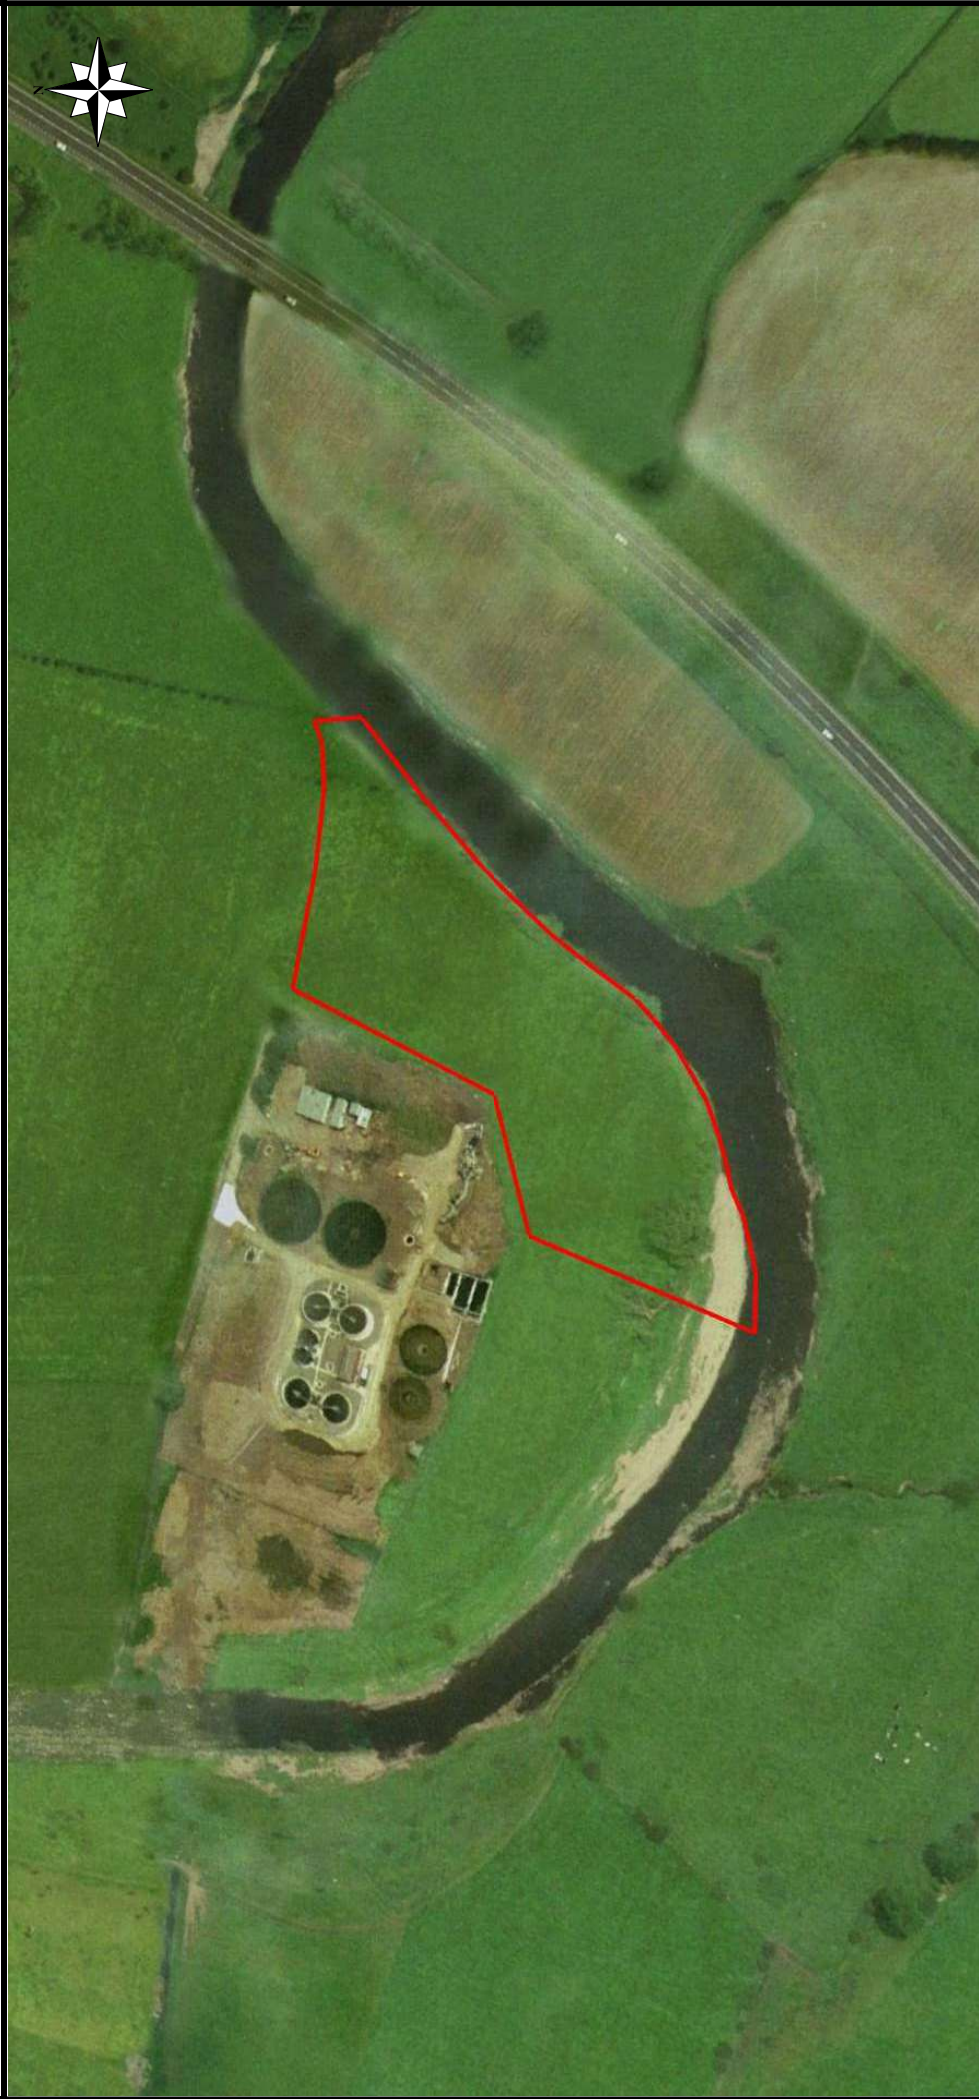
| Date: | 01 November 2018 | | Drawing: | 10 | |

- 2.14 Although not clear the site was used as a land fill with the last operation taking place in 1973. However, this operation was related to heaped materials not after an excavation. Henceforth the modern topography where the land rises significantly higher than the surrounding agricultural land and the sewage farm.
- 2.15 The route of Riddings Lane is not visible and the sewage works to the west appears to be no longer in use. The site appears derelict

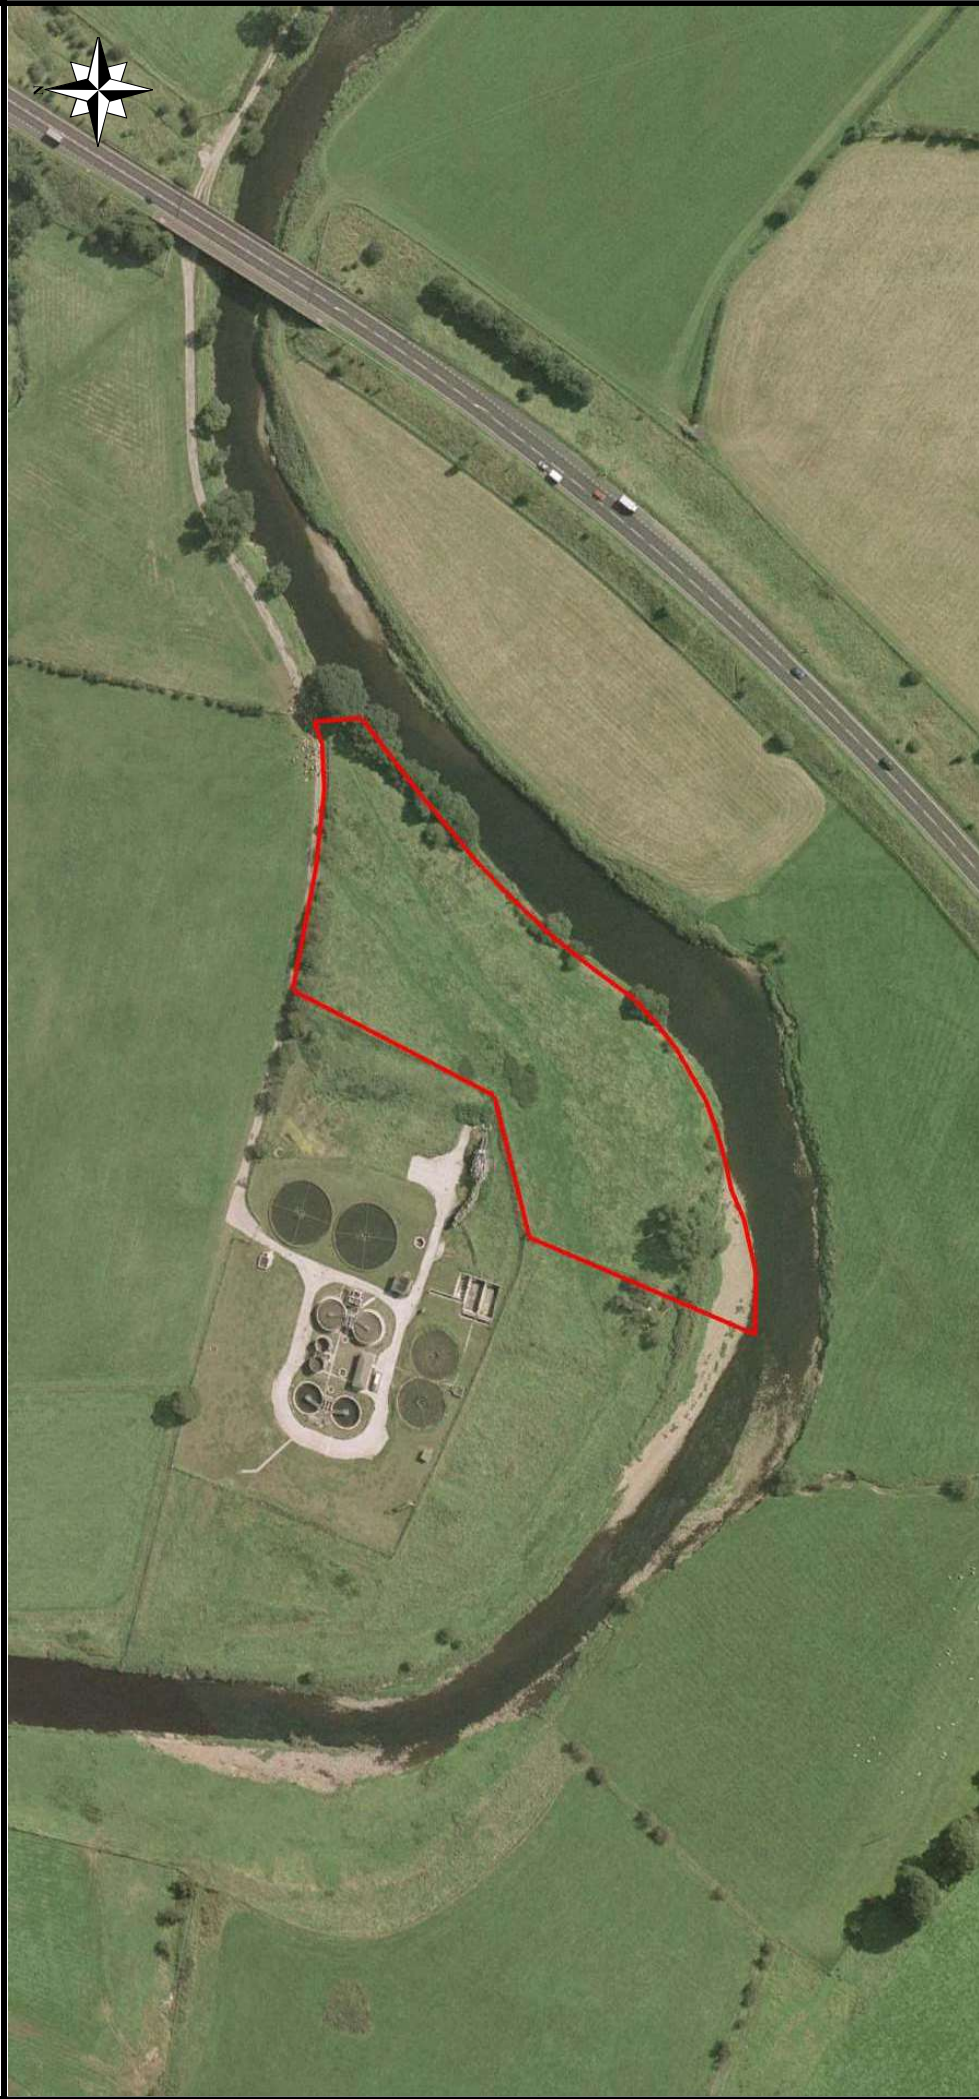
| Project: <b>Land at the south side of Riddings Lane,<br/>Whalley BB7 9SF</b> | | Drawing: <b>11</b> | |

- 2.16 The sewage works has been regenerated and the subject site remains in agricultural pasture use.

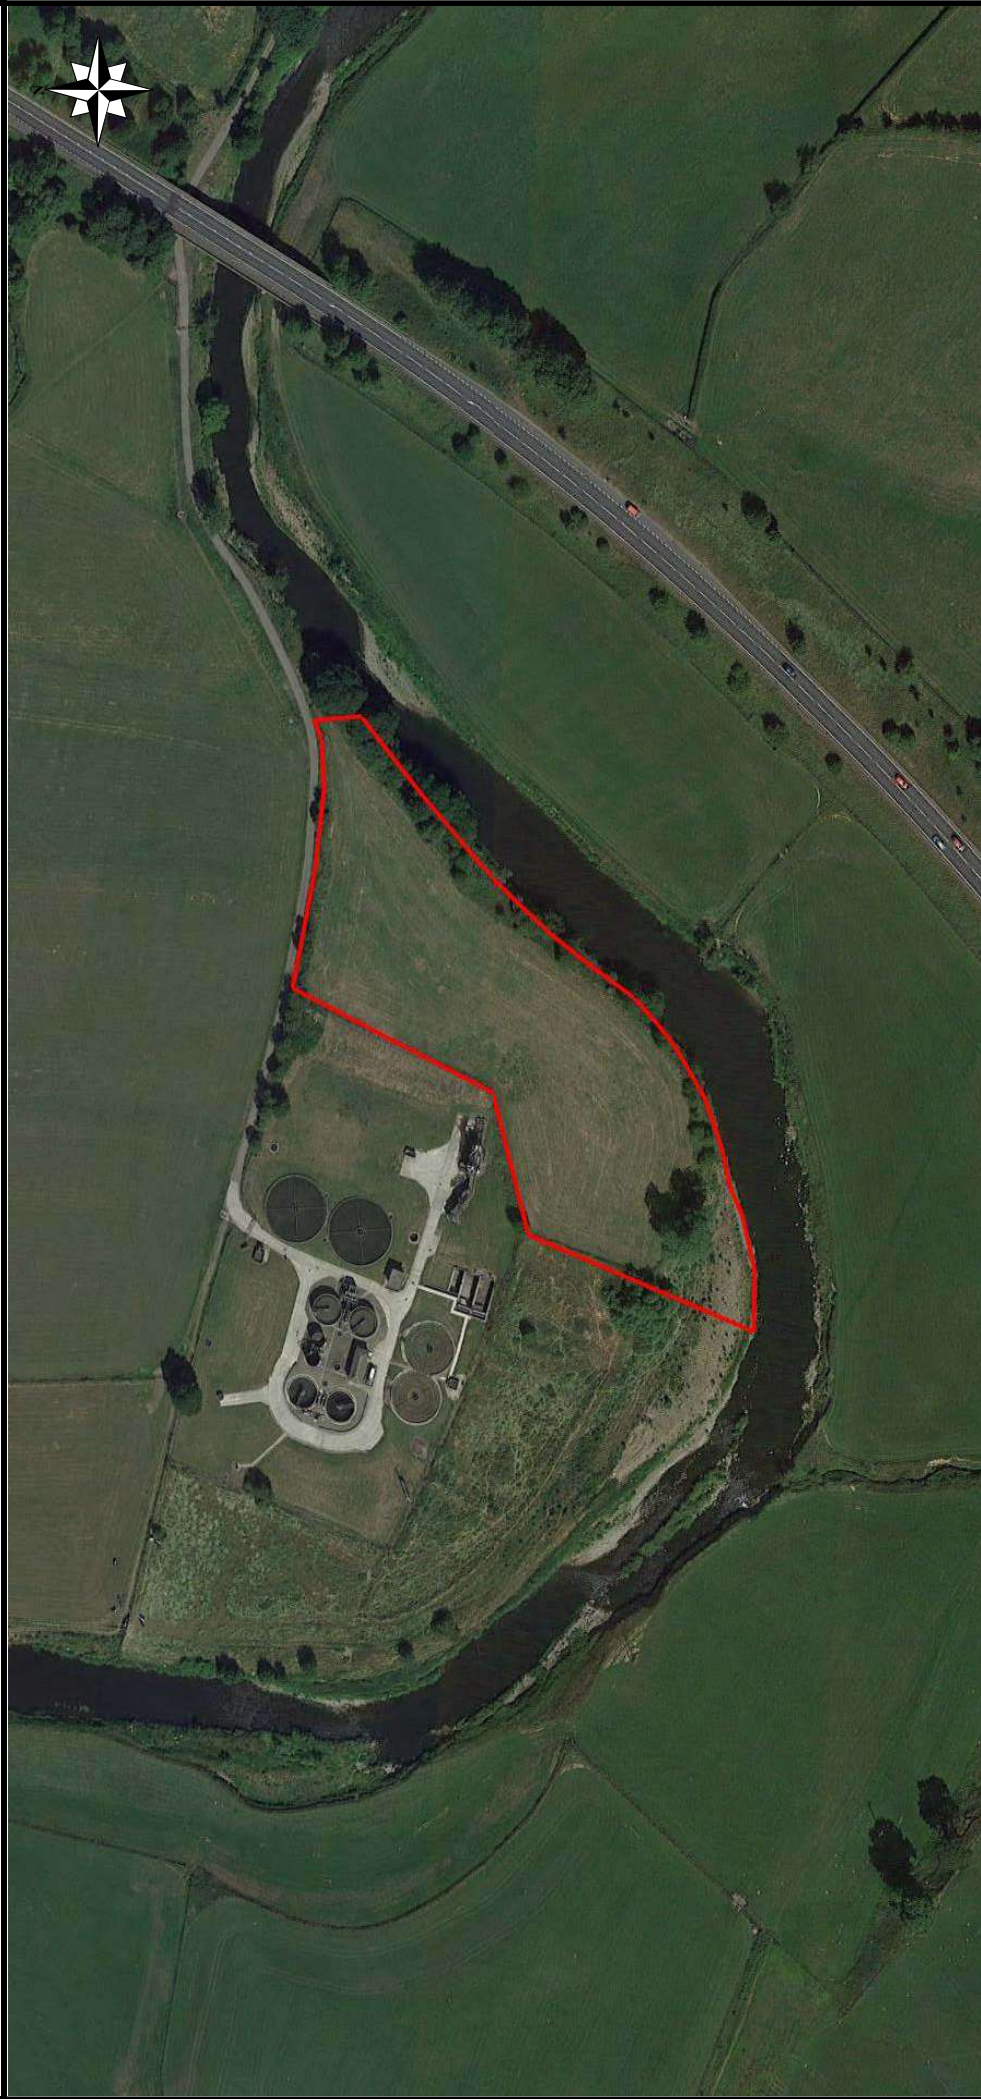
| Project: <b>Land at the south side of Riddings Lane, Whalley BB7 9SF</b> | | Drawing: <b>12</b> | |

- 2.17 There are no material changes from the preceding aerial extract.

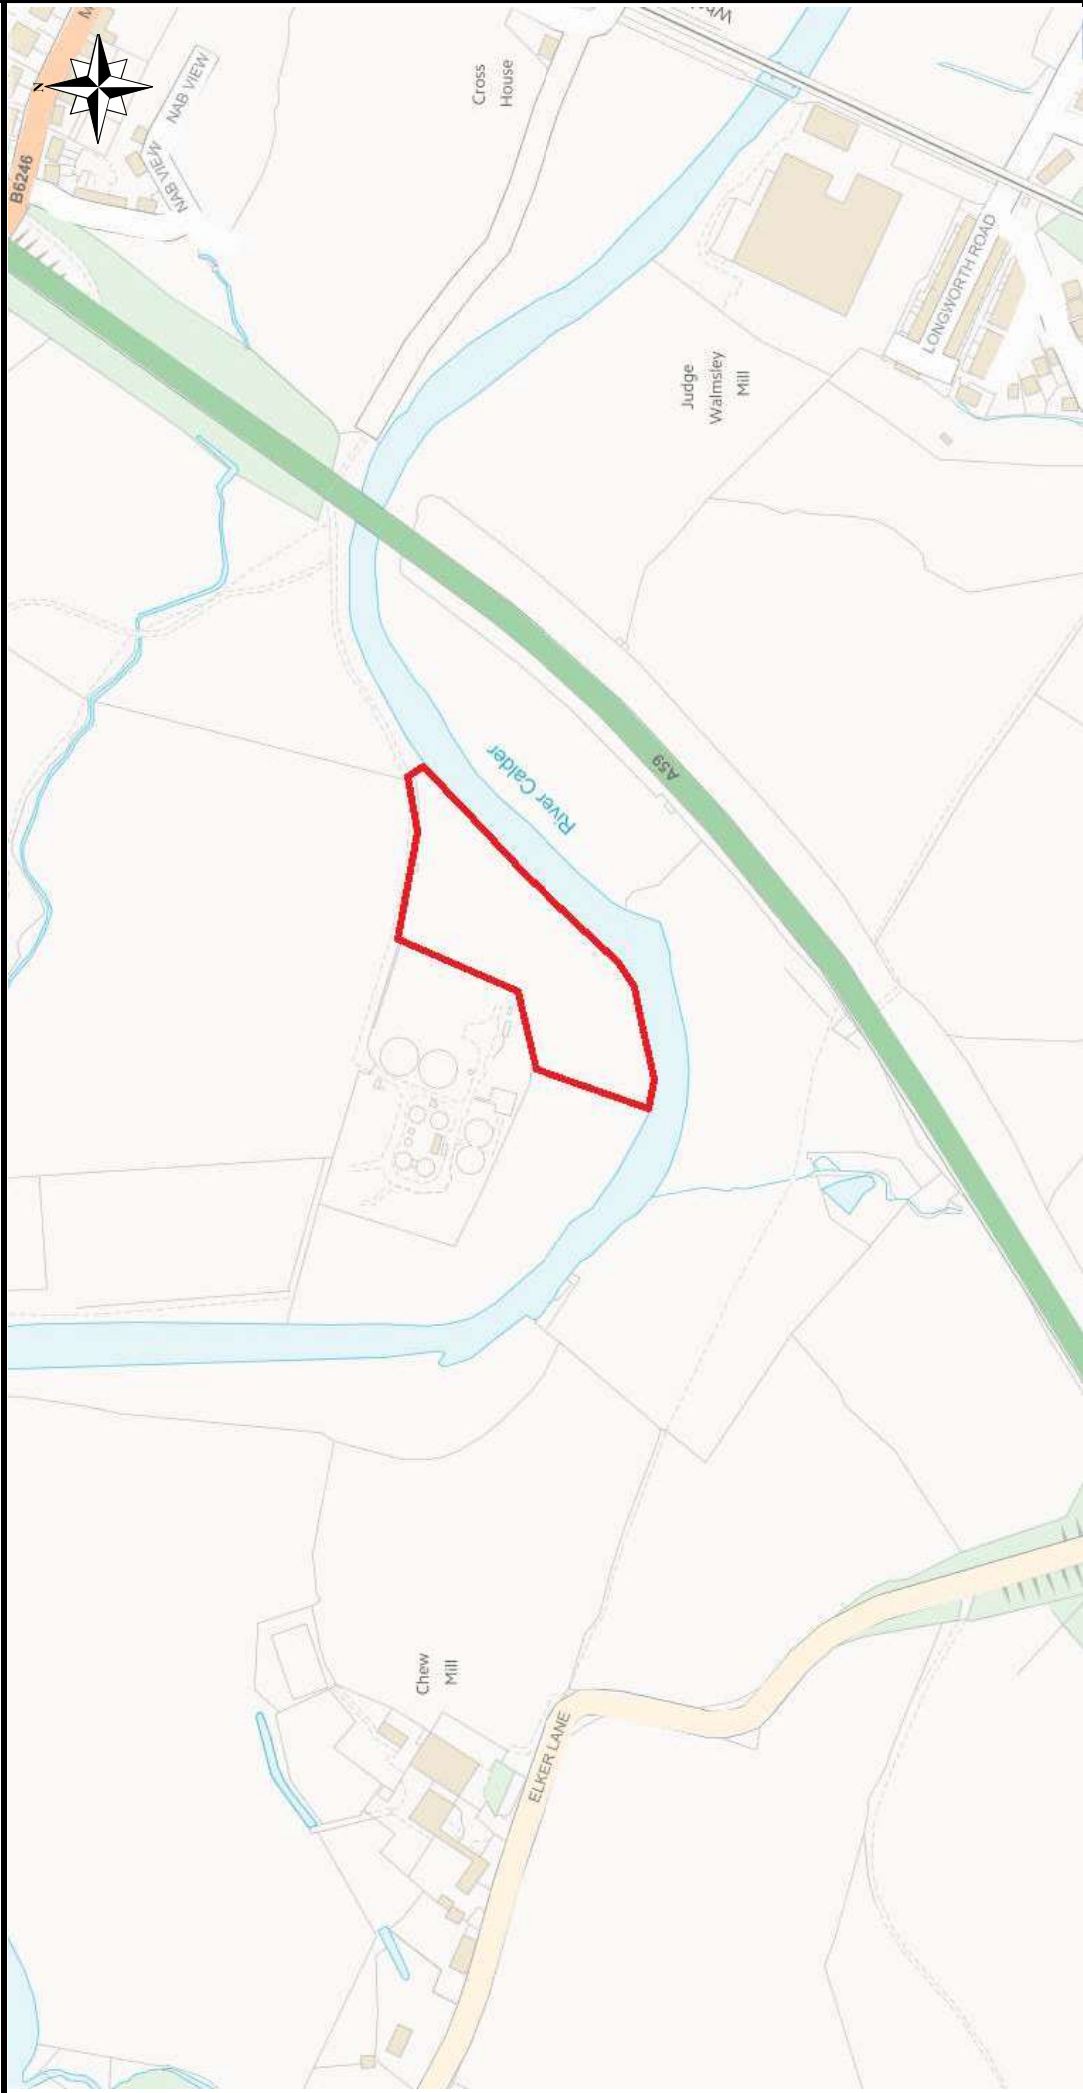
| Client: <b>The Brockhall Properties Syndicate SIPP</b> | Title: <b>Extract From<br/>Ordnance Survey<br/>of 2018</b> | |

- 2.18 There are no material changes from the preceding aerial extract.

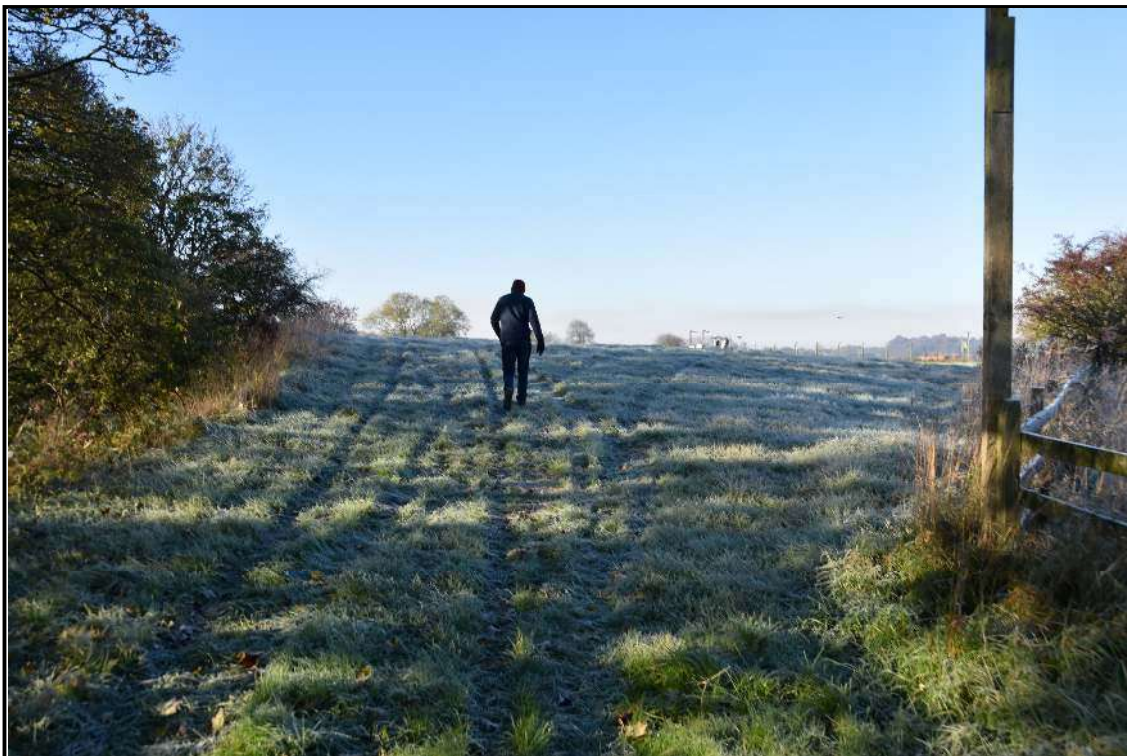
3.6 The site comprises pasture which is verdant and in good condition. Topographically the site rises to form a small raised area reflecting the deposit of materials on it in 1973. The site is approximately 4 metres higher than the surrounding land at its peak.

3.8 The topography comprises heaped materials but there is no evidence of subsidence or visual evidence of what was deposited in the site in 1973.

**Plate 3      Raised heap from the main entrance**

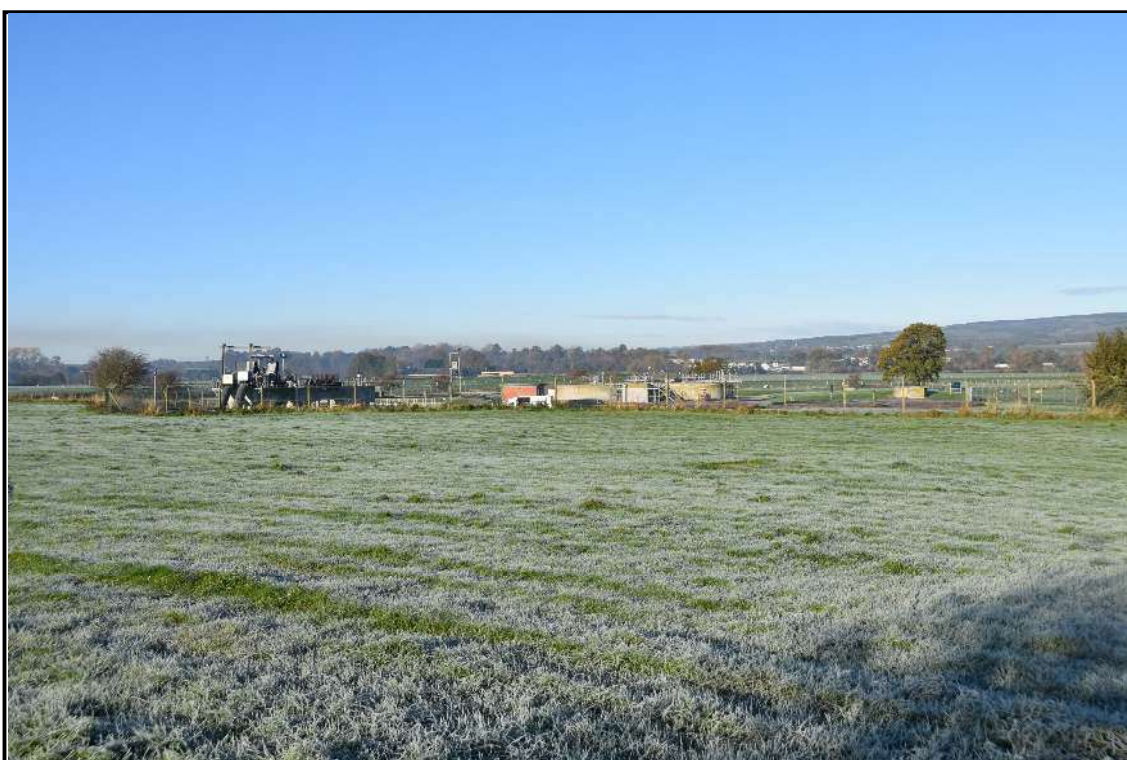
3.9 The onsite representative reported that the site has not flooded. It is certainly significantly higher than the surrounding area

**Plate 4      Elevation above the neighbouring sewage works**
