PRELIMINARY ECOLOGICAL APPRAISAL

- Land at: Ingledale, Clayton le Dale, Lancashire -

May 2019 Updated October 14th 2020

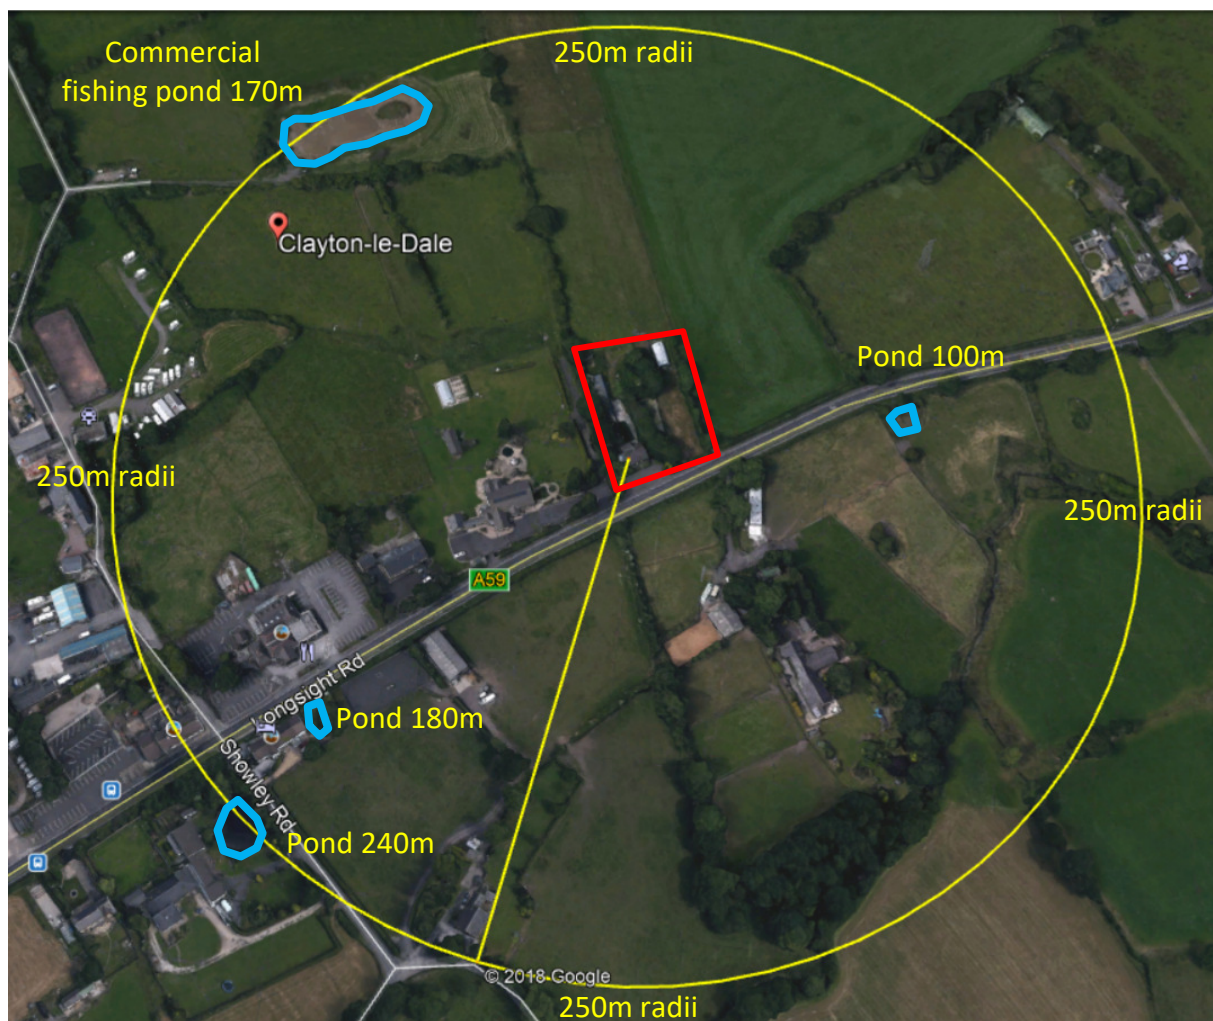
There are four ponds within 250m of the proposed development. These are shown on the above aerial photograph together with the distance from the nearest point of the site.

There is one pond approximately 170m NW of the site, this is a commercial fishery and totally unsuitable for the species.

There are three ponds on the other side of the busy A59 Longsight Road at distances of between 100 and 240m from the site. For the purposes of this study it is assumed that GCN could potentially be present in these ponds.

In addition, and in relation to the ponds to the south of the site, these are all located on the other side of the A59 which separates the ponds from the site. This busy road is considered to be a significant barrier to amphibian dispersal towards the site.

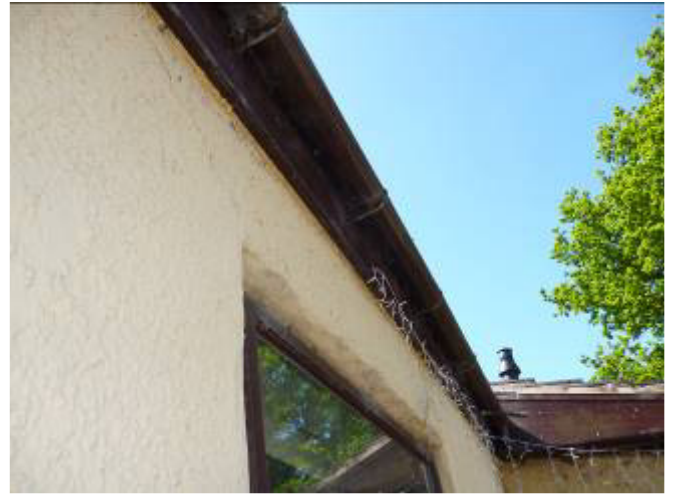
The building is of rendered brick construction with a slate pitched roof. The fascia boards are tight fitting and there are few if any gaps under slates. There are some minor gaps under the roof ridge tiles. There is a loft space but there is no internal access point to the loft.

Fascia boards tight fitting / sealed against render.

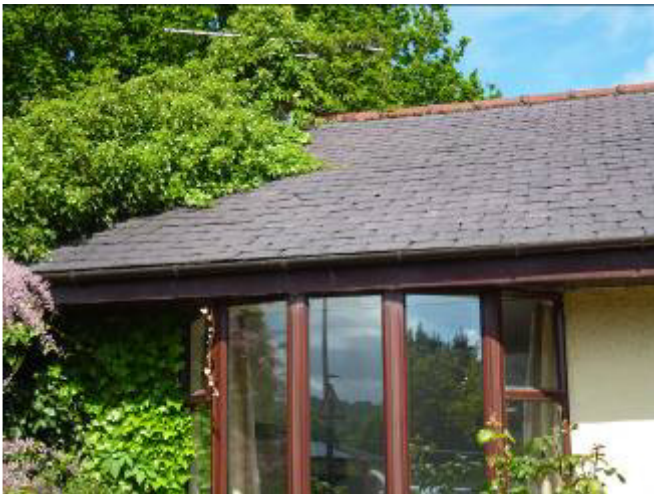
There is negligible roost potential associated with the wall hole and roof ridge tiles.

Existing bungalow with negligible bat roost potential.

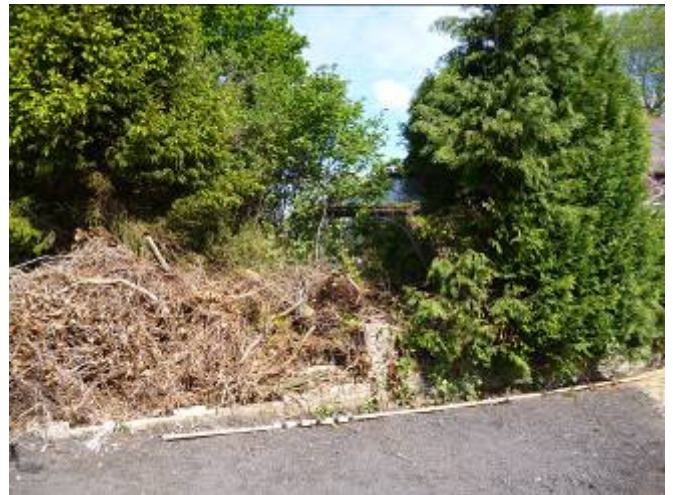
The introduced shrub and ivy on the bungalow have breeding bird potential. The stables are open and also have potential to support swallows, although no current or historical evidence was present at the time of survey. The hedgerows on the boundaries and on site trees are unaffected by the development.

Introduced shrubs adjacent to bungalow.

No strategic bird surveys are required. However, before any development and in order to minimise impacts on birds any removal of introduced shrub / ivy on the building should take place outside of the breeding season, i.e. between the end of August and end of February. Following the removal of shrubs etc., piles of shrub should be removed from the site, failure to do so could provide potential nest sites if left in situ until the following breeding season.

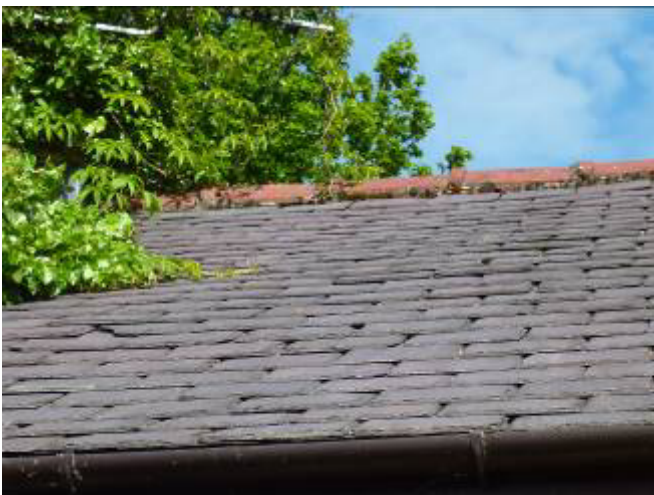
The hole in the bungalow wall and minor gaps under roof ridge tiles have very limited bat roost potential. These are very localised and are considered to have negligible suitability.

Existing bungalow with negligible bat roost potential. Some localised gaps under ridge tiles requiring supervised removal. Slates generally tight fitting.

- Bungalow: Immediately before demolition the hole in the wall will be inspected by endoscope and torch and during demolition the removal of fascia and brickwork in the near vicinity will be supervised. The removal of the roof ridge tiles will also be supervised.

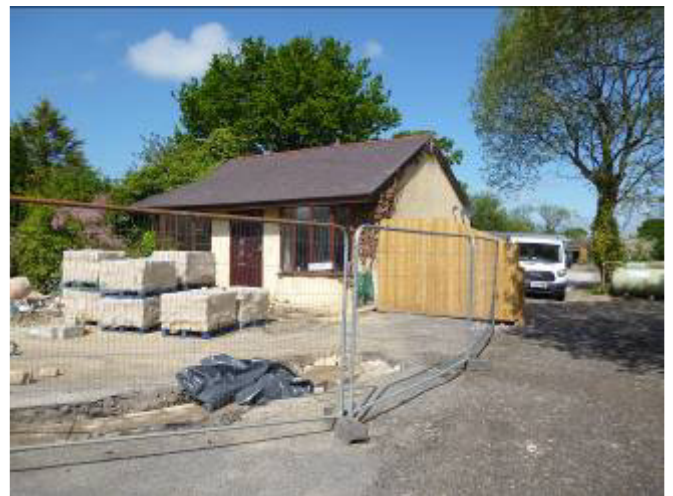
Existing bungalow with negligible bat roost potential.

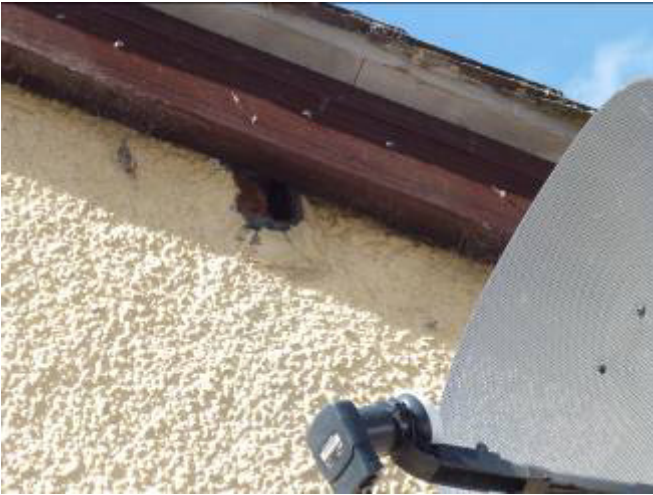
There is a small hole in the wall beneath the fascia on the eastern elevation at approximately 2.5m above ground level.

Small hole on east elevation rendered wall requires precautionary inspection with torch / endoscope.

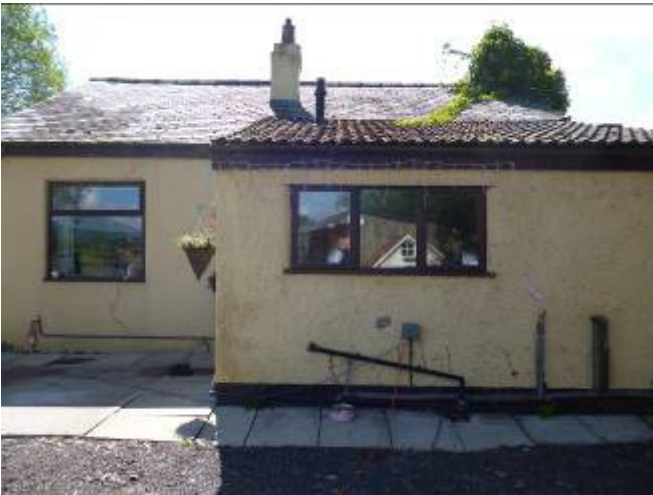
Rear northern elevation of bungalow with negligible bat roost potential.

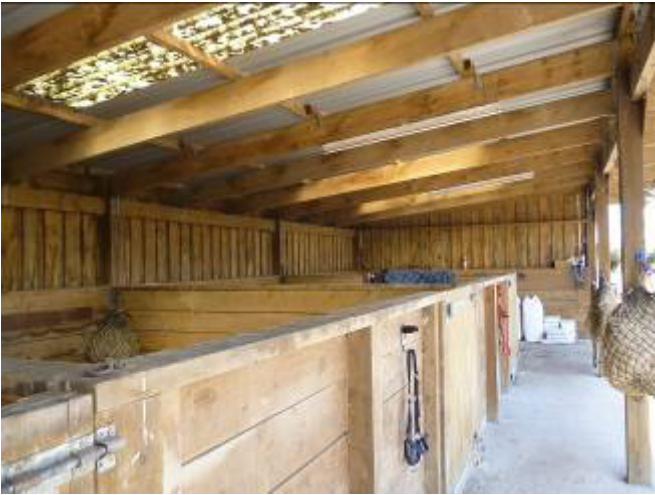
The stables are of timber construction with Perspex / corrugated sheet roof and no lining. There are no potential bat roost features.

Wooden stable block with negligible bat roost potential.

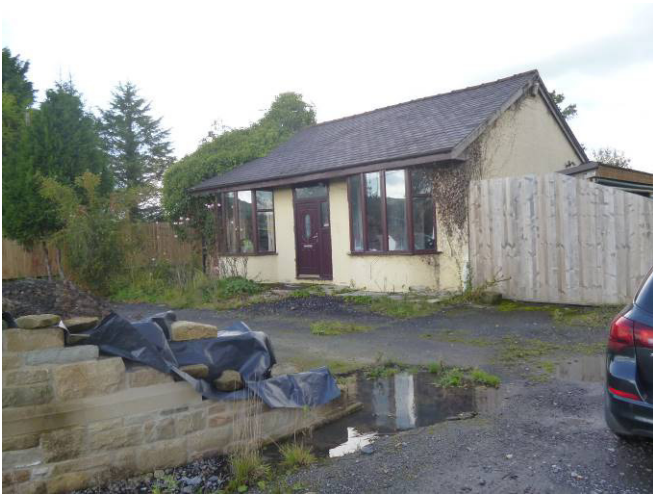
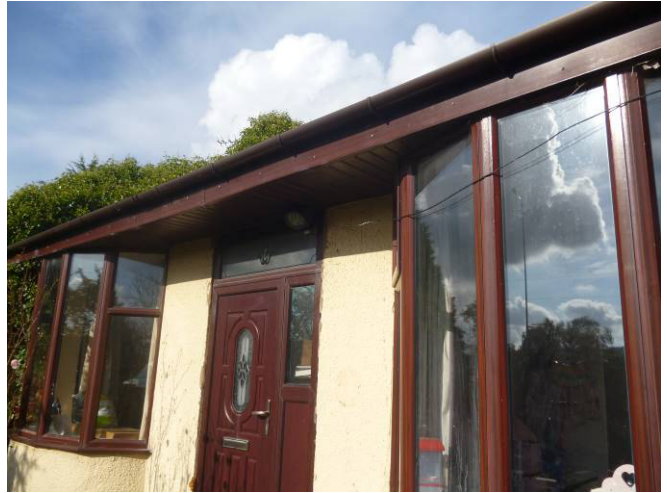
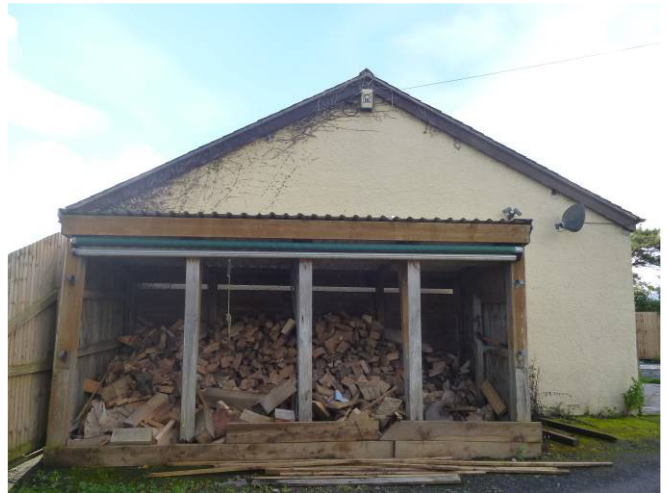
Existing bungalow with negligible bat roost potential.

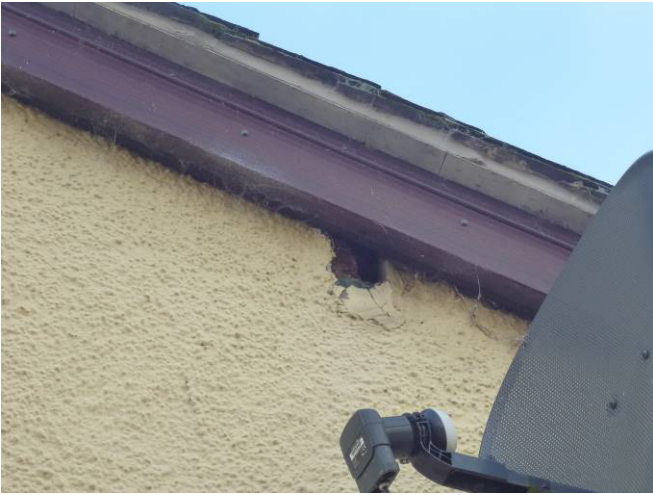
Small hole on east elevation rendered wall requires precautionary inspection with torch / endoscope.

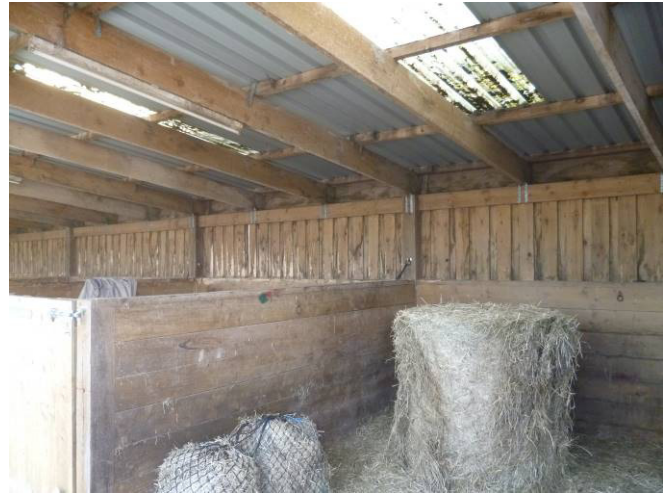
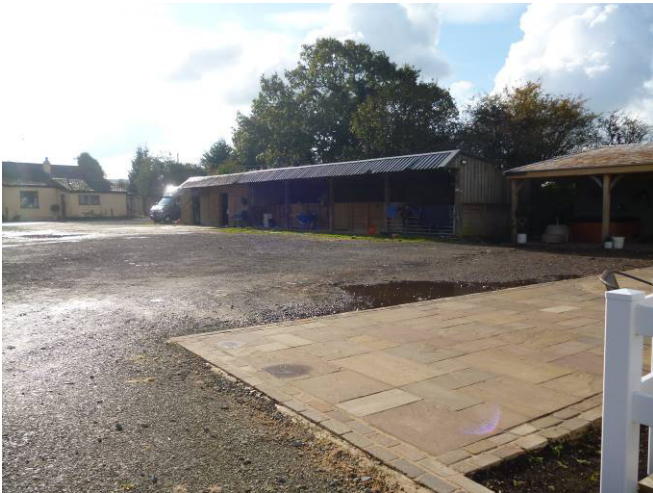
Wooden stable block with negligible bat roost potential.
