# **Preliminary Bat Roost Assessment Report**

**Shenstone,  
Longsight Road,  
Clayton-Le-Dale,  
BB1 9EX**

**18.10.2020**

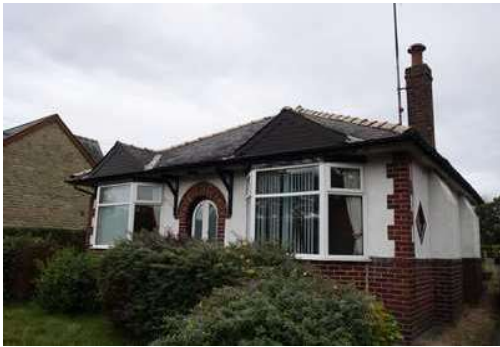
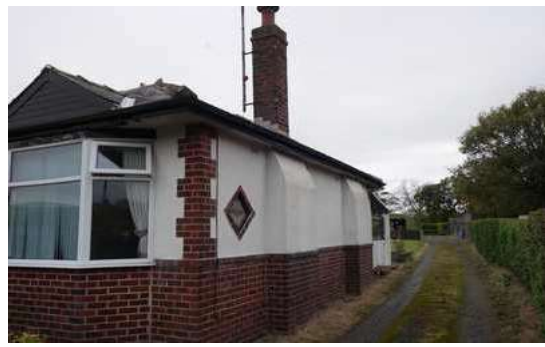
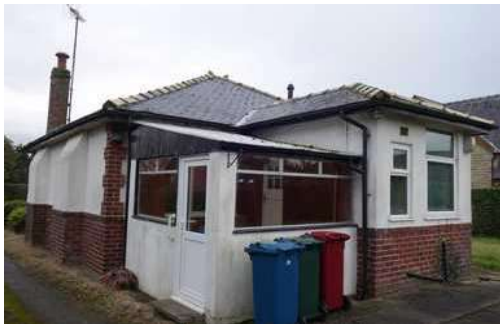
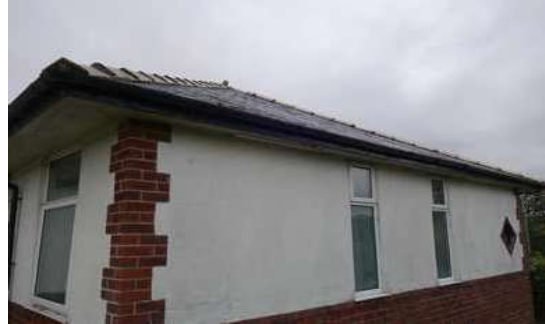
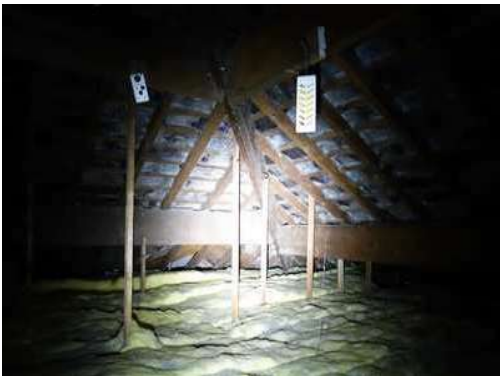
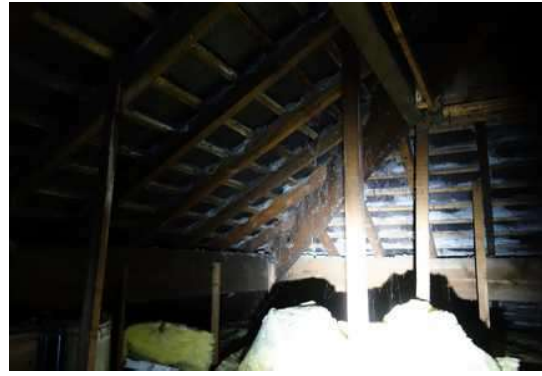
The property consists of a detached brick built bungalow with a hipped slate roof. External walls are well pointed and partially rendered, with no obvious cracks, gaps or crevices, and well sealed. Roof slates are in good condition with no lifted, slipped or missing tiles, ridge tiles are pointed and well sealed. The property has been extended to the rear and has a lean to porch present.

Roof slates are unlined with a plaster and lathe construction in good condition, the loft space is insulated and heavily cobwebbed.

The building can be considered to offer negligible roosting bat potential.

The property was assessed as offering low roosting potential with no obvious gaps or crevices suitable for roosting bats.

No physical evidence of bats grease marks or urine splashing was recorded on or within the building despite suitable horizontal surfaces being present and undisturbed.

No evidence of roosting bats was observed either inside or on the exterior of the building.
