Preliminary Bat Roost Assessment Report

59 Downham Road,
Chatburn,
BB7 4AU

05.10.2020

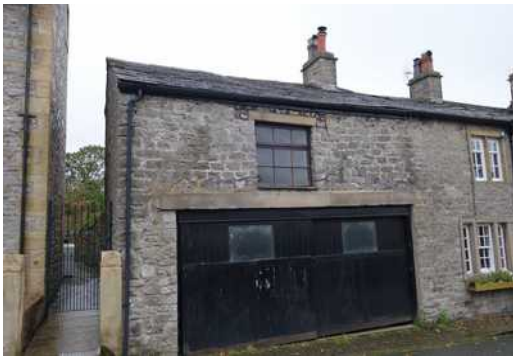
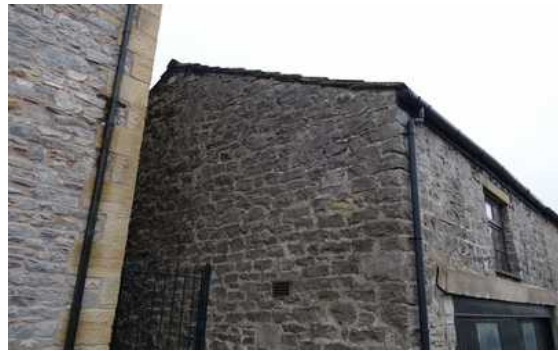
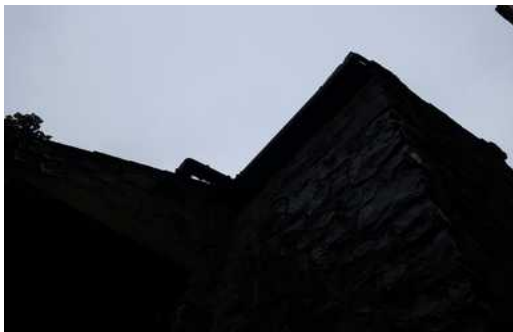
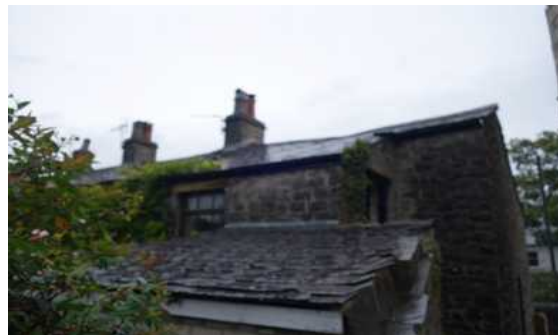
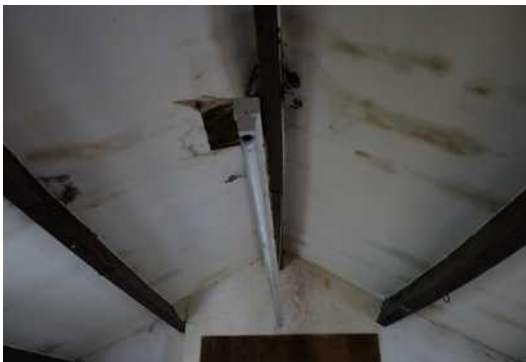
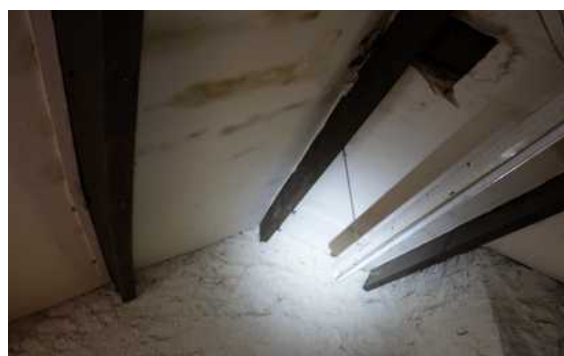
The property consists of a detached two storey stone built outbuilding with a double pitched slate roof, .

External walls have no obvious cracks, gaps or crevices, gable ends are pointed and well sealed. Roof slates are in good condition with no lifted, slipped or missing slates, ridge tiles are pointed and well sealed. The property has no loft space and is lined with a combination of timber and rockwool insulation.

The building can be considered to offer negligible roosting bat potential.

The property was assessed as offering negligible roosting potential with no obvious gaps or crevices suitable for roosting bats.

No physical evidence of bats grease marks or urine splashing was recorded on or within the buildings despite suitable horizontal surfaces being present and undisturbed. No evidence of bats was observed on the exterior of the building.
