# **Arboricultural Impact Assessment Overview**

in Relation to Proposed Construction  
of Detached Residential Property at

**Plot 3, Fairview, Brockhall Village,  
Old Langho, Lancashire, BB6 8HY**

# ARBORICULTURAL IMPACT ASSESSMENT OVERVIEW

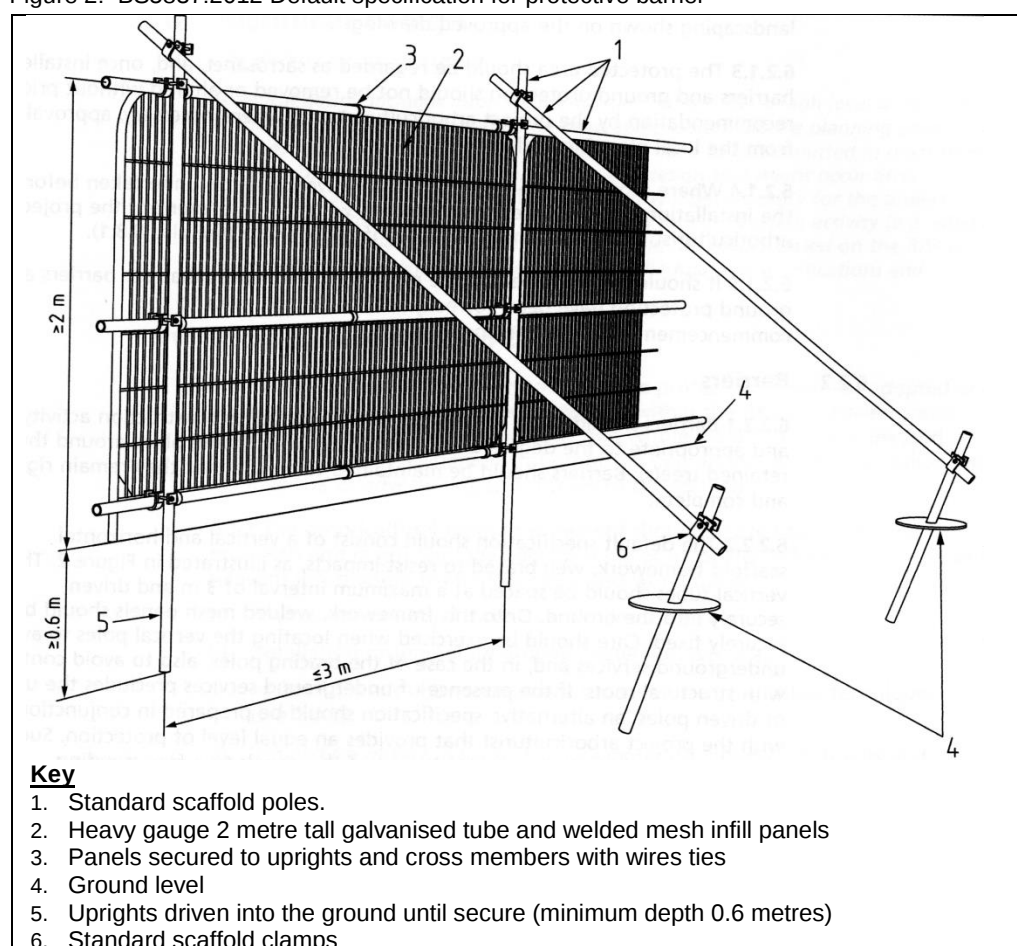
Figure 2: BS5837:2012 Default specification for protective barrier

**Type 1 (i.e. 'Default') Temporary Protective Fencing Construction** (see Figure 2, below)

1. Temporary protective fencing panels shall be weldmesh "Heras" panels of at least 2.0 metres in height.
2. The panels shall butt together and be securely fixed to a scaffold framework, as per points 3 to 5 of Figure 2, overleaf.

3. The scaffold framework shall comprise of upright poles of at least 3.0 metres in length driven no less than 0.6 metres into the ground at maximum 3.0 metre centres with horizontal and diagonal poles fixed to the uprights, as per points 4 to 5.

4. The two horizontal rail poles shall be attached to the uprights at heights of 0.6 and 1.8 metres with 3 no. clamps to each joint.
5. The diagonal scaffold pole struts be clamped to the top rail of the scaffold framework at a 45° angle and extend back into the CEZ and clamped to a 0.7 metre length of scaffold tube that shall be driven no less than 0.5m into the ground.

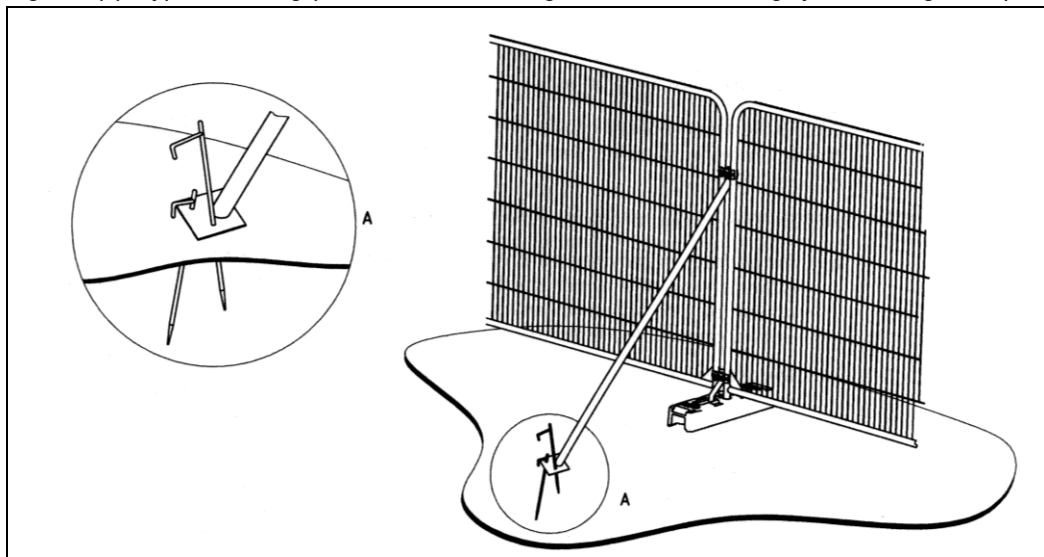
Figure 3(a): Type 2 Fencing (BS5837:2012 above-ground strut stabilising system with ground pins)

### **Type 2 Temporary Protective Fencing Construction** (see Figure 3(a), below)

1. Temporary protective fencing panels shall be weldmesh "Heras" panels of at least 2.0 metres in height.
2. The panels shall stand on rubber or concrete feet.

3. The panels shall butt together, and be joined together using a minimum of two anti-tamper couplers, installed so that they can only be removed from inside the fence.

4. The distance between the fence couplers shall be at least 1.0 metre, and shall be uniform throughout the fence.
5. The panels shall be supported on the inner side by stabiliser struts, which shall be clamped to the scaffold framework at a 45° angle and extend back into the CEZ and shall be attached to a base plate, which shall be secured to the ground with pins (Figure 3a).

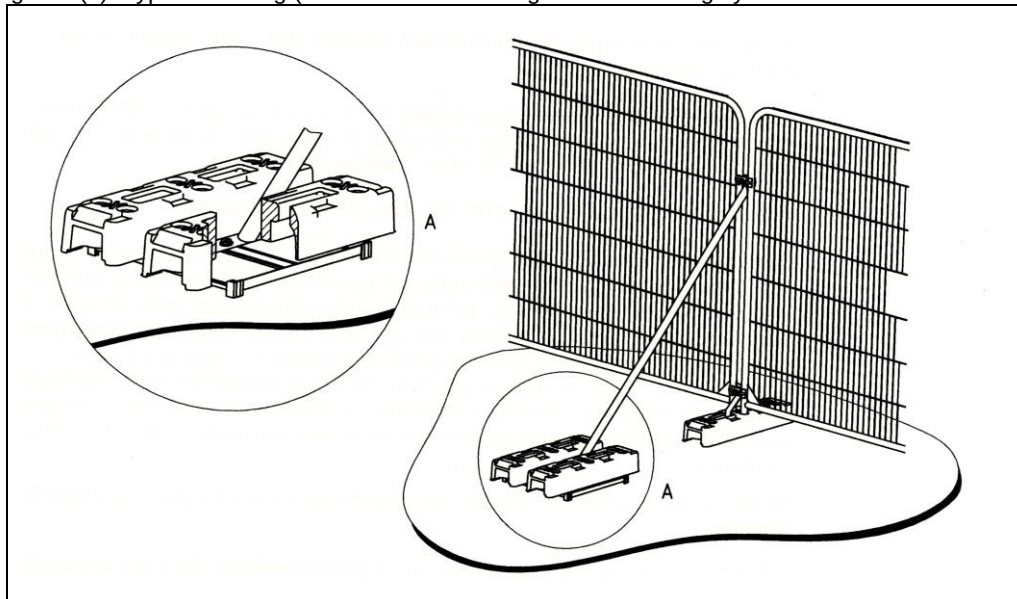
Figure 3(b): Type 3 Fencing (BS5837:2012 above-ground stabilising system with strut on block tray)

### **Type 3 Temporary Protective Fencing Construction** (see Figure 3(b), overleaf)

1. Temporary protective fencing panels shall be weldmesh "Heras" panels of at least 2.0 metres in height.
2. The panels shall stand on rubber or concrete feet.

3. The panels shall butt together, and be joined together using a minimum of two anti-tamper couplers, installed so that they can only be removed from inside the fence.

4. The distance between the fence couplers shall be at least 1.0 metre, and shall be uniform throughout the fence.
5. The panels shall be supported on the inner side by stabiliser struts, which shall be clamped to the scaffold framework at a 45° angle and extend back into the CEZ and shall be attached to a block tray base (Figure 3b).

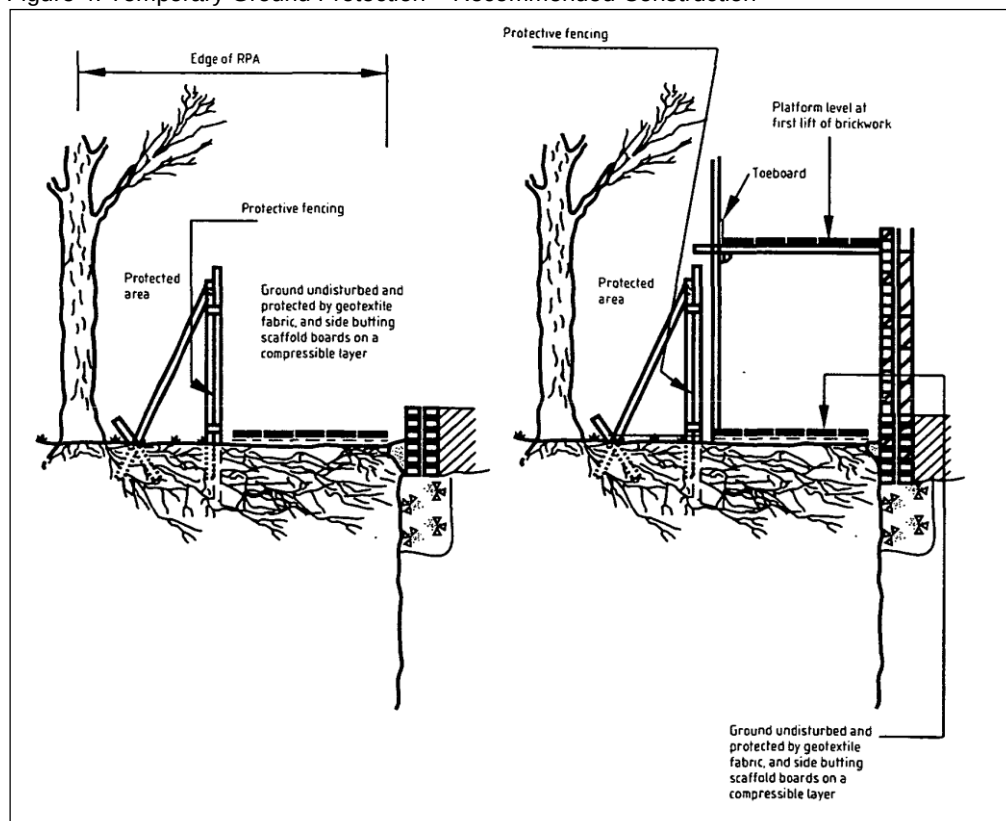
Figure 4: Temporary Ground Protection – Recommended Construction

### Temporary Ground Protection

1. Any necessary Temporary Ground Protection areas shall conform to Figure 4, below, unless otherwise agreed with the LPA.
2. The Ground Protection Area shall be left undisturbed and covered by a semi-permeable geotextile membrane which shall, in turn, be covered by a compressible layer consisting of a material such as woodchip.
3. Side-butting scaffold boards shall then be fitted to cover the Ground Protection Area.
4. On completion of installation, and prior to any demolition or construction works, site preparation, excavation or delivery of plant and materials, the Consulting Arboriculturist or the LPA Tree Officer, as agreed, shall inspect the Temporary Ground Protection.
5. The Temporary Ground Protection shall remain in place until completion of the project and only removed following receipt of written permission from the LPA.
