## Preliminary Bat Roost Assessment

Site: Ash Croft, Mill Lane  
Off Slaidburn Road  
Waddington BB7 3JJ

31<sup>st</sup> October 2020

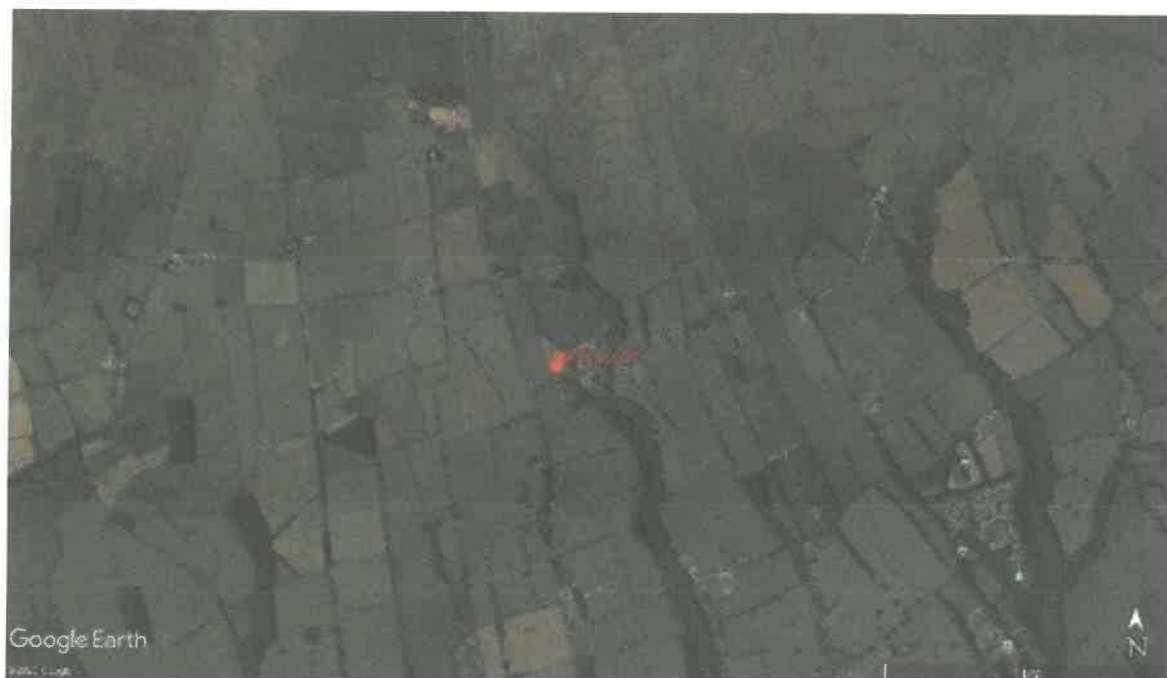
Figure 1: Aerial photo of site, showing surrounding landscape structure

The site is located within a small hamlet in a rural agricultural setting, with further agricultural and converted residential buildings in close proximity. The landscape is dominated by large fields of pasture and grass crops, with hedges, woodland and tree lines around the area, which could be used for foraging and commuting by bats. Adjacent to the south is the large stretch of ancient semi-natural woodland known as "Feazer Wood" which follows Waddington brook south towards Waddington and on to the River Ribble. This habitat together with Cuttock Clough to the north will be an important local food and refuge resource for bats. Other habitats including semi-improved grassland, areas of deciduous woodland and irrigation ditches around the area will also provide abundant insect foraging for bats.

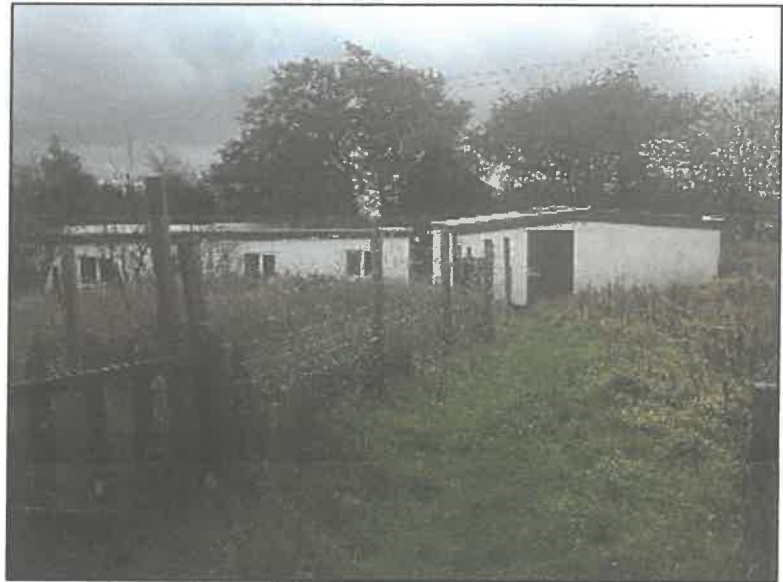
The residential and out building are mainly rendered cement block construction, with timber cladding to some elevations.

The roof of both buildings is felted plywood. The main area of roof is flat with a low dual pitched section to the outbuilding, the ridge running north – south.

Photo 1: North elevations of house and outbuilding, showing roof pitches.

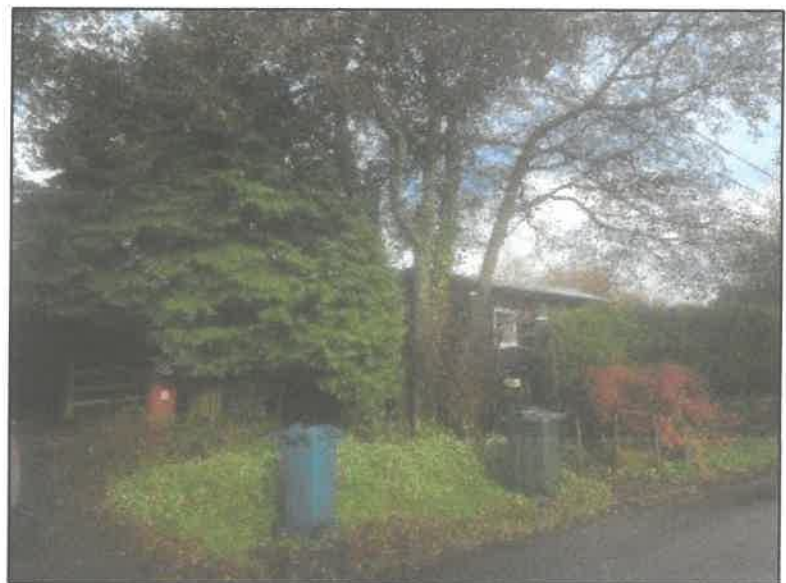
The south elevation is fronted by large mature alder trees, and some large conifers.

Photo 2: South elevation, showing mature trees and shrubs.

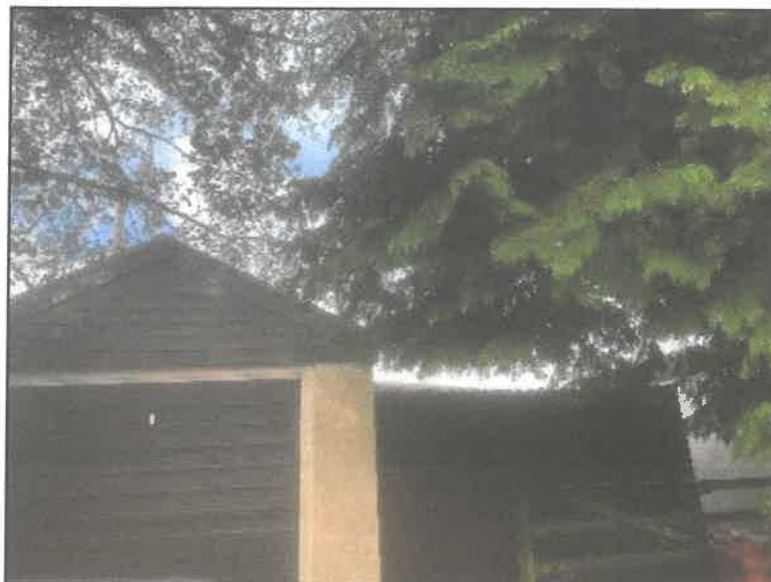
The south elevation of the outbuilding is timber clad, with an “up and over” garage door. The door and cladding are all in a reasonable state of repair with no gaps in materials allowing ingress to the interior by bats or birds.

Photo 3: South elevation of the outbuilding.

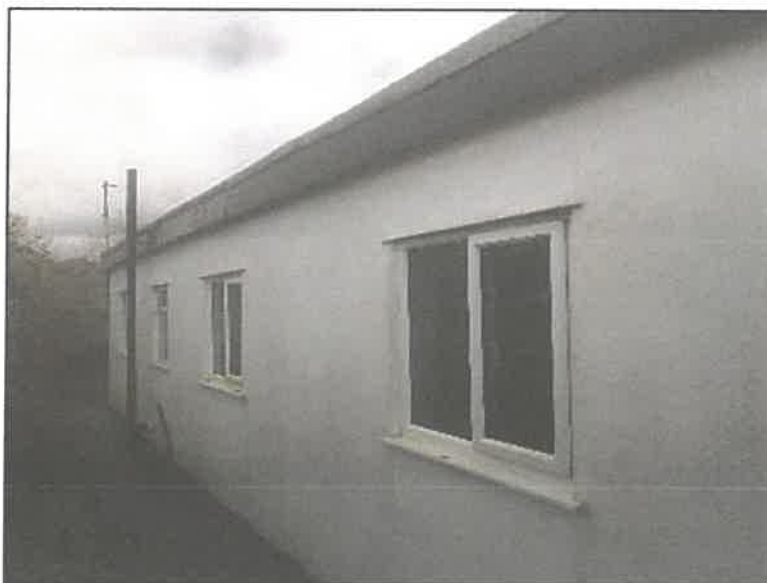
The windows of the residential building are uPVC and close fitting.

Photo 4: uPVC windows to the north elevation..

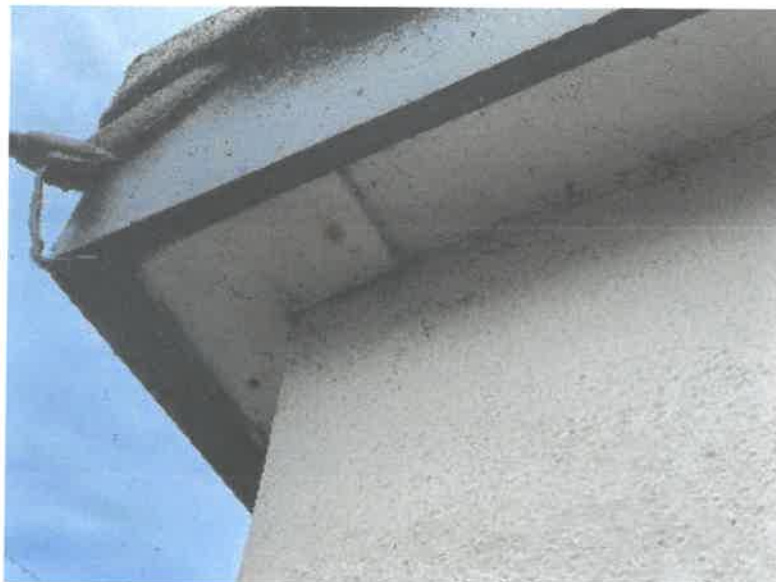
The soffit boxes and roofing materials are all in a good state of repair, with no gaps or missing or rotting materials.

Photo 5: Example close-up of soffit boxes and eaves

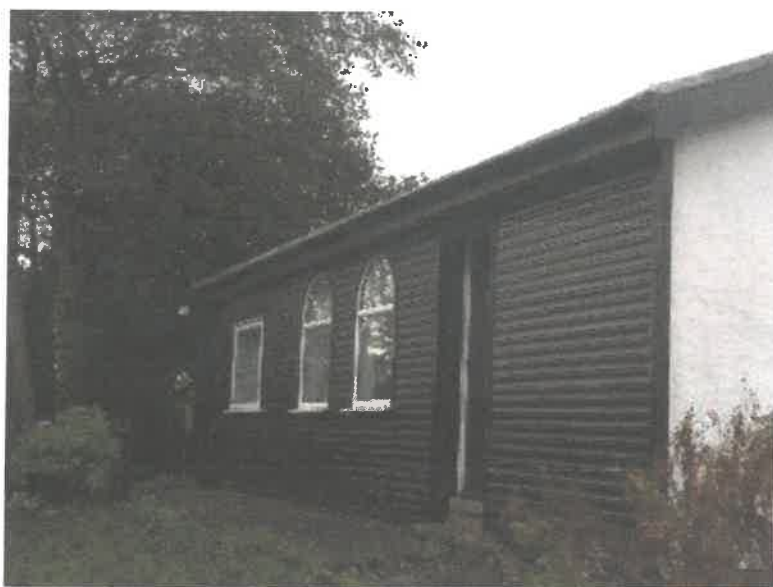
The front (south) elevation of the property has uPVC windows, and timber cladding. All materials are in a good condition, with no gaps or niches typically used by roosting bats.

The mature trees and shrubs to the front of the property, whilst having low potential for roosting bats, have good potential nesting and foraging habitat for the local breeding bird population.

Photo 6: South elevation of property, with mature trees in the background.

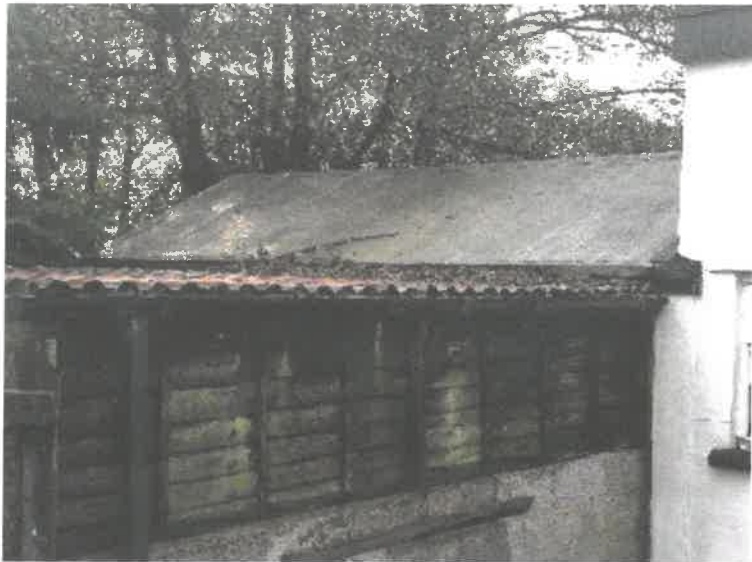
One section of the outbuilding has a metal sheet roof, and timber cladding. Only one gap was visible to the inside, and there were no signs that this has been used by bats, such as grease marks or urine staining.

Photo 7: Rear of open outbuilding.

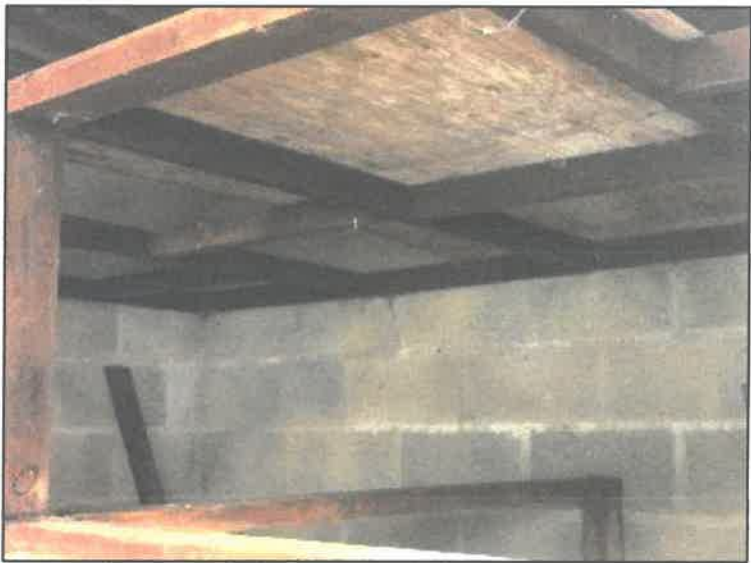
The main outbuilding is in a good state of repair with no gaps to the outside visible. The timber roof construction was visible in the section surveyed.

The space is light and airy, with open access to the front.

Photo 8: Internal view of the roof construction.

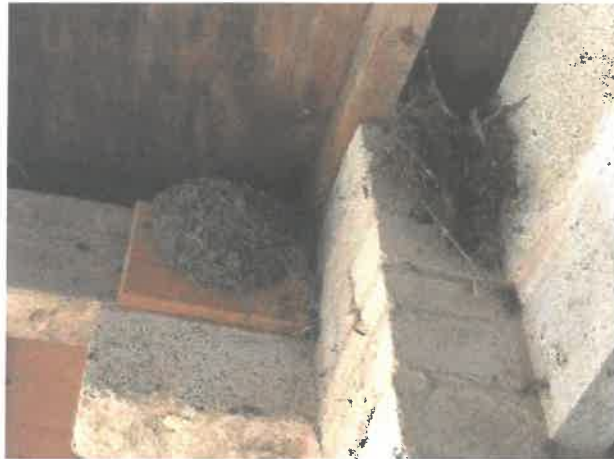
In the open section of the outbuilding there is a swallow nesting cup and nesting material close by, suggesting that this building is used by breeding swallows or other birds.

Photo 12: Swallow nest cup and adjacent nesting materials

<p>This building contains evidence of nesting birds.</p> <p>.</p>	<p>Active nests could be destroyed during building/vegetation removal.</p> <p>Any works which affect The Site could have an impact on nesting birds.</p>	<p>Any building/tree and scrub removal should be undertaken outside the period 1st March to 31st August. If this timeframe cannot be avoided, a close inspection of the building and scrub to be removed should be undertaken by a suitably qualified ecologist, immediately prior to clearance. All active nests will need to be retained until the young have fledged.</p>	<p>Install a minimum of two bird boxes on retained trees/buildings on site e.g. Schwegler swallow nest cups, placed under the eaves</p> <p>Schwegler 1SP Sparrow Terrace</p> <p>Schwegler 1B nest boxes</p> <p>Schwegler 2H Robin Boxes</p> <p>Nest boxes should be positioned approximately 3m above ground level where they will be sheltered from prevailing wind, rain and strong sunlight.</p>
