Arboricultural Impact Assessment Overview

in Respect of a Proposal to Demolish Existing Dwelling and Construct a Replacement Dwelling at

Ashcroft, Mill Lane, Waddington, Lancashire, BB7 3JJ

ARBORICULTURAL IMPACT ASSESSMENT OVERVIEW ASHCROFT, MILL LANE, WADDINGTON

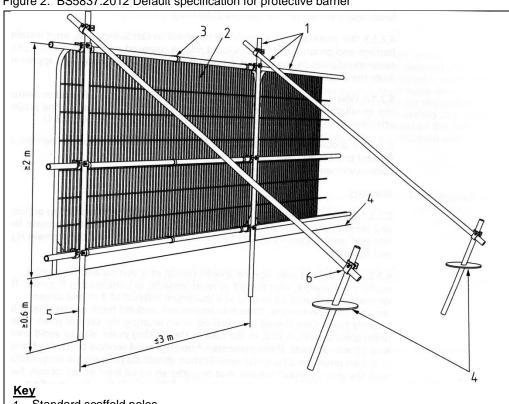
Figure 2: BS5837:2012 Default specification for protective barrier

- 1. Standard scaffold poles.
- Heavy gauge 2 metre tall galvanised tube and welded mesh infill panels
- Panels secured to uprights and cross members with wires ties
- Uprights driven into the ground until secure (minimum depth 0.6 metres)
- Standard scaffold clamps

Type 1 (i.e. 'Default') Temporary Protective Fencing Construction (see Figure 2, below)

- 1. Temporary protective fencing panels shall be weldmesh "Heras" panels of at least 2.0 metres in height.
- 2. The panels shall butt together and be securely fixed to a scaffold framework, as per points 3 to 5 of Figure 2, overleaf.

- 3. The scaffold framework shall comprise of upright poles of at least 3.0 metres in length driven no less than 0.6 metres into the ground at maximum 3.0 metre centres with horizontal and diagonal poles fixed to the uprights, as per points 4 to 5.

- 4. The two horizontal rail poles shall be attached to the uprights at heights of 0.6 and 1.8 metres with 3 no. clamps to each joint.
- 5. The diagonal scaffold pole struts be clamped to the top rail of the scaffold framework at a 45° angle and extend back into the CEZ and clamped to a 0.7 metre length of scaffold tube that shall be driven no less than 0.5m into the ground.

- 6. No fixing shall be made to any tree and all possible precautions shall be taken to prevent damage to tree roots when locating posts.
- 7. A 600mm x 300mm warning sign reading "TREE PROTECTION AREA KEEP OUT" (see Figure 1) shall be fixed to every 10.0 metre length of protective fencing.

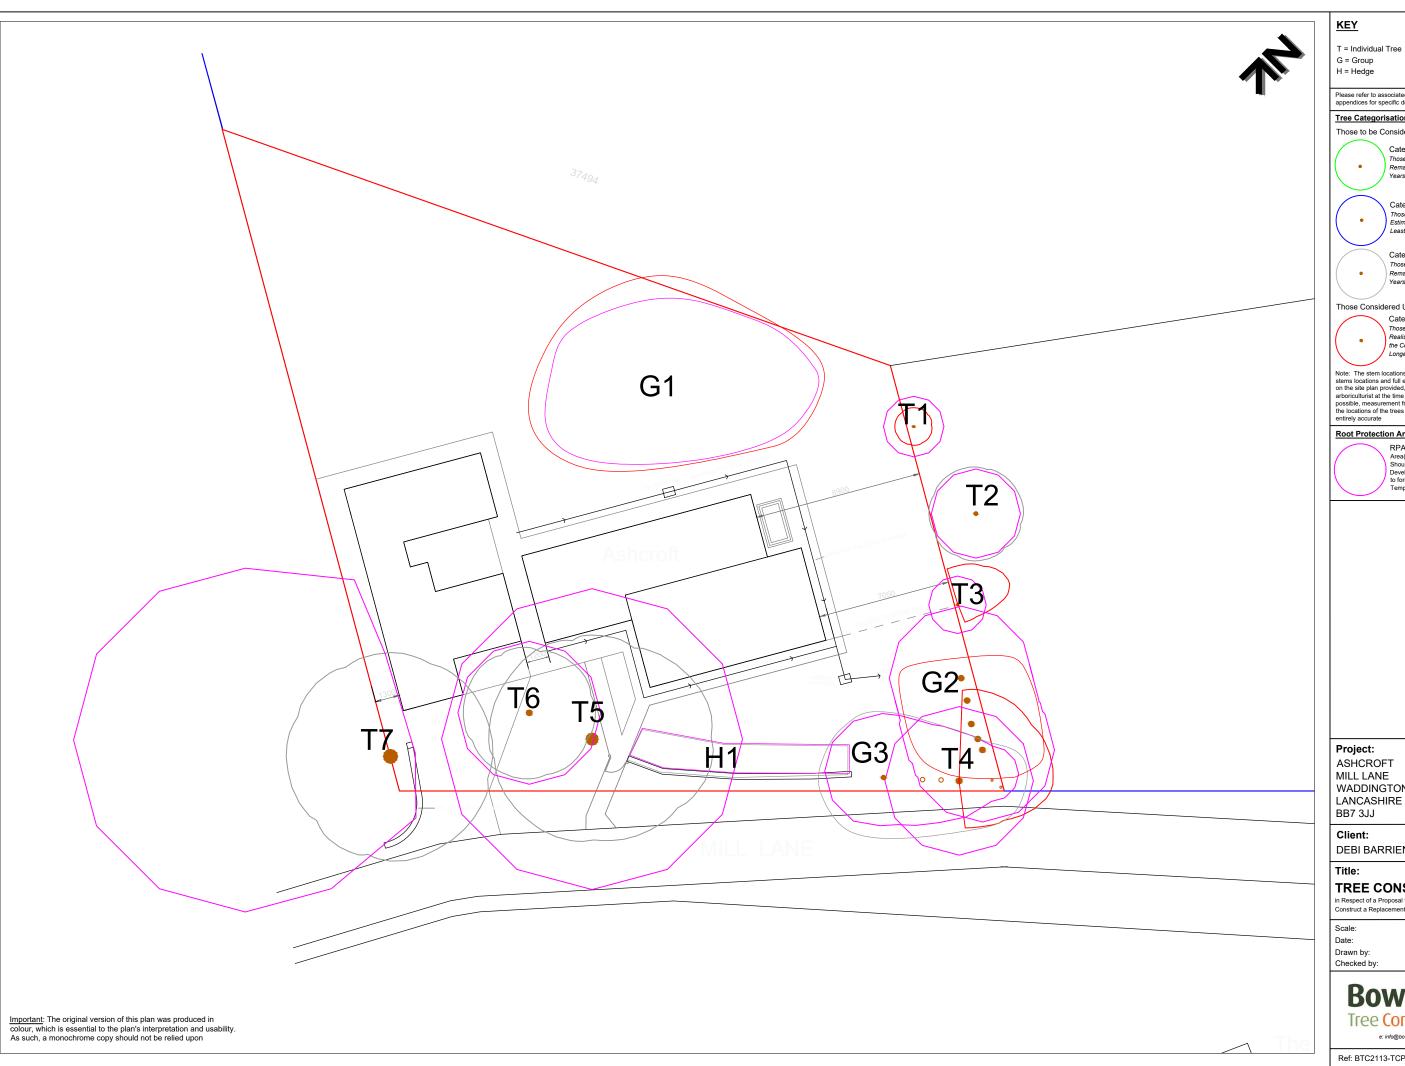
TREE CONSTRAINTS PLAN

Note: The stem locations of trees T1, T2 and T3, and the stems locations and full extents of the groups, were not included on the site plan provided, and were subsequently plotted by the arboriculturist at the time of the survey using GPS and, where possible, measurement from existing site features. As such, the locations of the trees cannot therefore be considered to be entirely accurate

RIPAS
Area(s) of Ground Around Trees that
Should be Protected Throughout
Development Works with Protective Fencing
to form a Construction Exclusion Zone - see
Temporary Protective Fencing Specification

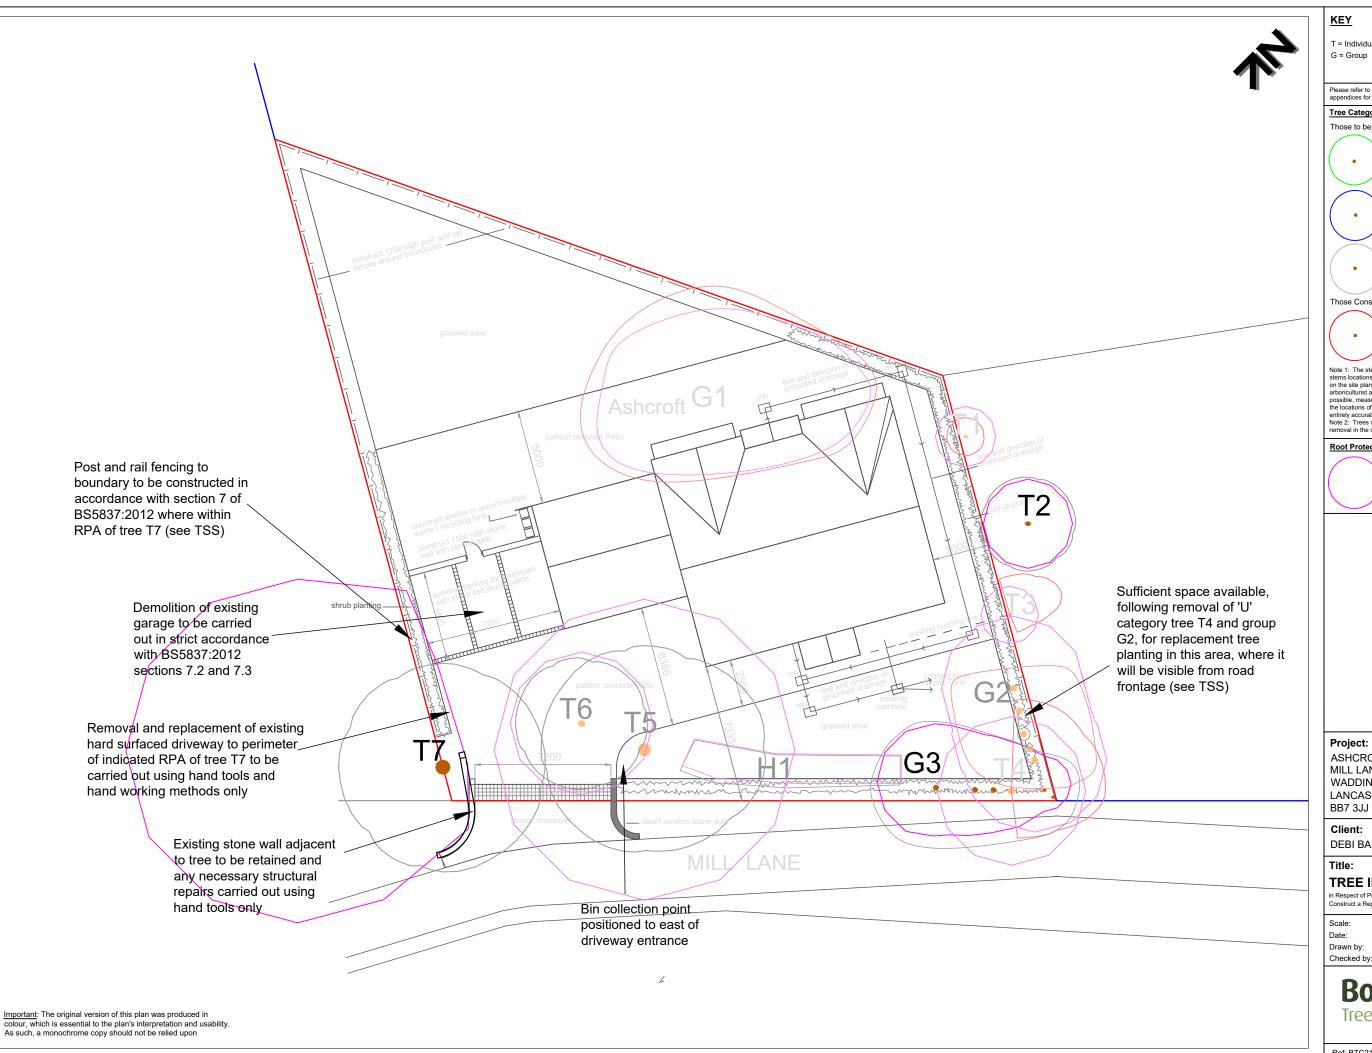
TREE IMPACT PLAN

Note 1: The stem locations of trees T1, T2 and T3, and the stems locations and full extents of the groups, were not included on the site plan provided, and were subsequently plotted by the arboriculturist at the time of the survey using GPS and, where possible, measurement from existing site features. As such, the locations of the trees cannot therefore be considered to be entirely accurate.

Area(s) of Ground Around Trees that Should be Protected Throughout
Development Works with Protective Fencing
to form a Construction Exclusion Zone - see
Temporary Protective Fencing Specification
